To Inspect Vehicle No: SHC 1472D Insured: SLG 85875at Workshop m/s Comfortdugro Tel: 62148300of 59 Layan DrivePolicy No: MV 009304 Claim No: M1904920

Make: Hyundai Santa Fe C.C. 1901Colour: Blue A/C: Insured / Std / NI / NASp. Reading: 382776 T/Radio: Insured / Std / NI / NA

VEHICLE DAMAGE INSPECTION REPORT

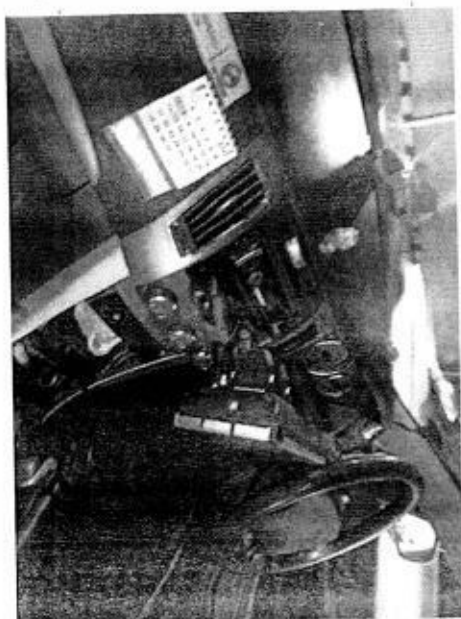
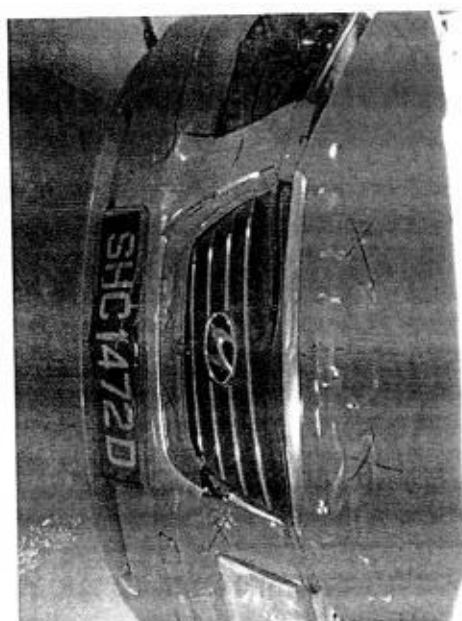
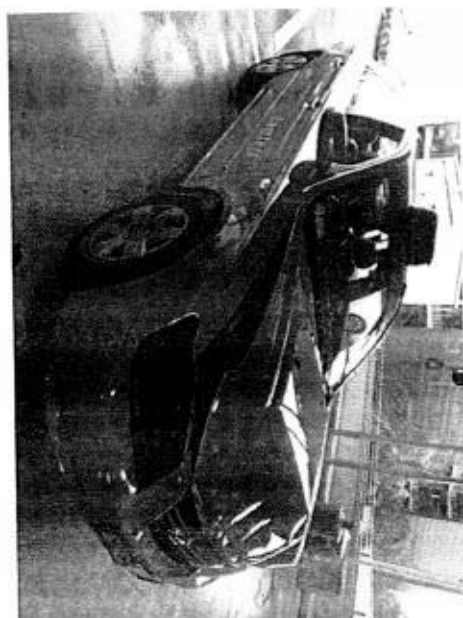
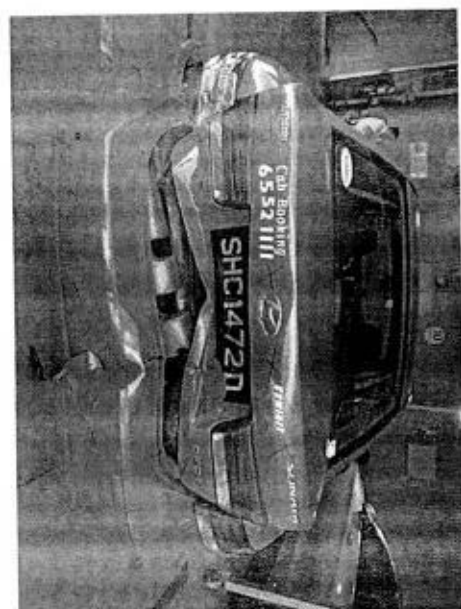
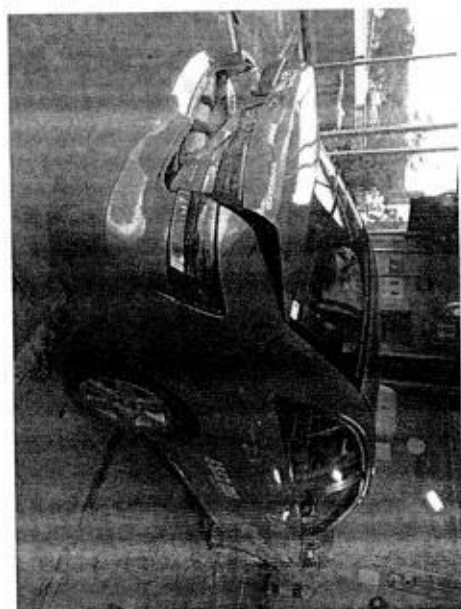
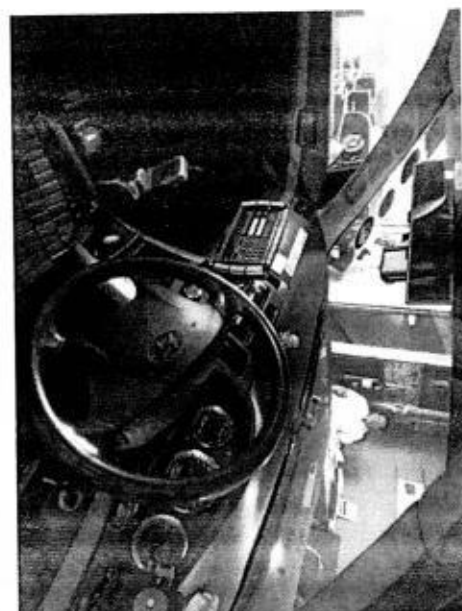
Remark: The veh had commenced its repair at the time of inspection.

BS / DUN / EXNOVA / GY / FS / LIZA / MIC / OHTSU / PIR / SUMI /
TOYO / YOKO or WestlakeFront 7 mm Rear 7 mmR/Bal. 7 mmL/Bal. 7 mmD.O.A. 2/7/12 D.O.I. 4/7/12Survey held at CPHE (Loyang)Des. of Damages: Frt / Rear / O/S / N/S / U/C / Rooftop or
Front / Rear

The U/C / Chassis frame / Body Structure affected due to collision.

PLEASE BE INFORMED OWNER THAT THE VEHICLE NOT ECONOMICAL FOR REPAIR.

IN VIEW OF THE ABOVE, THE VEHICLE IS UNECONOMICAL TO BE REPAIRED
