ACCIDENT REPAIR ON: SLT3510C

VEHICLE DAMAGE INSPECTION REPORT

Our File No: CS/CTI19011947/GTF3N2

Reg No:	SLT3510C	Engine No:	27091030423943
Make & Model:	MERCEDES-BENZ A180 R18, 1.6 (A)	Chassis No:	WDD1760422J286314
Reg. Date:	23/07/2014 (Man. Year: 2014)	Odometer:	82885 km
Colour:	Grey		
Engine Capacity:	1595 cc		
Market Value/New Car Price:	N/A		
Sum Insured (\$\$):	Market Value/New Car Price

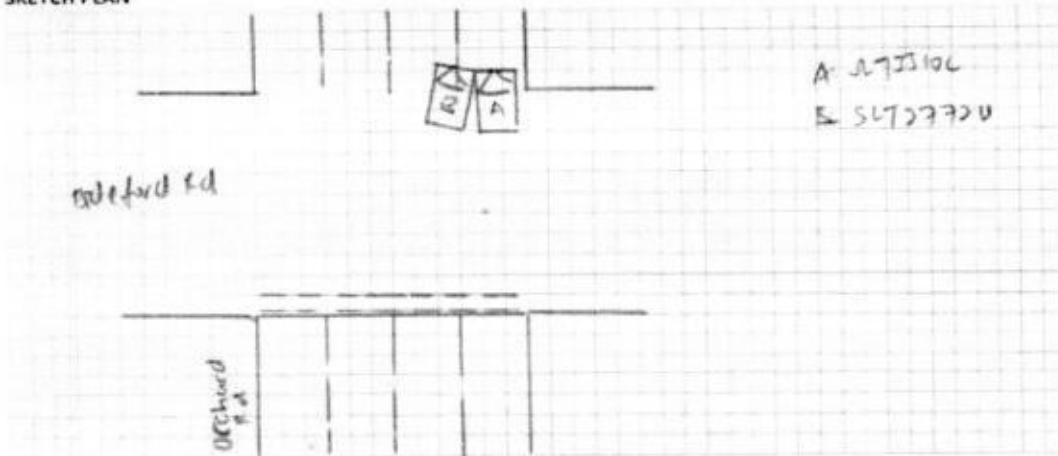
SKETCH PLAN

ON STATED DATE AND TIME, I WAS TRAVELLING STRAIGHT ALONG THE STATED VENUE. SUDDENLY I FELT AN IMPACT OF MY VEHICLE AND REALIZE THAT VEHICLE B HIT ONTO MY VEHICLE FRONT LEFT PORTION.
