1. Policy Particulars :- THIRD PARTY CLAIM			
Insured Veh.	FBM 2650T	Veh. Inspected	SLW 9870H
Policy No.		Coverage (\$)	0.00
Claim No.	C20003432/JW	Excess (\$)	0.00
Assign From	IVY RATILLA	Assign Date	09/07/2019

4. Description of Damages			
THE VEHICLE SUSTAINED DAMAGES AT THE REAR O/S PORTION. DAMAGES SEE DETAILS.			
5. General Information			
Accident Date	05/07/2019	Inspection Date	09/07/2019
Survey held at	FASTECH AUTO PTE LTD 1 KAKI BUKIT AVENUE 6 #01-46/48/50 AUTOBAY SINGAPORE 417883		
5a. Remarks

ADJUSTMENT ON REPAIR COST FOR VEHICLE NO. SLW 9870H

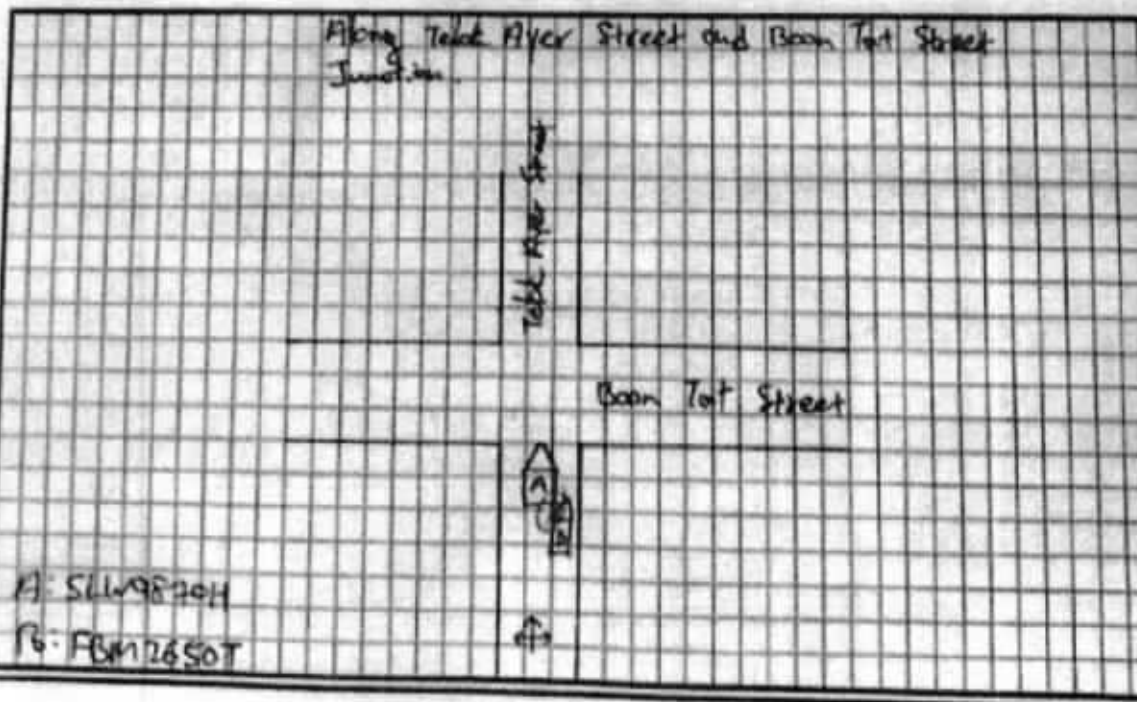
Sketch Plan

I was driving my along Telok Ayer Street and Boon tat Street junction. When I was stationary at the junction to checking my blind spot and turning to the right. Suddenly a motorcycle hit onto my car rear right side position. Damages of my car rear right side position. No injuries were involved.
