Veh No SKR 7107E

Make: Honda Vezel 1.5

PRE-REPAIR SURVEY NOTICE - ACCIDENT INVOLVING SKR7107E & SMM1090K (MSIG) ON 07/07/2019

VEHICLE DAMAGE INSPECTION REPORT

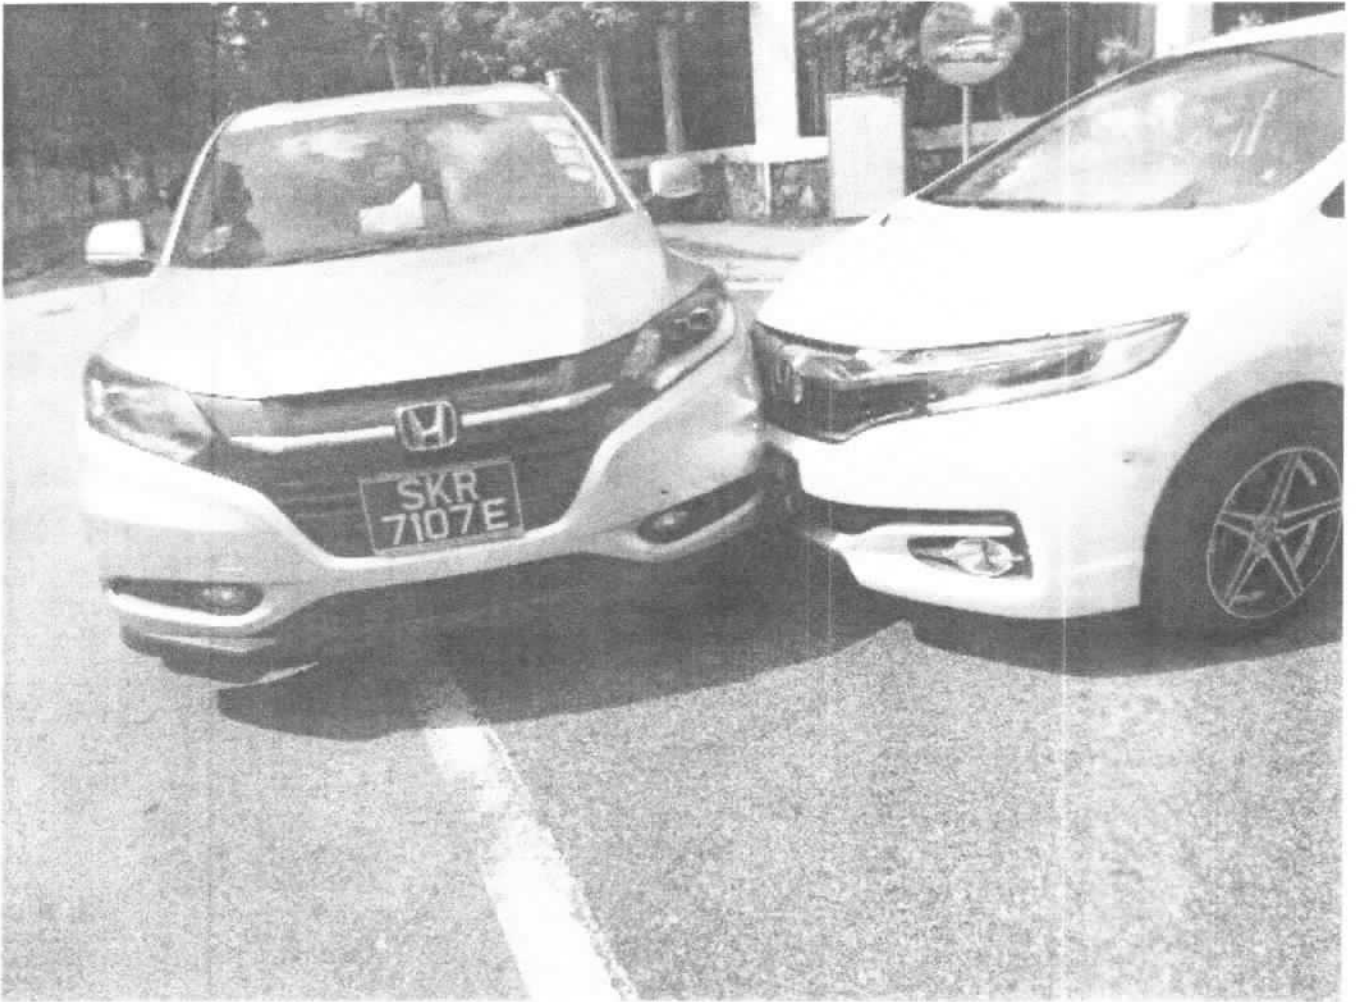
Accident Photo

MY VEHICLE WAS TRAVELLING STRAIGHT ALONG FLOWER ROAD. I WAS GOING STRAIGHT AHEAD. VEHICLE B ON THE SIDE ROAD (KOVAN ROAD) FAILS TO STOP AND LOOKOUT FOR ONCOMING TRAFFIC AND DROVE PAST THE STOP LINE, THUS HIT ONTO MY VEHICLE FRONT LEFT PORTION. NO ONE WAS INJURED.

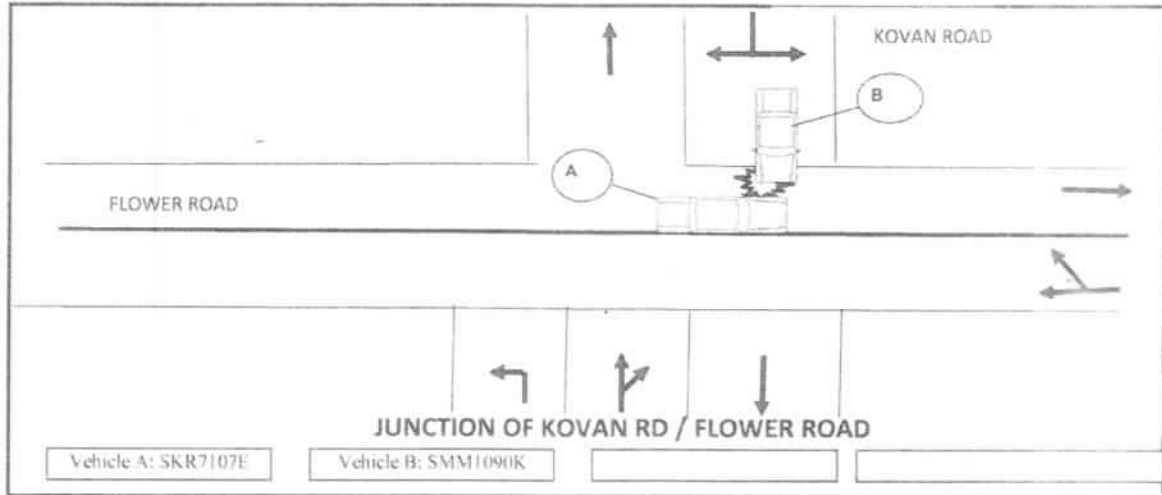
SKETCH PLAN

MY VEHICLE WAS TRAVELLING STRAIGHT ALONG FLOWER ROAD. I WAS GOING STRAIGHT AHEAD. VEHICLE B ON THE SIDE ROAD (KOVAN ROAD) FAILS TO STOP AND LOOKOUT FOR ONCOMING TRAFFIC AND DROVE PAST THE STOP LINE, THUS HIT ONTO MY VEHICLE FRONT LEFT PORTION. NO ONE WAS INJURED.
