| Affiliated to Federation Internationale Des Experts En Automobile | | | | |
|---|---|---|---|---|
| BLUWEL AUTOMOTIVE SERVICE PTE LTD | | Ref : CS/TP19012161/Uqd3n2 | | |
| THE VEHICLE SUSTAINED DAMAGES AT THE O/S REAR PORTION.THE UNDERCARRIAGE AFFECTED DUE TO COLLISION.<br><br>DAMAGES SEE DETAILS. | | | | |

## ADJUSTMENT ON REPAIR COST FOR VEHICLE NO. SKF 7436T

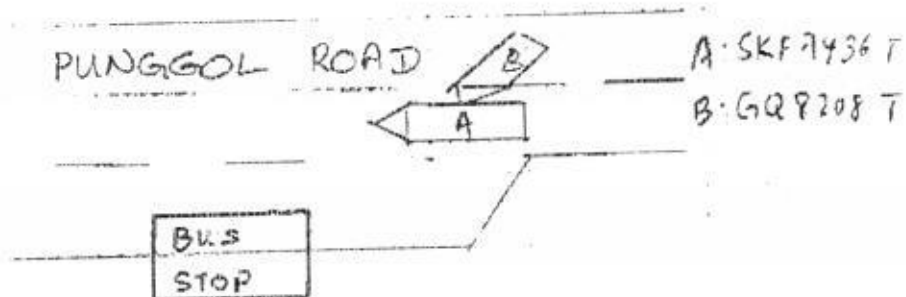
## SKETCH PLAN

## DESCRIBE CIRCUMSTANCES OF THE ACCIDENT

My car was travelling straight in the most left lane and  
a van hit onto my vehicle.
