SMF 182Y

Preliminary Advice

Vehicle No	: SMF182Y	Accident Date	: 10/07/2019
Make	: MERCEDES-BENZ GLS400	Policy No.	: 999995580
Assignment Date	: 12/07/2019	Excess	: S\$0.00
Date of Inspection	: 12/07/2019	Est. Duration of Repair	: 4.00
Inspection At	: TONG LUCK AUTO PTE LTD (HQ) 160 SIN MING DRIVE, #07-01 SIN MING AUTOCITY SINGAPORE 575722

VEHICLE DAMAGE INSPECTION REPORT

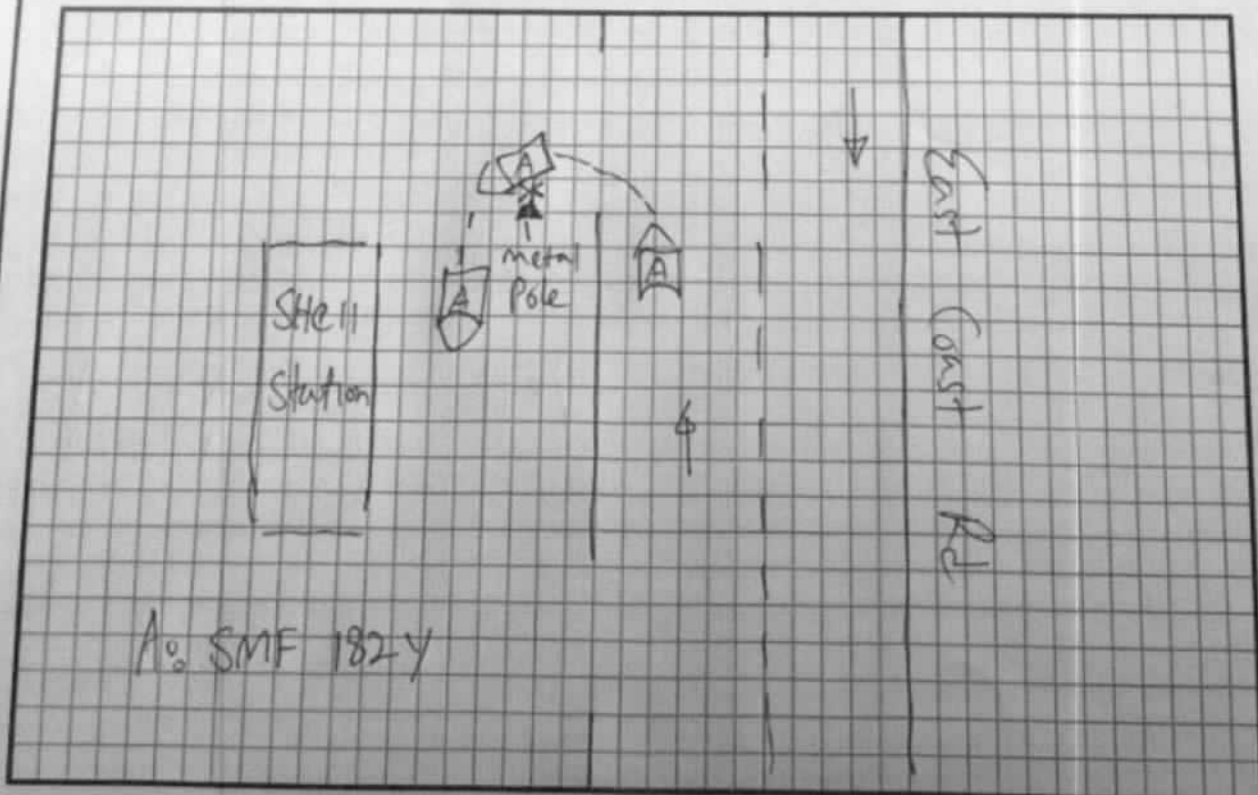
Sketch Plan

Making a left turn to SHELL STATION. While turning, accidentally brushed onto the metal pole. The pole was still intact, only the paint a bit chip.
