Preliminary Advice

Vehicle No	: SLG2627A	Accident Date	: 09/07/2019
Make	: HONDA CIVIC	Policy No.	: D18MTRENT000661
Assignment Date	: 12/07/2019	Excess	: S\$750.00
Date of Inspection	: 12/07/2019	Est. Duration of Repair	: 3.00
Inspection At	: HITACHI CAPITAL ASIA PACIFIC PTE. LTD (HQ) NO 8 FOURTH LOK YANG ROAD SINGAPORE 629705

VEHICLE DAMAGE INSPECTION REPORT

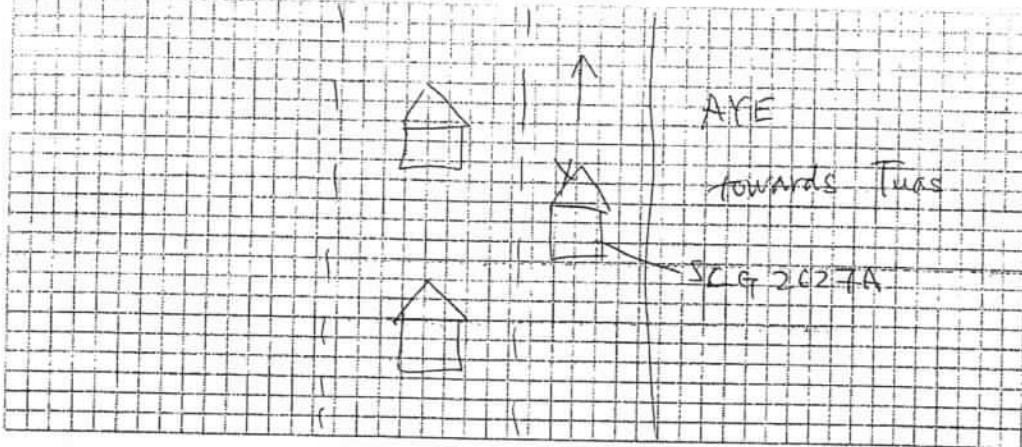
SKETCH PLAN

I, SLG2627A was driving on AYE towards Tuas near Norman Park Exit. I found something (like tree) in my front but couldn't turn to next lane.
