MSIG Insurance (Singapore) Pte. Ltd. LKK Auto Consultants Pte Ltd To: 51 Ubi Ave 1 #01-25 4 Shenton Way Paya Ubi Industrial Park #21-01 SGX Centre 2 Singapore 408933 Singapore 068807 Date: 22 Jul 2019 Pauline Tham Attn: **Preliminary Advice** Insured Vehicle No : SLF6116L : 17/07/2019 Accident Date TP Vehicle No : SLL9684L Assignment Date : 19/07/2019 : CHEVROLET ORLANDO Make Est. Duration of Repair : 4.00 Date of Inspection : 19/07/2019 HOCK WAH MOTOR WORKSHOP PTE LTD (TAMPINES) Inspection At

VEHICLE DAMAGE INSPECTION REPORT

CS/MSG19012756/UVF3E2

CHEVROLET ORLANDO, 1.4 Turbo (A)

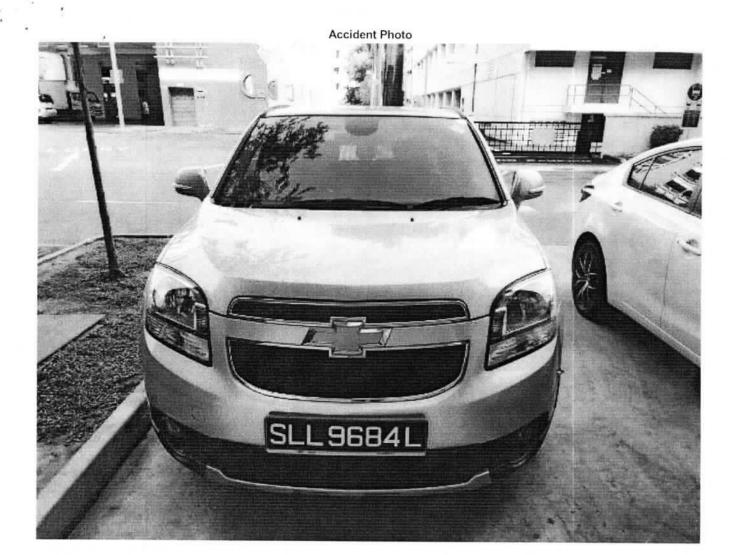
Sketch Plan #2

ON THE STATED DATE & TIME, THERE'S VEHICLES MOVING SLOWLY ALONG PASIR RIS DRIVE 8 & PASIR RIS CENTRAL T-JUNCTION. I SLOWED BEFORE THE YELLOW BOX AT THE PASIR RIS DRIVE 8 TO WAIT THE FRONT VEHICLES TO CLEAR BEFORE MOVING AHEAD . VEHICLE B FROM THE PASIR RIS CENTRAL TURNED LEFT GOING TOWARDS PASIR RIS DRIVE 8 DIDN'T SAW ME AND COLLIDED WITH MY VEHICLE FRONT LEFT PORTION. THERE WERE NO INJURIES INVOLVED. 1 PAX ON VEHICLE A AND 1 PAX ON VEHICLE B.

SKETCH PLAN	PANIR XIS COMTABL PASIR RIS ORIUS 8	09 322 96842 69 32F 61162
DESCRIBE CIRCUMSTANC	ES OF THE ACCIDENT	
	cappe to the night	
	The same of the sa
