MOTOR SURVEY ASSIGNMENT

Affiliated to Federation Inter	nationale Des Experts En Auton	nobile	
MS FIRST CAPITAL	INSURANCE LTD	Ref : CS/FCI190128	84/Ktf3e2	
86 ROBINSON ROAD #16-01 CITY HOUSESINGAPORE 068877		Date: 18-03-2020 Code: FCI2		
	Policy Particu	lars :- THIRD PARTY CLA	IM	
Insured Veh.	SHC 3959D	Veh. Inspected	SKS 2001D	
Policy No.		Coverage (\$)	0.00	
Claim No.	D19004738MFSH	Excess (\$)	0.00	
Assign From	SERENE LER	Assign Date	22/07/2019

ADJUSTMENT ON REPAIR COST FOR VEHICLE NO. SKS 2001D

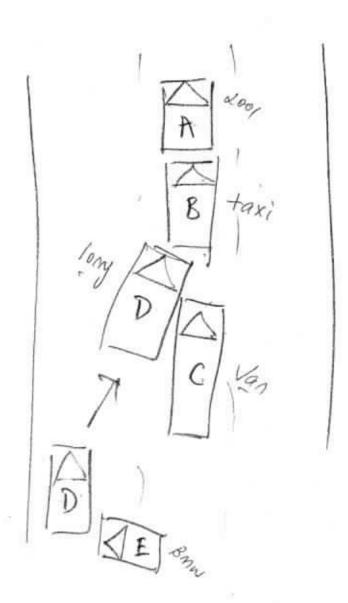
Sketch Plan Pg. 2

SKETCH PLAN
Relu Attach ekcetch
DESCRIBE CIRCUMSTANCES OF THE ACCIDENT
I was travelling along buillenard Food towards
Changi for a meeting.
4
As I was warting at the traffic junction. I
suddenly heard & loud bong. I som a taxi had collided into my year from my rear View morn Then I turn into
a snall road slightly ahead in order not to obstruct the traffic
a small road slightly ahead in order not to obstruct the trappy
After I parked my car safely I alighted my car and realised that I was the dirst vehicle involved in a chain collision.
Nobody was injured during the accident
& Repair other workshop*
We declare the foregoing particulars are true in every respect. All To Im All To Im Centre Personnel's Signature Reporting Centre Personnel's Signature
ate & Time: (If driver is not the policyholder) Name: ompany Chop (if applicable) Date & Time: NRIC/FIN No.:

A=SKS2001D B=S4C3959D C=6894794E D=YP1119E E=SKN8860C
