Insured Vehicle No	: SLH1266J	Accident Date	: 22/07/2019
TP Vehicle No	: SMG6533Z	Assignment Date	: 24/07/2019
Make	: HONDA FIT	Est. Duration of Repair	: 4 days
Date of Inspection	: 25/07/2019		
Inspection At	: Cartimes Autolotion (HQ) 160 Sin Ming Drive #02-04 Autocity Singapore 575722

VEHICLE DAMAGE INSPECTION REPORT

Our File No: CS/SMO19013065/KSF3N2

Handling Insurer:	Sompo Insurance Singapore Pte. Ltd.	Policy No:	D18MTPV01017898
Claimant Vehicle No :	SMG6533Z	Insured Vehicle No :	SLH1266J
Date of Loss:	22/07/2019	Nature of Claim:	TP
		Claim No:	CMTD1903536

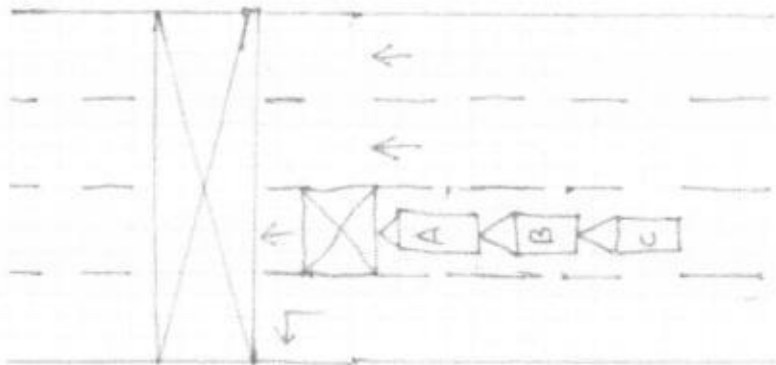
SKETCH PLAN

A-SMG65332
B-SLH1266J
C-Sem954529

Upper bukit Timah Rd (Beside shell)

On 22 July 2019 1920hrs, I was driving along upper bukit timah road. It was heavy and slow traffic. I stop behind the yellow box. when I was about to move, suddenly vehicle B hit on the rear of my vehicle.
