VEHICLE NO : SHA 3808S

# HYUNDAI I40

### **ACCIDENT INVOLVING SGT 8957Z(FWD) & SHA 3808S ON 23/07/2019**

## VEHICLE DAMAGE INSPECTION REPORT

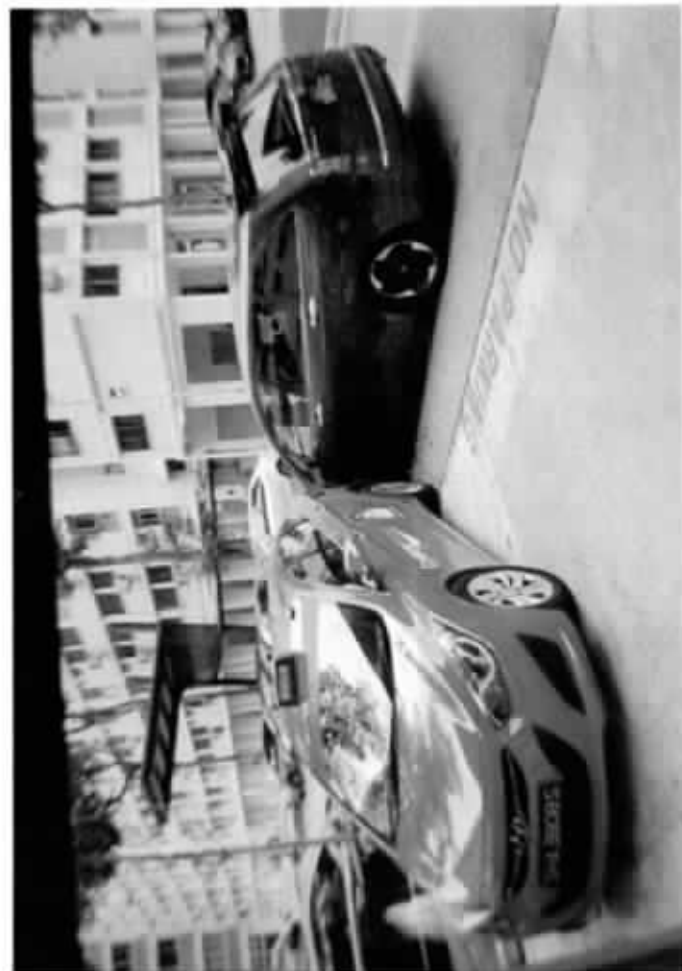
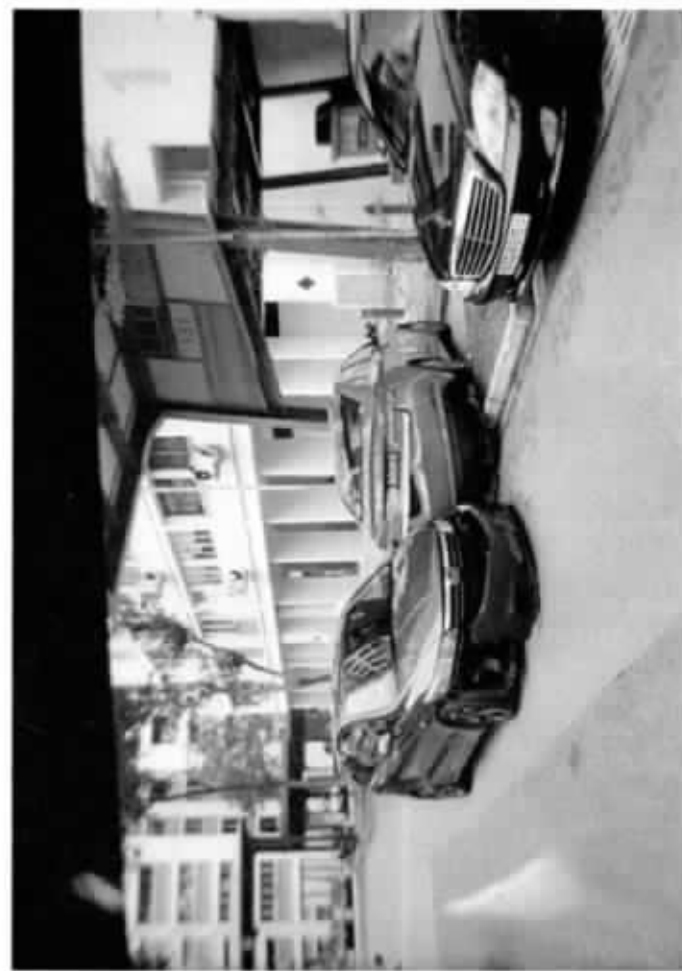
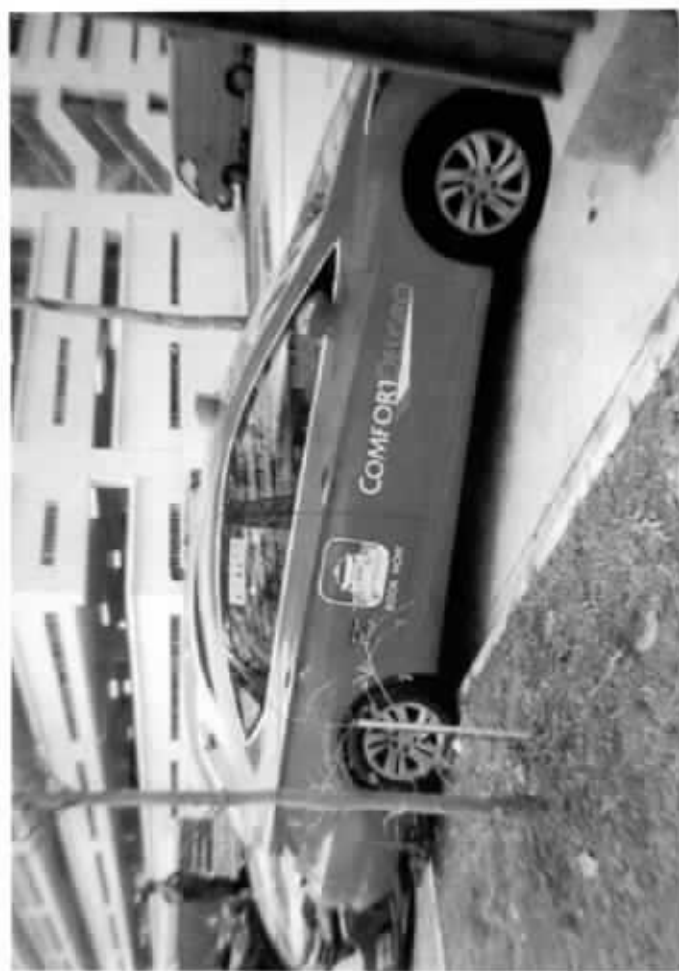
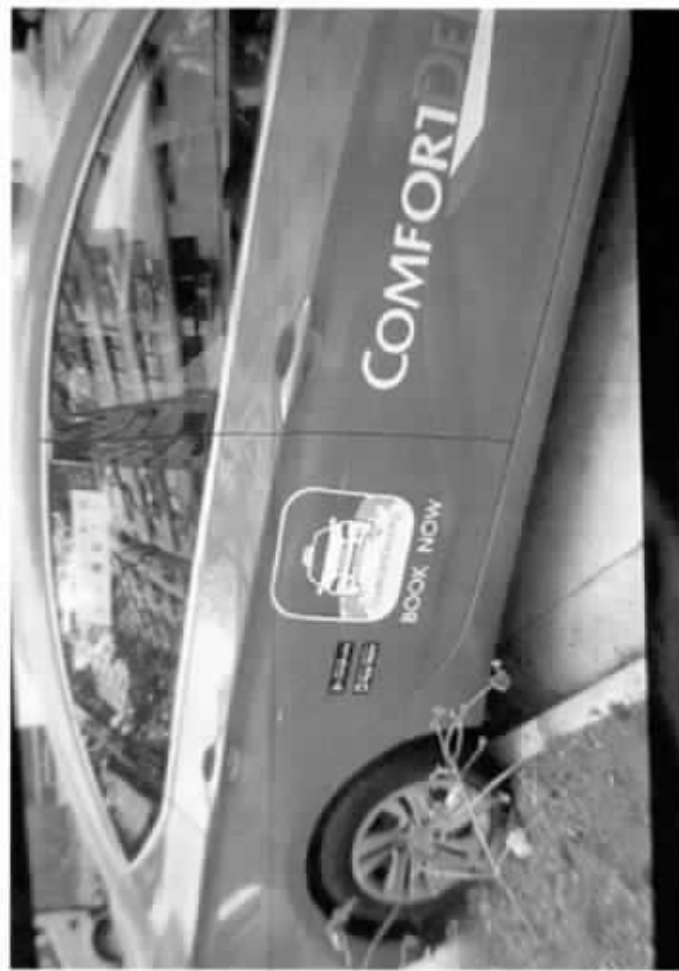
Des. of Damages : Frt / Rear / O/S / N/S / U/C / Rooftop or

The U/C / Chassis frame / Body Structure affected due to collision.
