**Preliminary Advice**

## VEHICLE DAMAGE INSPECTION REPORT

Our File No: CS/SMO19013176/KSD3N2

Reg No:	SLL9893A	Engine No:	L15B5002010
Make & Model:	HONDA SHUTTLE, 1.5 G CVT (A)	Chassis No:	GK81101678
Reg. Date:	17/03/2017 (Man. Year: 2016)	Odometer:	62422 km
Colour:	Metallic Dark Blue		
Engine Capacity:	1496 cc		
Market Value/New Car Price:	N/A		
Sum Insured (\$\$):	Market Value/New Car Price

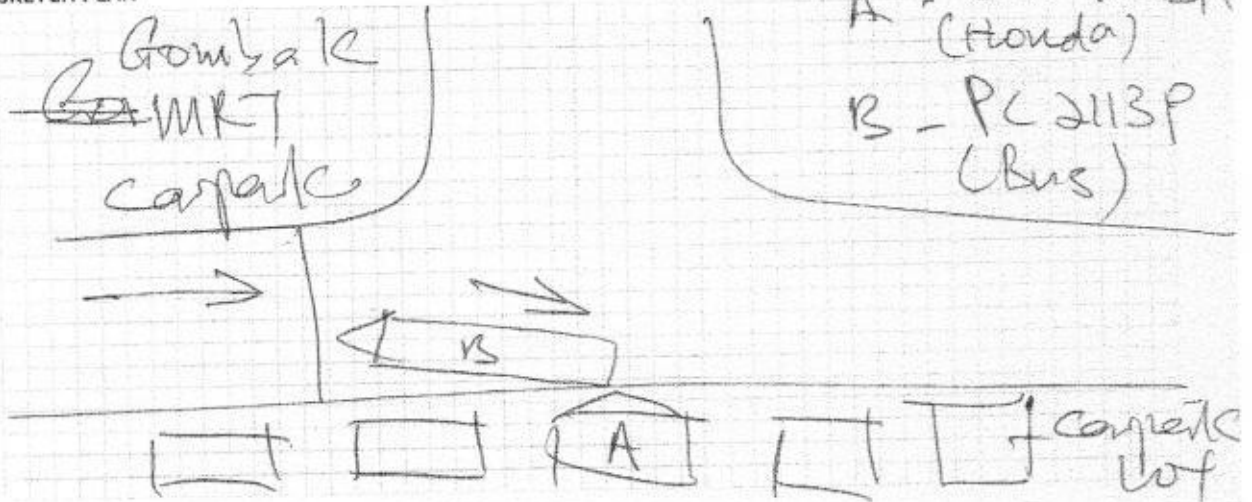
SKETCH PLAN

My car was parked stationary when a bus suddenly reversed and back onto my car (SLL 9853A). No one was injured and we exchange particulars after the incident.
