REF: CS/CT/19013182/TIVF312

To inspect Vehicle No: SKH 2829R Insured: GBB 5266H

E S T I M A T E

VEHICLE DAMAGE INSPECTION REPORT

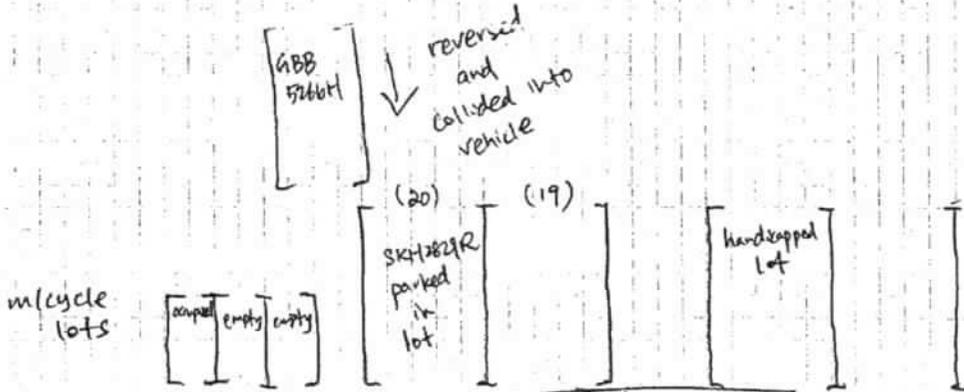
Sketch Plan Pg. 2

open carpark at J2 (Jurong East St 13)

On 21st July 2019, 1500 hours, my car (SKH 2829 R) was parked in lot 20 at open carpark J2 (Jurong East St 13). I was at a unit in BLK 109 and I heard a loud bang. I looked out of the window, to see a van parked in front of my vehicle. Thus, I went down to check.

Upon discussion with the driver of the van (G B B 5266 H), he admitted he had reversed carelessly into SKH 2829 R. Particulars of driver of van as follows:
