PRELIMINARY ADVICE OF VEHICLE NO. SMA 719B

Please be informed that we had conducted the inspection of the above mentioned vehicle
on 21/10/2019 at the premises of M/s N-51 AUTOMOTIVE PTE LTD
and have the following to report:-

ADJUSTMENT ON REPAIR COST FOR VEHICLE NO. SMA 719B

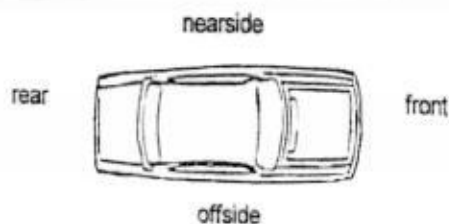
Description of Damage:

The vehicle sustained damages at the
o/s front portion

Comments/Present Status:
Damages Consistent

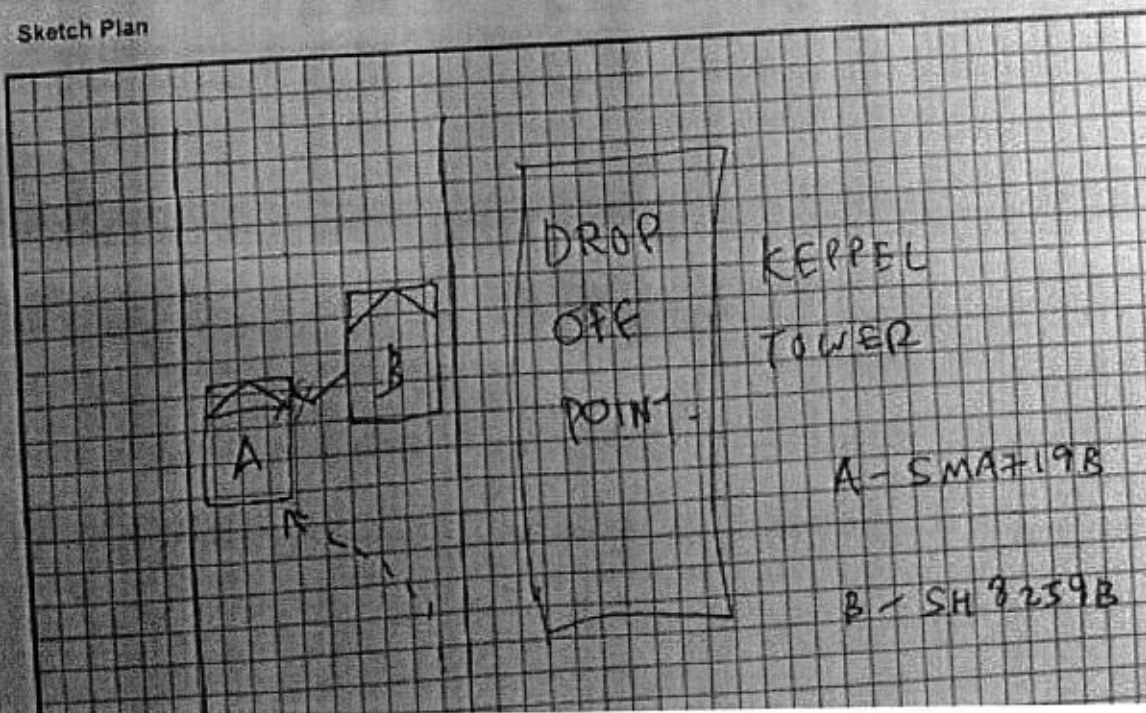
Sketch Plan

I drop off my passenger at the and drop off point of the building. Upon dropping off, I signal left and overtake the taxi that was stationary. Suddenly as I pass the taxi, the taxi left passenger door opened and hit my right side mirror. The Dover of my side mirror came off.

I stop and exchange particulars.
No injuries involved.
