Preliminary Advice

Insured Vehicle No	: SLJ754M		
TP Vehicle No	: SLL5142K	Accident Date	: 09/07/2019
Make	: NISSAN QASHQAI	Assignment Date	: 26/07/2019
Date of Inspection	: 08/08/2019	Est. Duration of Repair	: 4.00
Inspection At	: TAN CHONG MOTOR SALES PTE LTD (BUKIT TIMAH) 911, BUKIT TIMAH ROAD SINGAPORE 589622

VEHICLE DAMAGE INSPECTION REPORT

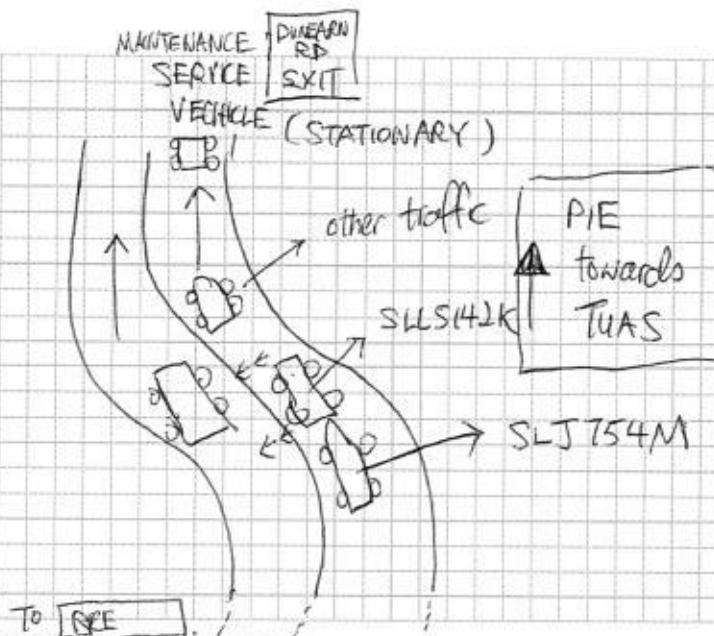
SKETCH PLAN

I was travelling along PIE on the most right lane. There was a maintenance truck ^(STATIONARY) on the right lane, traffic already slowed down. I signal left to change lane, slowly cutting in as traffic on my left passed me. One Volkswagen black vehicle SLJ 754M hit my rear, while I was changing lane.
