FBD 7740G

Triumph Bonneville 865

**From:** Chong Boon Sen <boonsen.chong@sg.cntaiping.com>  
**Sent:** Monday, 29 July 2019 8:41 AM  
**To:** PanEuroBikes  
**Cc:** assignments  
**Subject:** RE: OUR REF: SNM19D202828 - 3rd Party Survey request - Accident Between FBD 7740G/SLG 1631T on 15.06.2019 on 367 Onan Rd.

## VEHICLE DAMAGE INSPECTION REPORT

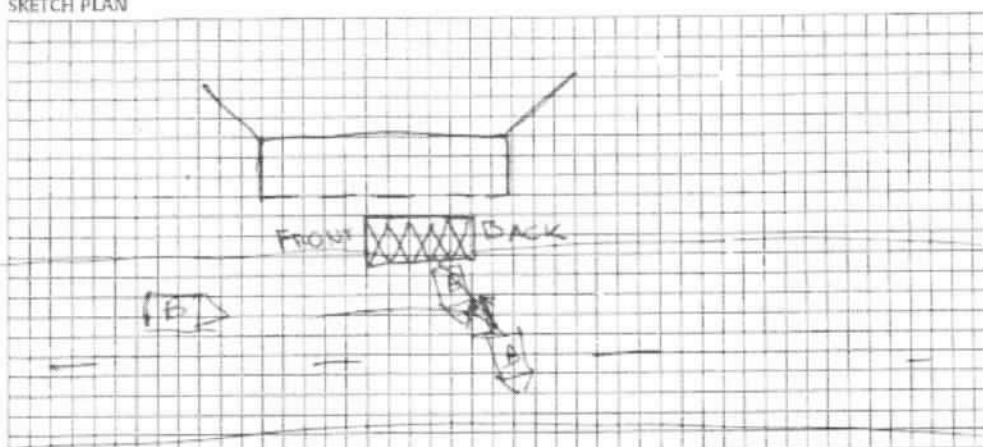
## Sketch Plan #2

APPROXIMATELY AT 11-15pm - 11 30pm I HEARD A LOUD CRASH FROM MY LIVING ROOM. I WENT TO FRONT DOOR. OPENED IT AND SEEN MY MOTORCYCLE ON ITS SIDE AND A SILVER BMW 320i PULLING AWAY FROM MY MOTORCYCLE. I PROCEEDED TO APPROACH THE VEHICLE AND TOLD THE DRIVER TO STOP THE CAR AS SHE WAS BEGINNING TO START TO DRIVE AWAY. EVENTUALLY THE DRIVER PULLED OVER THE CAR AND GOT OUT. THE DRIVER AT FIRST CLAIMED SHE DIDNT REALISE THAT SHE HAD REVERSED INTO MY MOTORCYCLE BUT AS WE SWAPPED DETAILS SHE ADMITTED SHE HAD DONE IT AND WAS AT FAULT AND APOLOGISED.
