## VEHICLE DAMAGE INSPECTION REPORT

Our File No: CS/CT119013348/KQD3N2

<b>Handling Insurer:</b>	China Taiping Insurance (Singapore) Pte. Ltd.	<b>Policy No:</b>	DMPCSN30961118022	
<b>Claimant Vehicle No :</b>	SMM6816B	<b>Insured Vehicle No :</b>	SKV7949X	
<b>Date of Loss:</b>	21/07/2019	<b>Nature of Claim:</b>	TP	<b>Claim No:</b> SNM19D203440C02

<b>Reg No:</b>	SMM6816B	<b>Engine No:</b>	LEB5625460
<b>Make &amp; Model:</b>	HONDA FREED HYBRID, 1.5 G (A)	<b>Chassis No:</b>	GB71087426
<b>Reg. Date:</b>	09/07/2019 (Man. Year: 2019)	<b>Odometer:</b>	657 km
<b>Colour:</b>	Metallic Blue		
<b>Engine Capacity:</b>	1496 cc		
<b>Market Value/New Car Price:</b>	N/A		
<b>Sum Insured (\$\$):</b>	Market Value/New Car Price

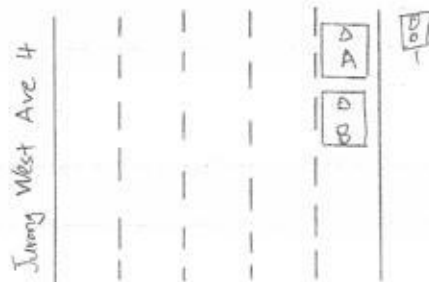
SKETCH PLAN

A: SMM 6816B  
B: SKV 7949X

On the 21<sup>st</sup> of July 2019, at about 1825 hrs. I was stationary along Jurong West Ave 4, waiting for the turn arrow to St 75. All of a sudden, I felt an impact from the rear. I realized the vehicle SKV 7949X hit onto the rear portion of my vehicle.
