VEHICLE DAMAGE INSPECTION REPORT

Handling Insurer:	China Taiping Insurance (Singapore) Pte. Ltd.	Policy No:	DMB1SN14396918044		
Claimant Vehicle No :	SLZ1062K	Insured Vehicle No :	CB6604Y		
Date of Loss:	26/07/2019	Nature of Claim:	TP	Claim No:	SNM19D203530C02

Reg No:	SLZ1062K	Engine No:	2ZR0A75711
Make & Model:	TOYOTA PRIUS, 1.8 (A)	Chassis No:	ZVW400027949
Reg. Date:	23/04/2018 (Man. Year: 2017)	Odometer:	121557 km
Colour:	Red		
Engine Capacity:	1797 cc		
Market Value/New Car Price:	N/A		
Sum Insured (S\$):	Market Value/New Car Price

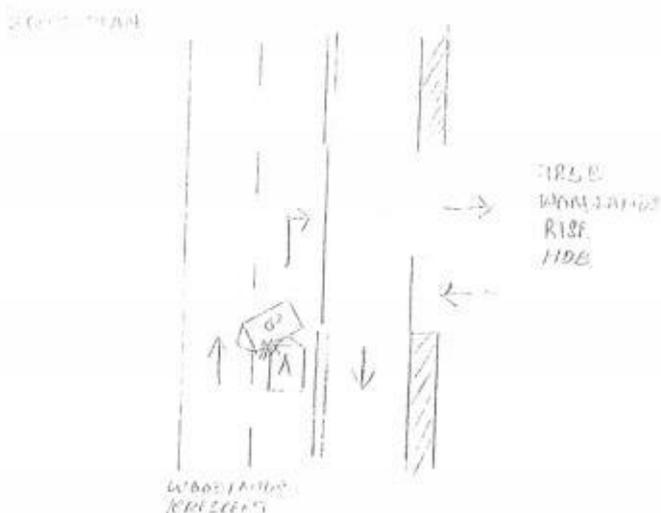
Sketch Plan Pg. 2

On 26/7/2019 @ 16:10, I was Driving along Bukit Panjang towards Woodlands crescent and was about to turn right in to ISSB Woodlands Rise HDB. I saw a Vehicle B at the entrance, so I stop at my lane, the vehicle B cut to my lane and hit on to my left hand front portion.
