PRE-REPAIR INSPECTION REQUEST – SMF7101K vs SGB8087D (OI) on D.O.A.: 29/07/2019

ACCIDENT INVOLVING SMF7101K & SGB8087D ON 29.07.2019

VEHICLE DAMAGE INSPECTION REPORT

Reg No:	SMF7101K	Engine No:	38749889B37D15A
Make & Model:	BMW 116D, 1.6 (A)	Chassis No:	WBA1V72090V944682
Reg. Date:	28/06/2017 (Man. Year: 2017)	Odometer:	43377 km
Colour:	White		
Engine Capacity:	1496 cc		
Market Value/New Car Price:	N/A		
Sum Insured (S\$):	Market Value/New Car Price

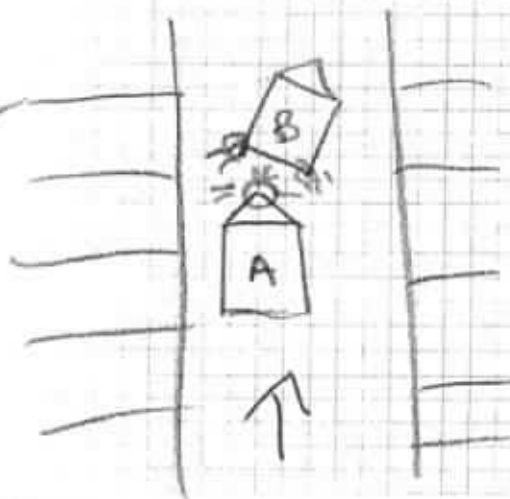
SKETCH PLAN

MY VEH WAS STATIONARY AT THE IMM SHOPPING CENTRE CARPARK LVL 5. SUDDENLY VEH(B) BEARING REG NO SGB8087D REVERSED HIS VEH AND HIT ONTO MY FRT PORTION OF MY VEH.

(A) SMF7101K
(B) SGB8087D
