Preliminary Advice

Vehicle No	: SLR1213J	Accident Date	: 20/07/2019
Make	: AUDI A6	Policy No.	: 1700033001-02
Assignment Date	: 02/08/2019	Excess	: S\$0.00
Date of Inspection	: 02/08/2019	Est. Duration of Repair	: 5.00
Inspection At	: PREMIUM AUTOMOBILES PTE LTD (UBI) 55 UBI ROAD 1 SINGAPORE 408699

VEHICLE DAMAGE INSPECTION REPORT

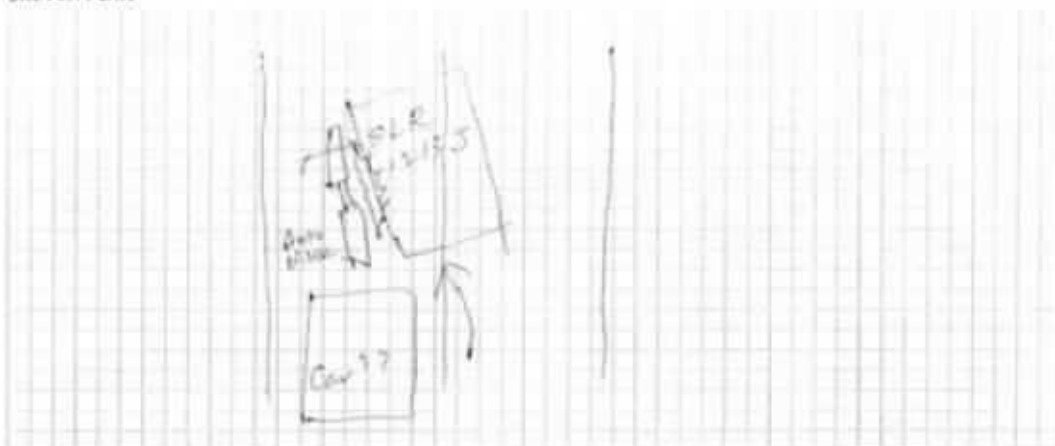
Sketch Plan #2

When I changed my lane to left side, left rear view mirror was folded by something. I have recognized that ~~or~~ one motorbike was shown on ~~the~~ left hand side thru side mirror. I have slow down to see the motorbike driver, but this guy just run away to Faras road direction.

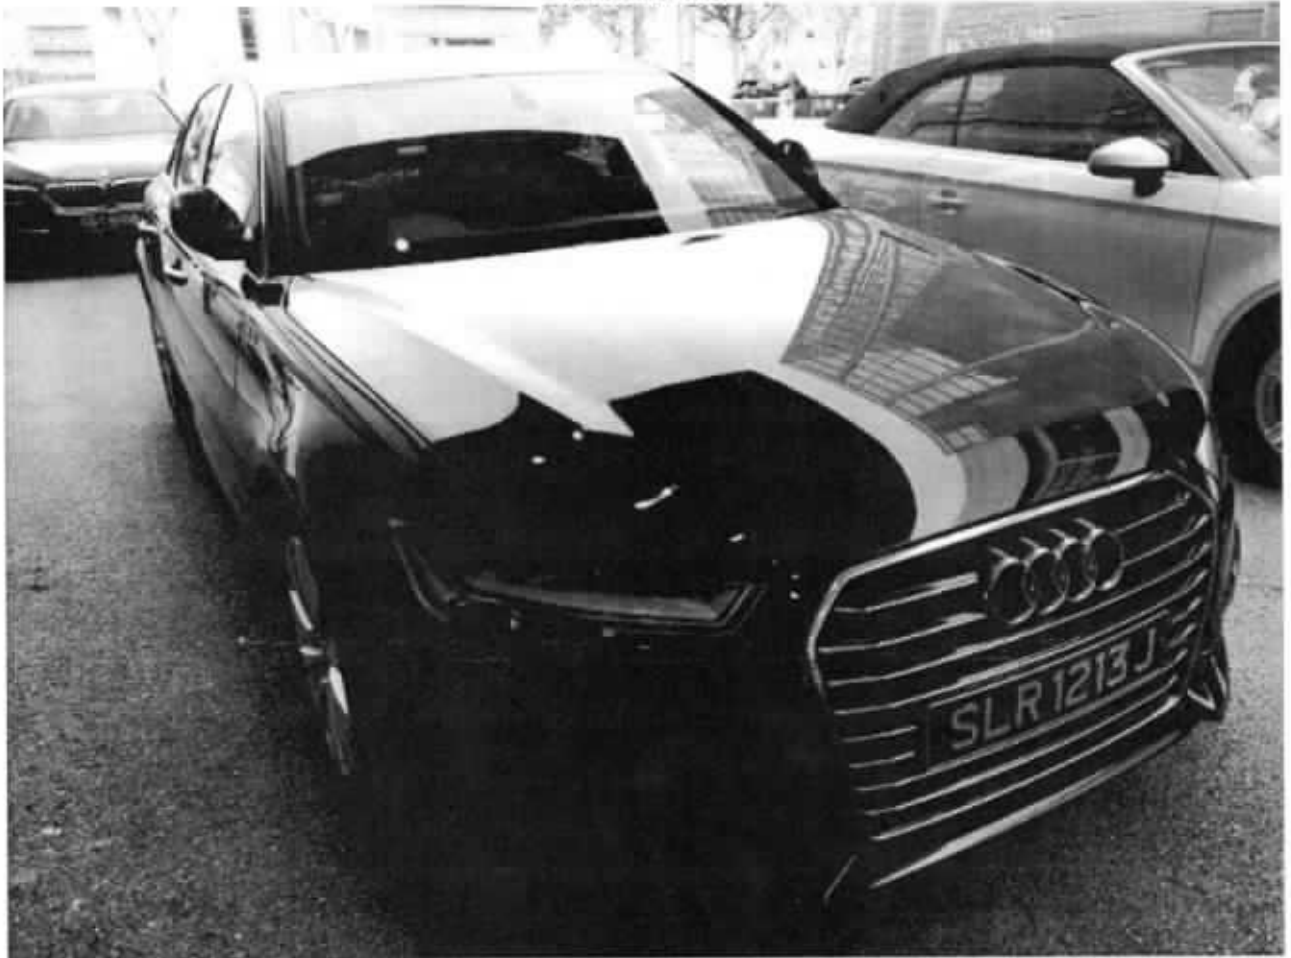
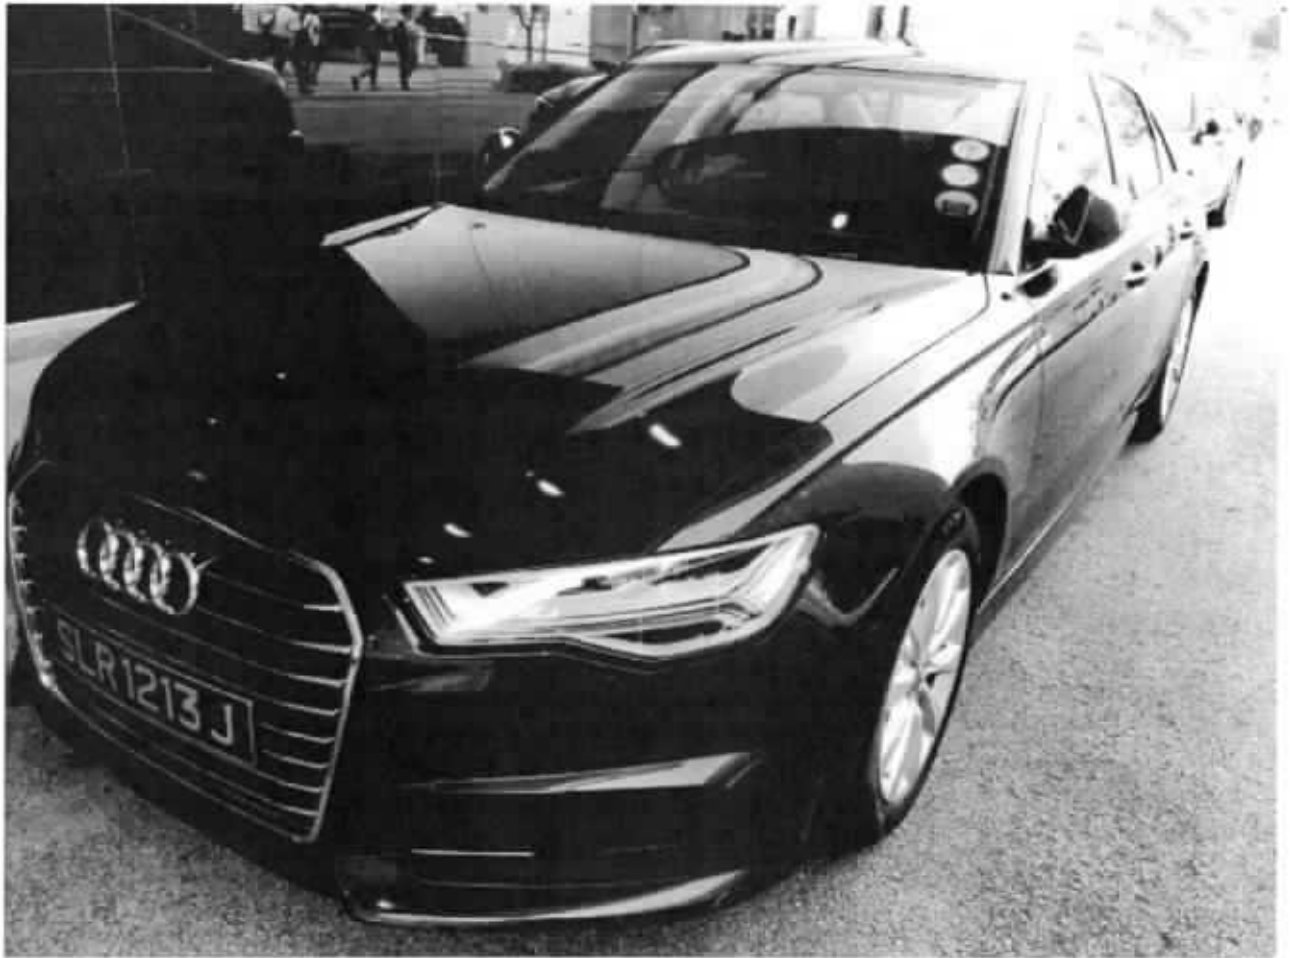
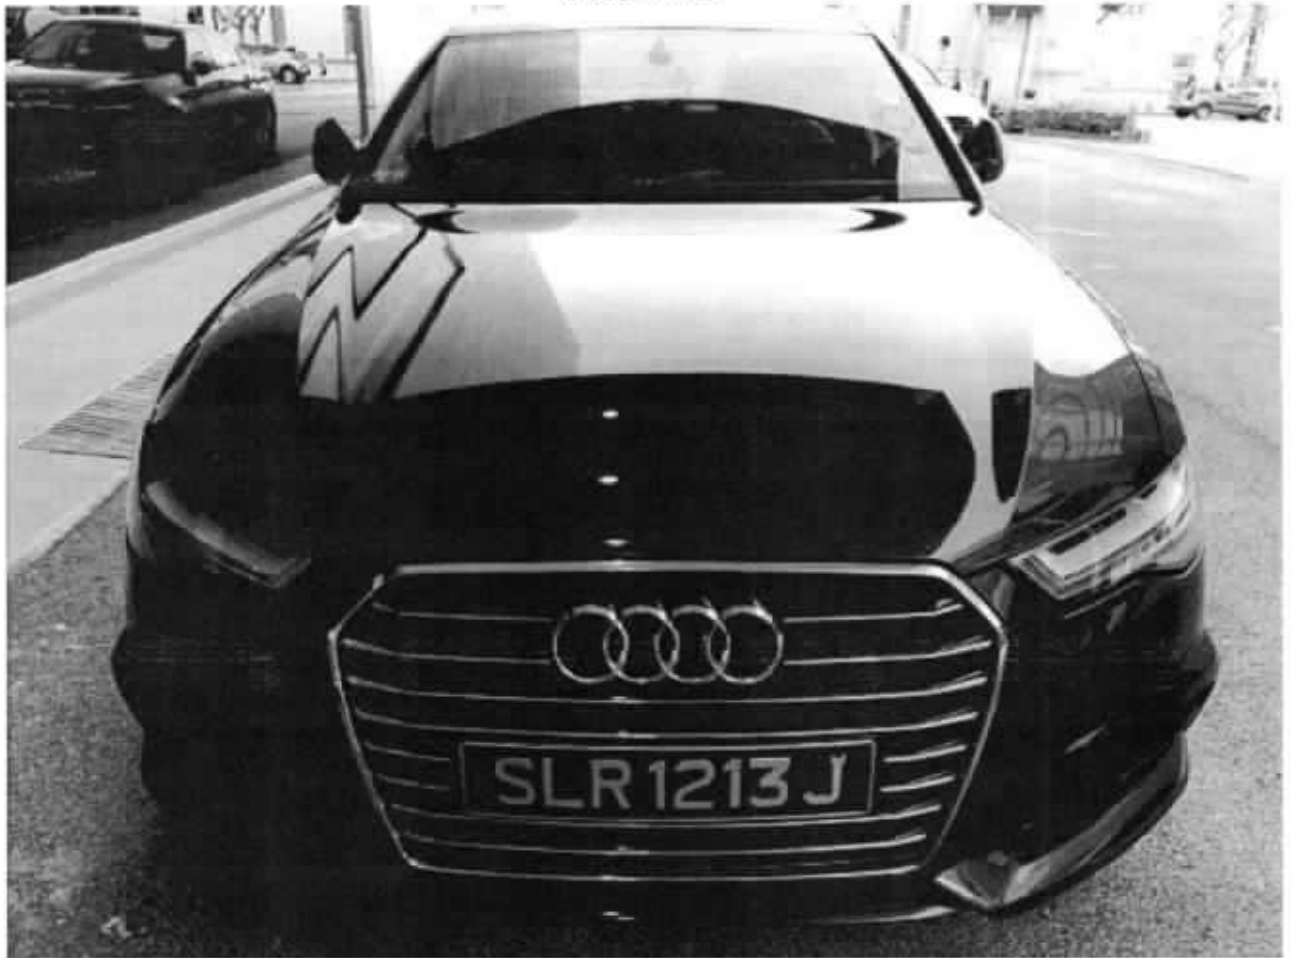
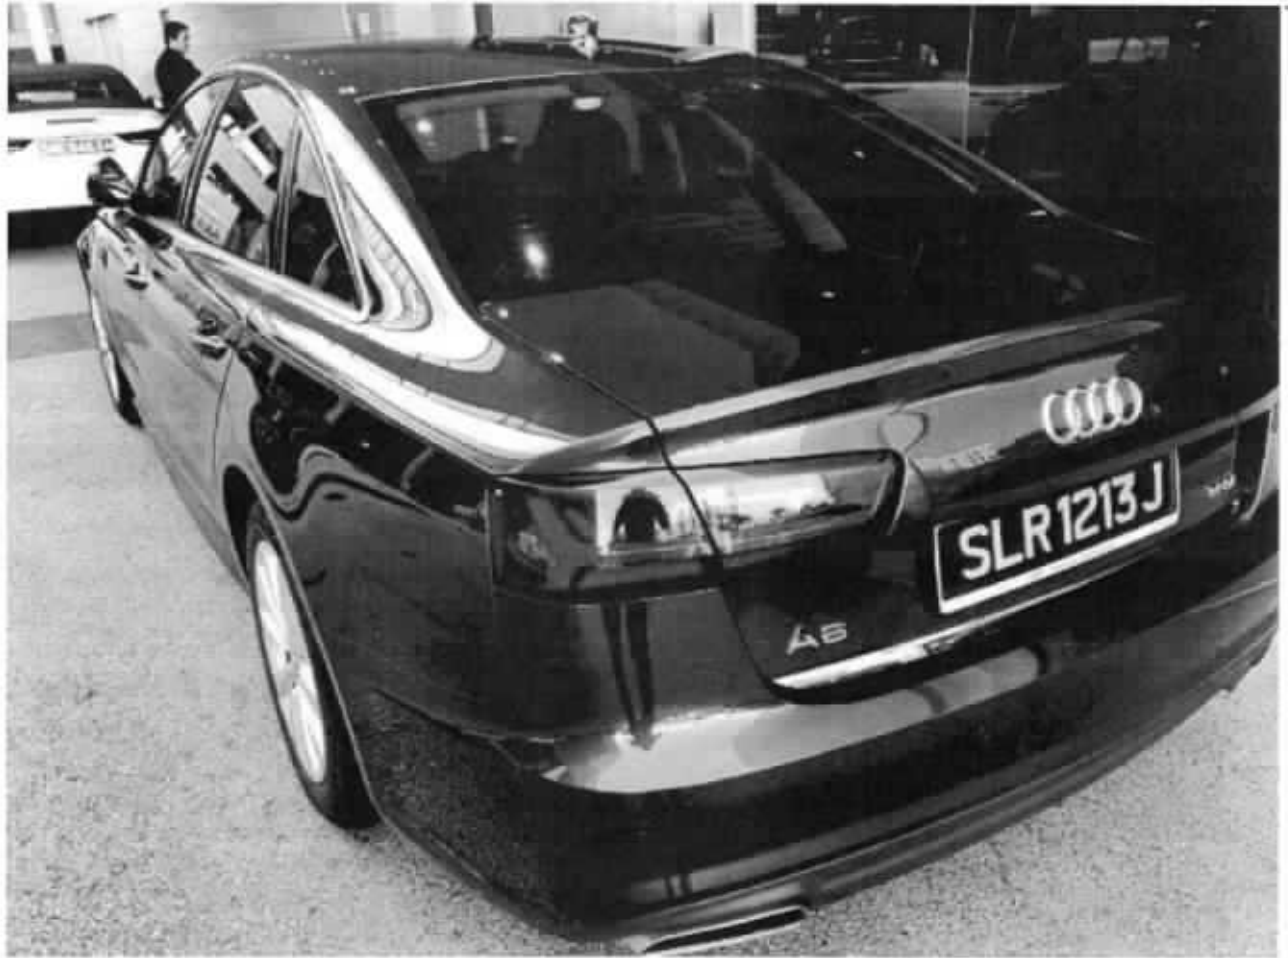
Accident Photo

The vehicle sustained impact / damages n/s body and parts claimed are consistent to the accident.

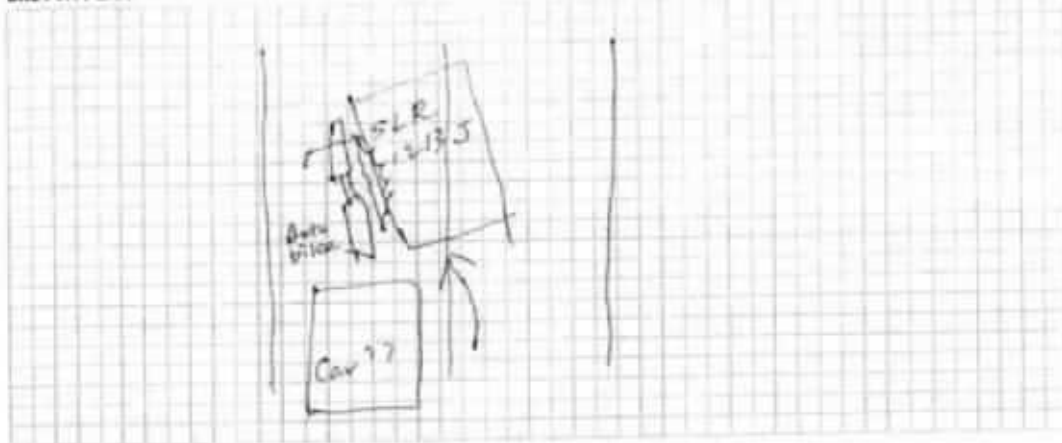
Sketch Plan #2

When I changed my lane to left side, left rear view mirror was folded by something. I have recognized that ~~or~~ one motorbike was shown on ~~the~~ left hand side thru side mirror. I have slow down to see the motorbike driver, but this guy just run away to Farrar road direction.
