VEHICLE DAMAGE INSPECTION REPORT

Our File No: CS/MSG19013622/GSF3E2

Reg No: SML3343Z

Make & Model: TOYOTA NOAH HYBRID, 1.8 X CVT (A)

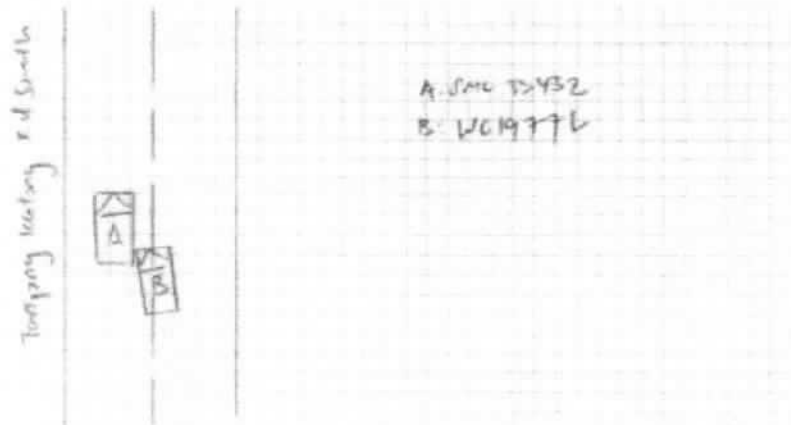
SKETCH PLAN

ON STATED DATE AND TIME, I WAS TRAVELLING STRAIGHT ALONG THE STATED VENUE. VEHICLE B WAS TRAVELLING ALONG LANE 1 CUT ONTO MY LANE. AS A RESULT, VEHICLE B HIT ONTO MY VEHICLE REAR RIGHT PORTION.
