Report Reference : TP / 19025-07/AY / 2019  
Date of Report : 31 Jul 2019

**THIRD PARTY SURVEY  
ACCIDENT HAPPENED ON 16 Jul 2019**

### ADJUSTMENT ON REPAIR COST FOR VEHICLE NO. SGW 479Z

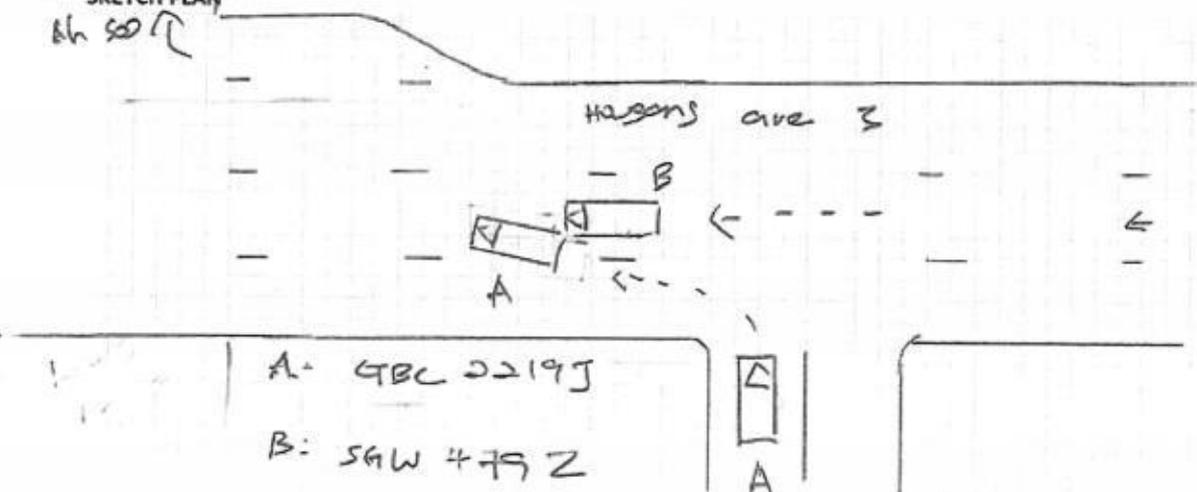
Accident Sketch Plan

A: GBC 2219J  
B: SGW 479Z

I was driving my company van GBC 2219J from defu lane to hagans ave 3. While I almost turn in to the middle lane. Suddenly the car SGW 479Z drive forward without give way to me & hit onto my van rear rh partition.

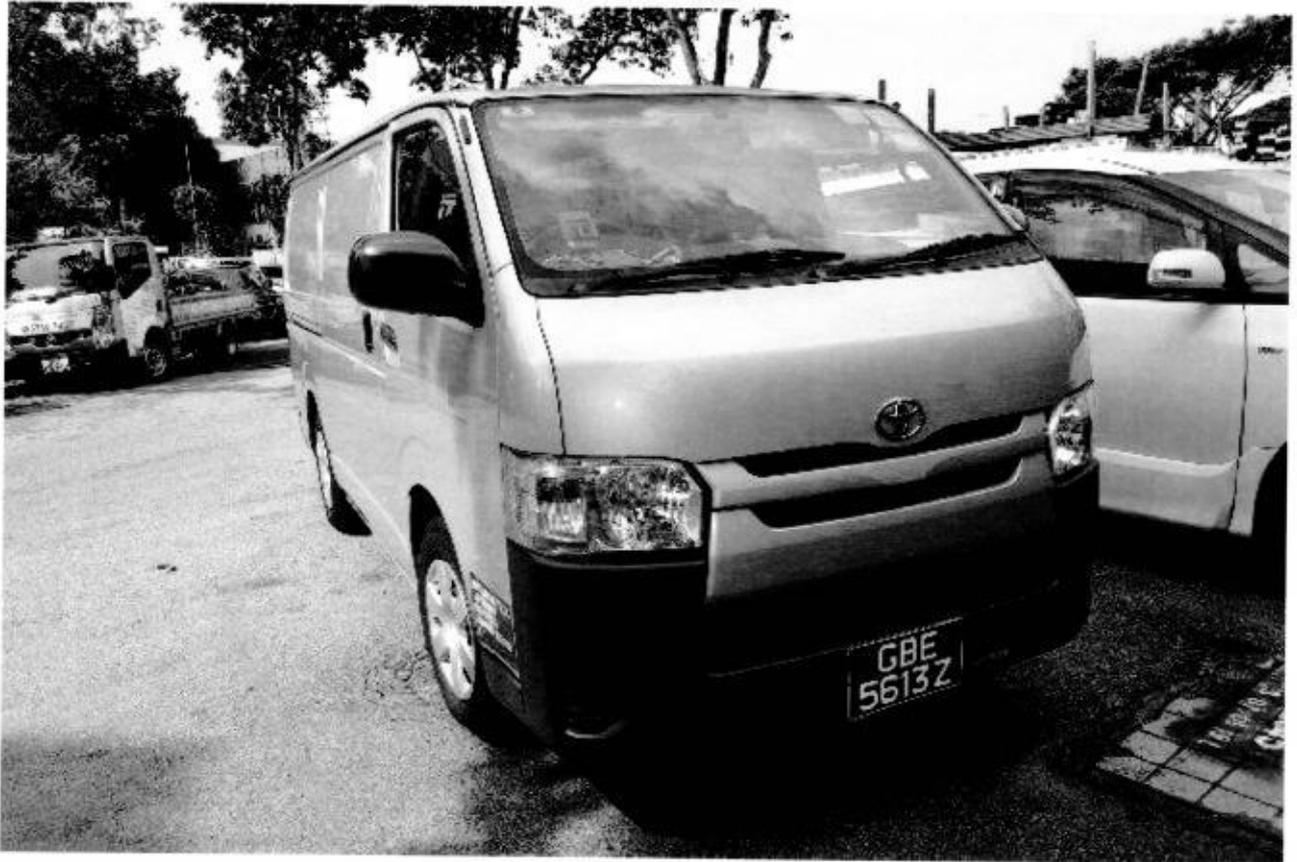
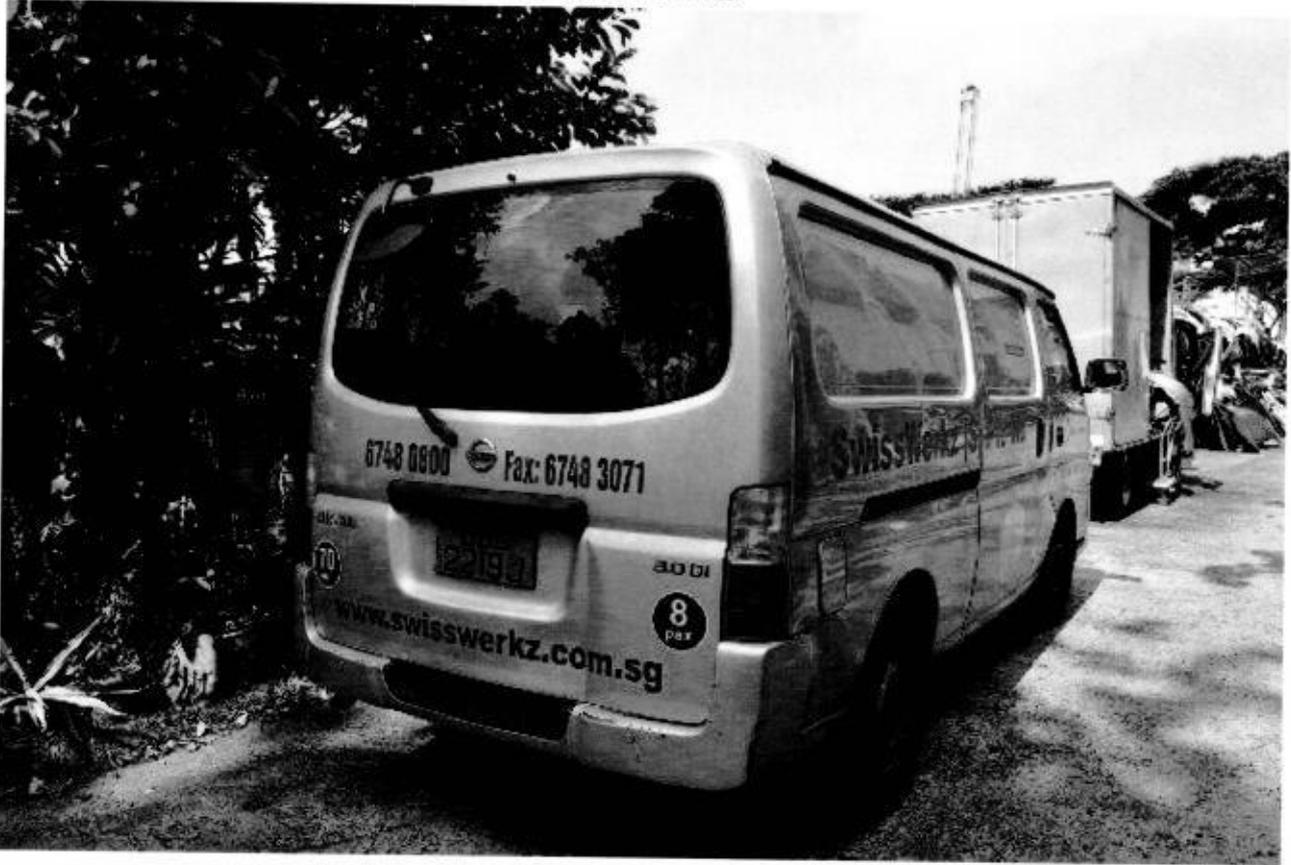
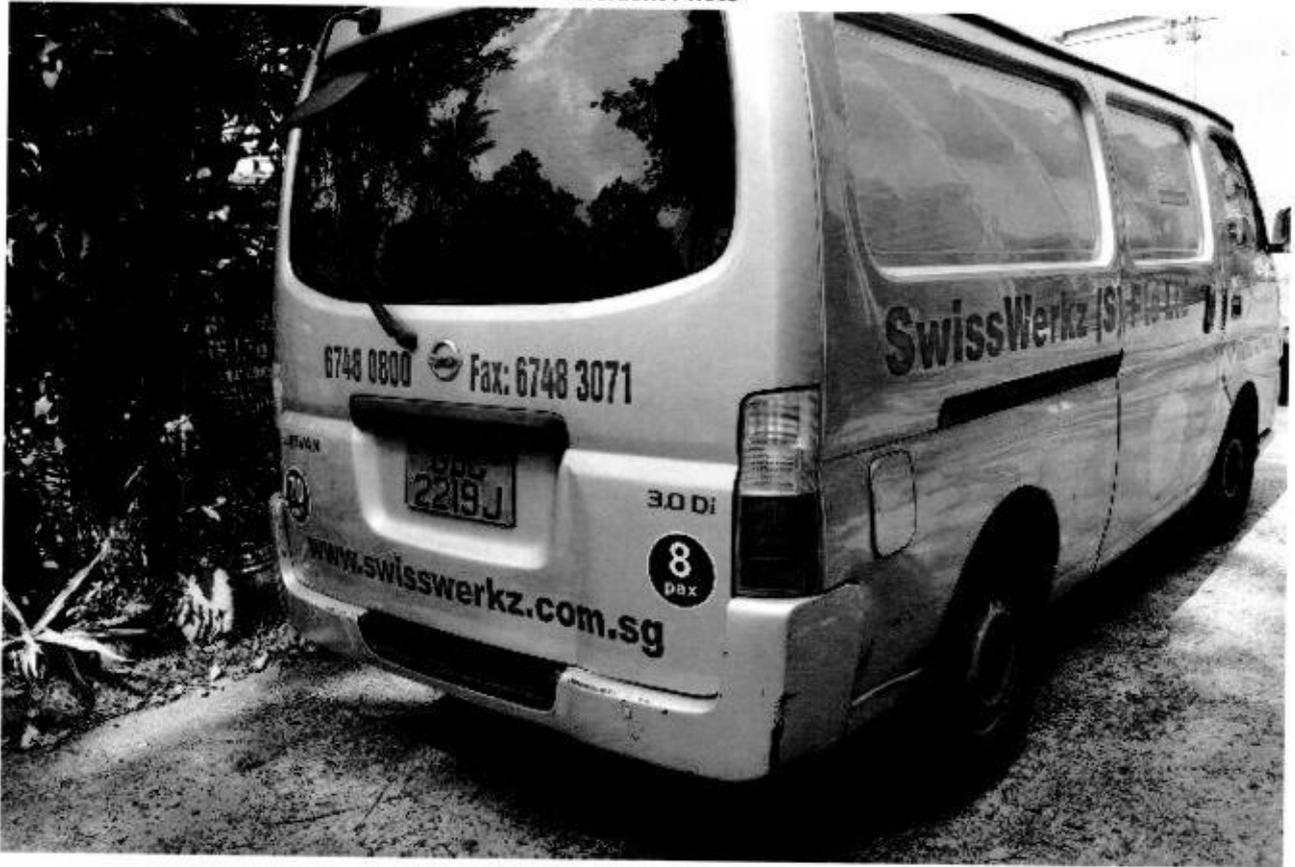
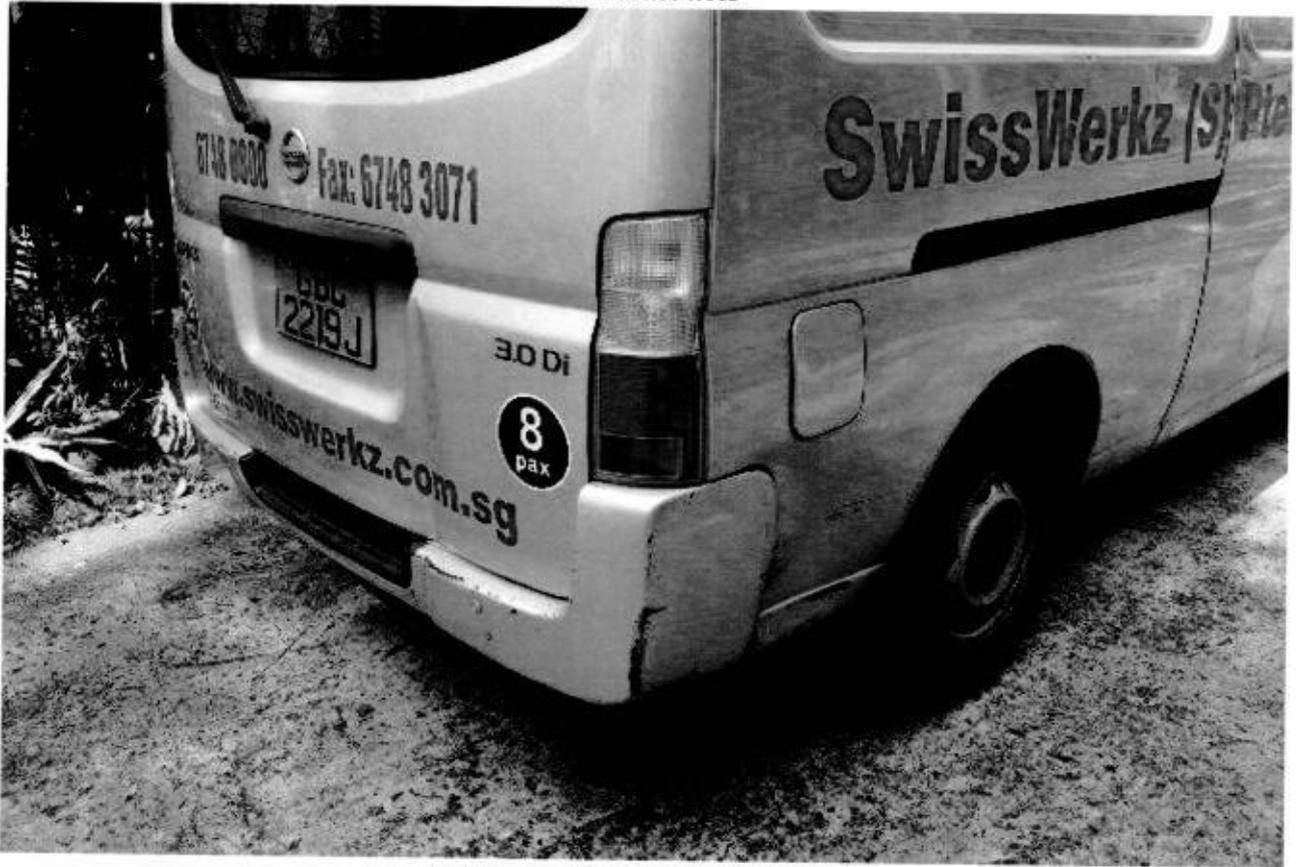
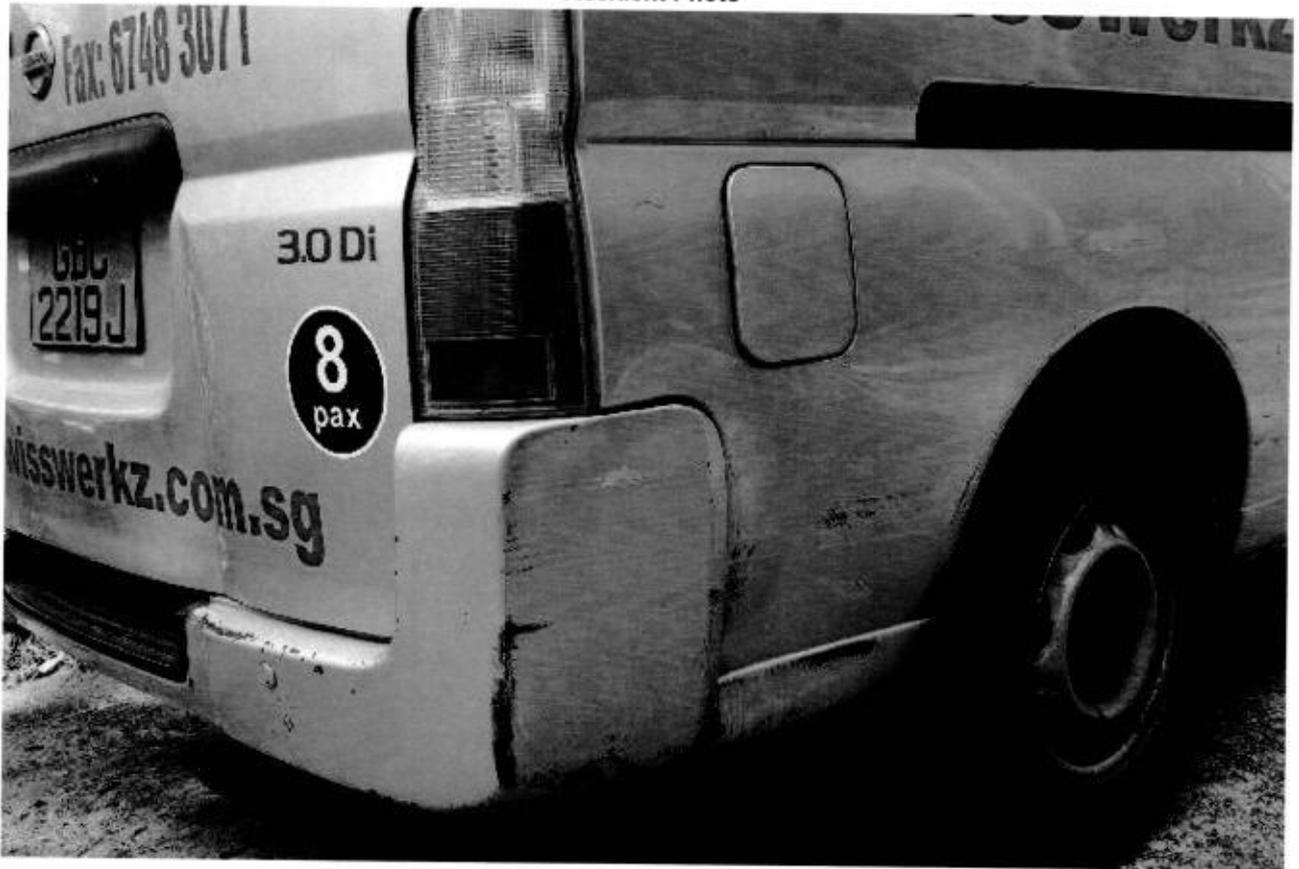
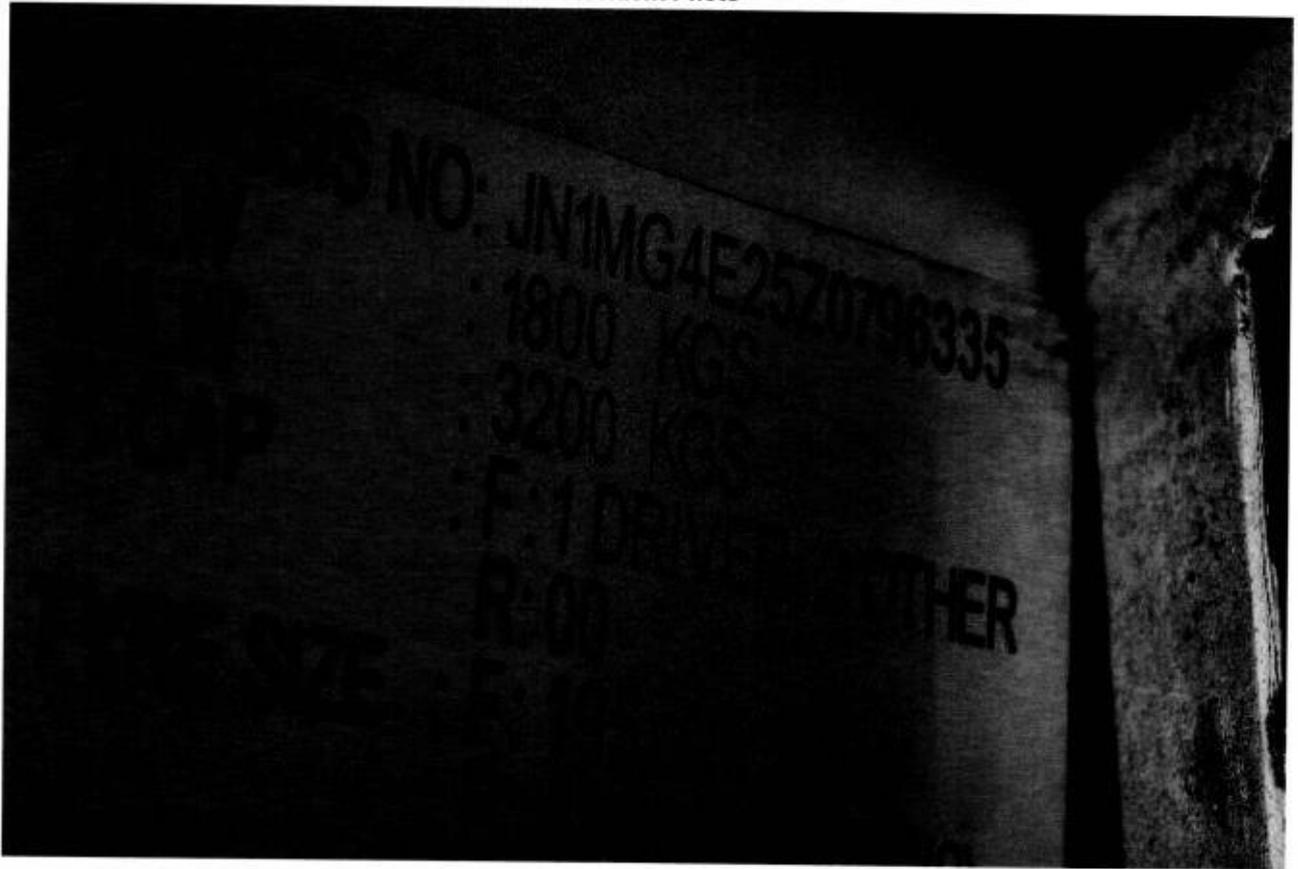
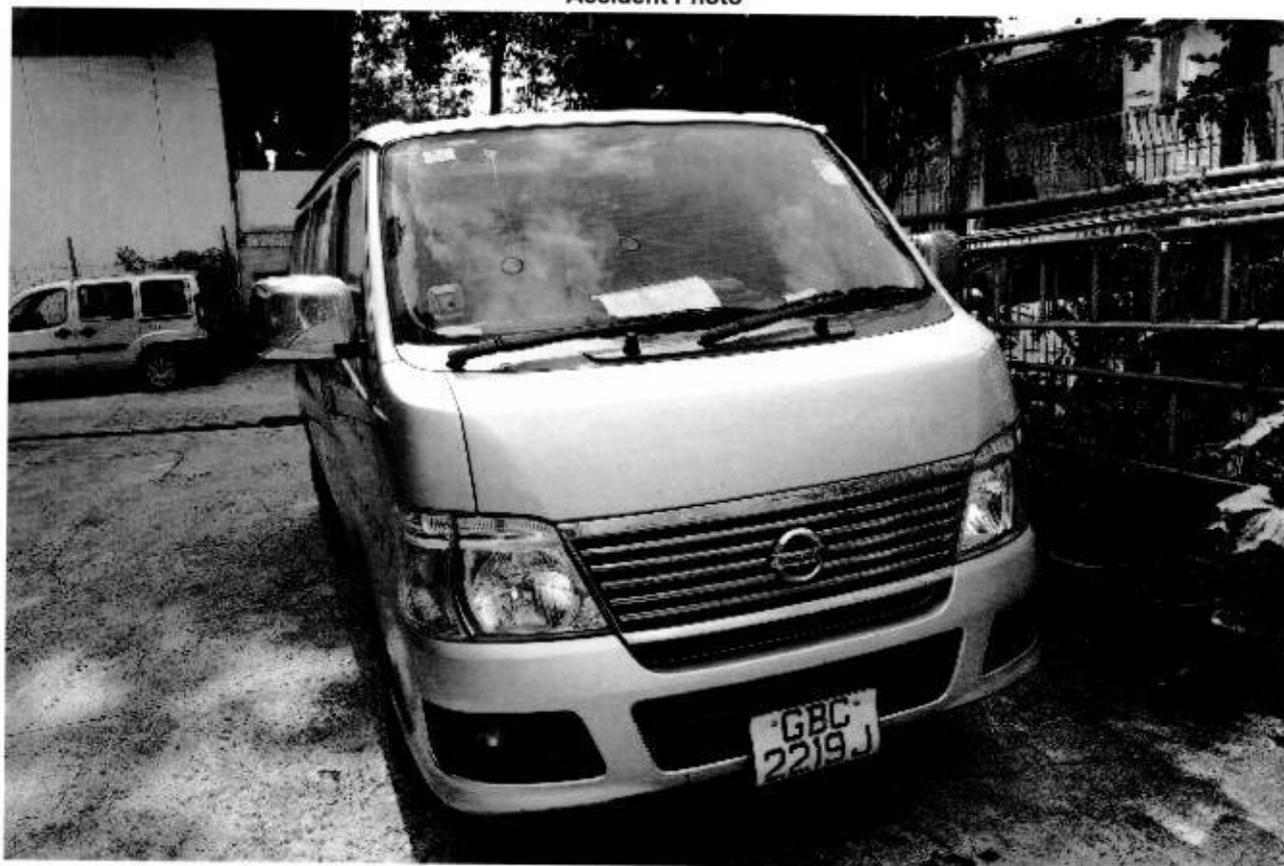
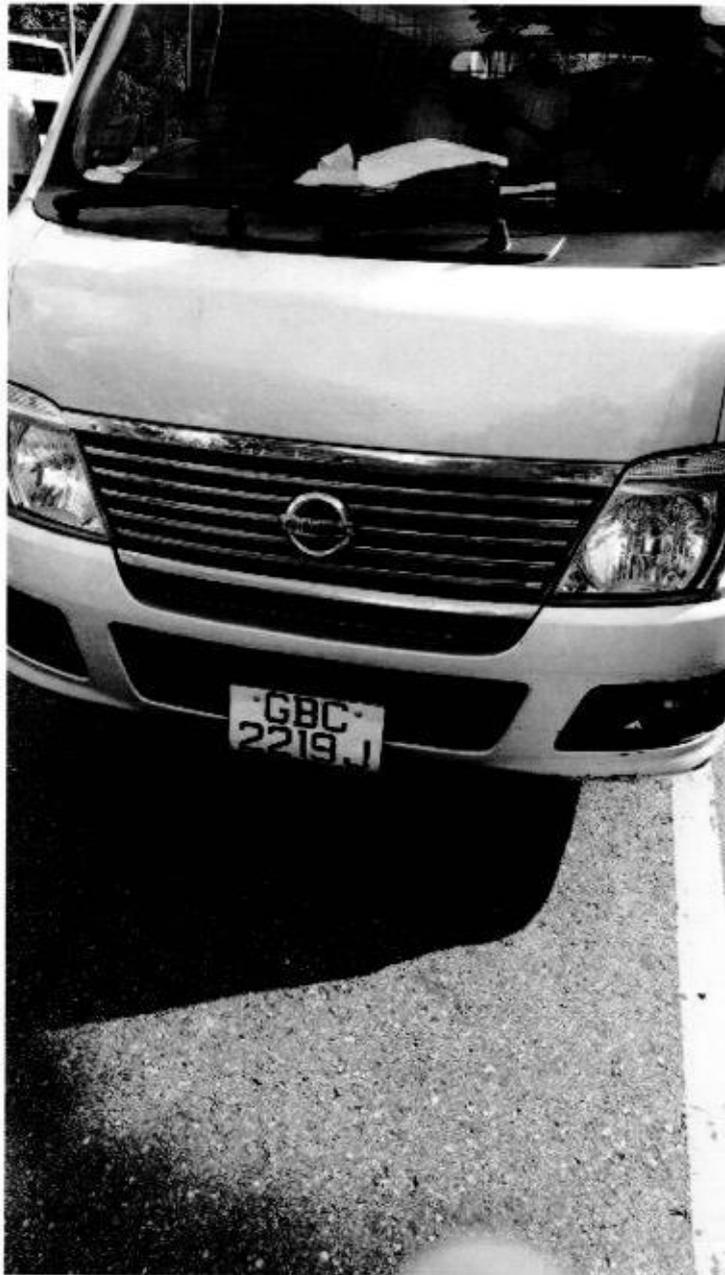
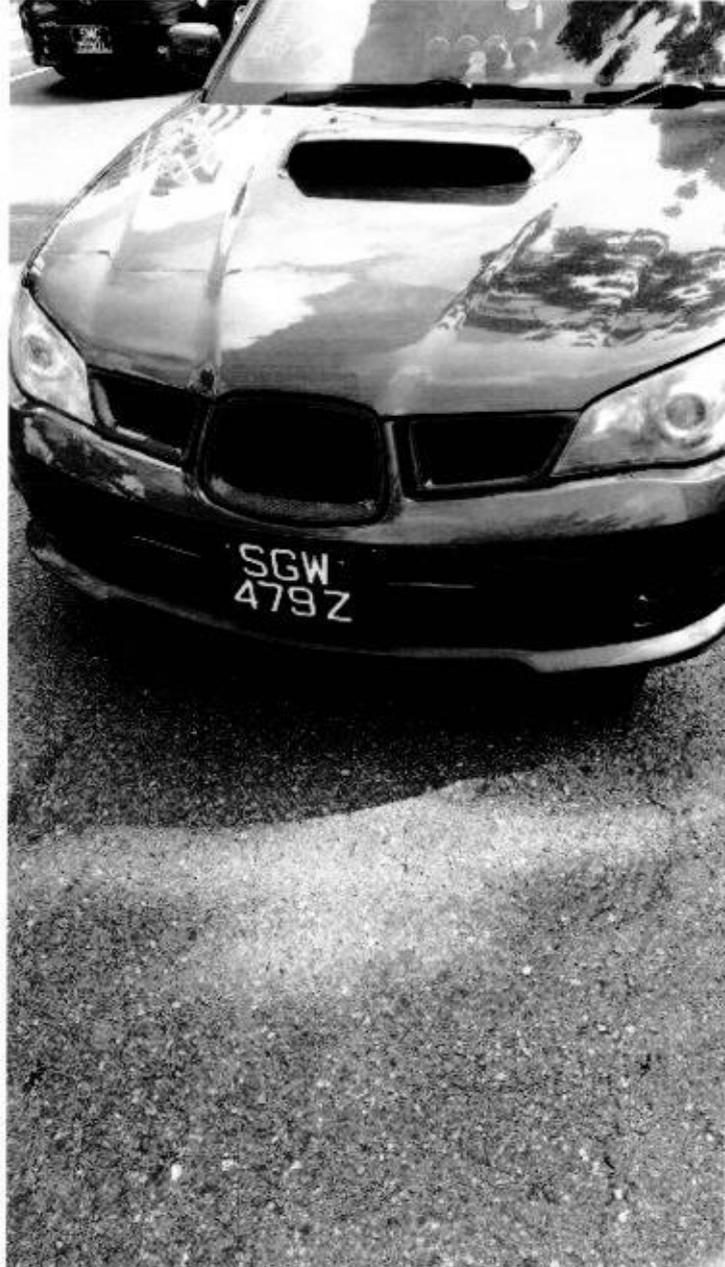
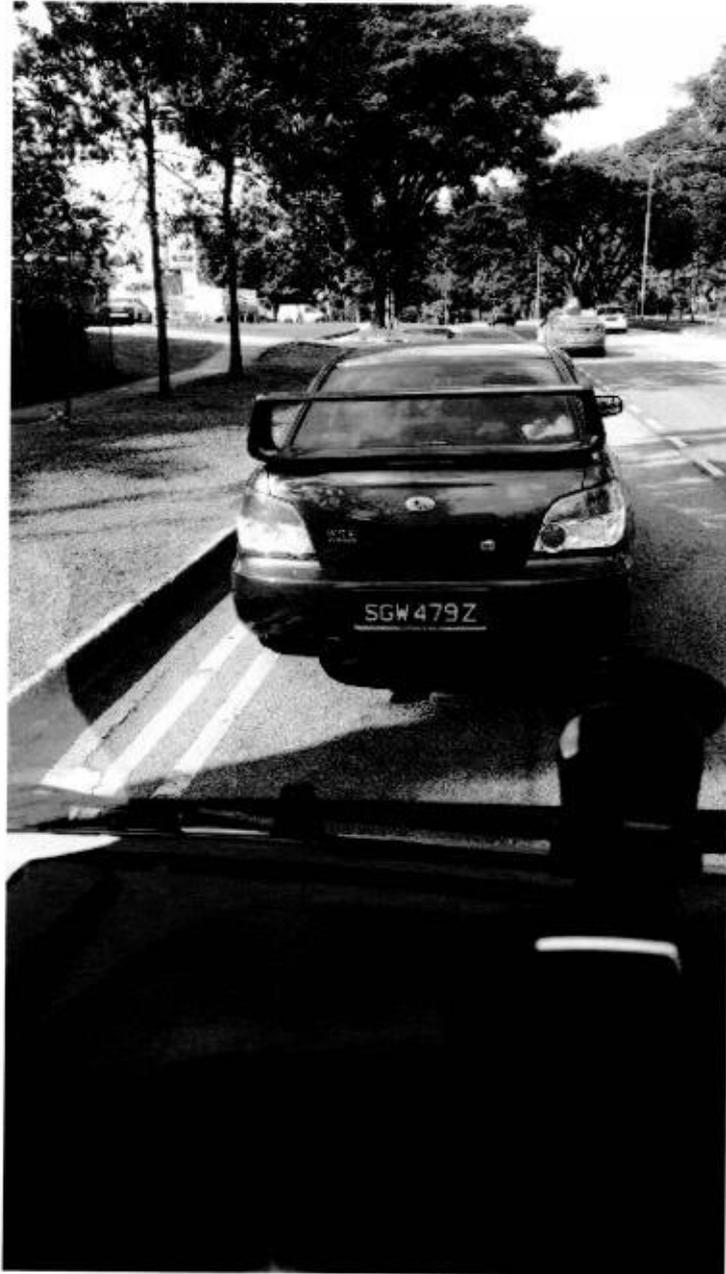
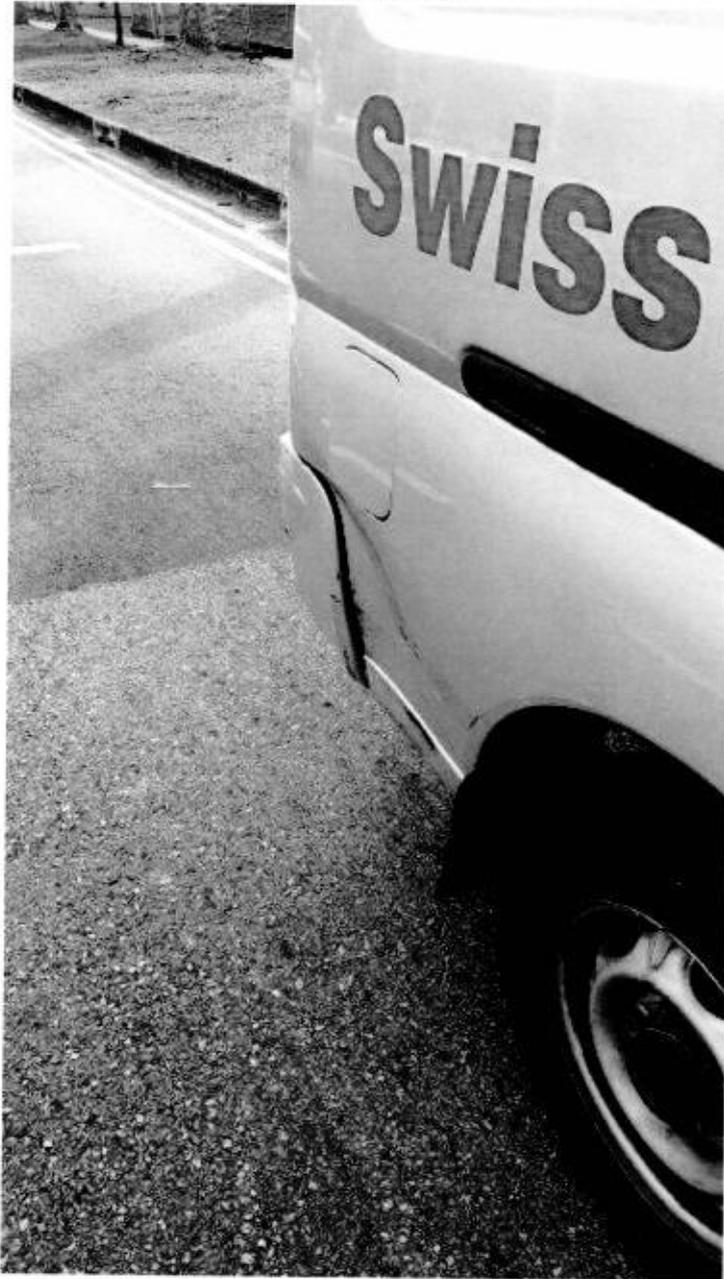
At the time of inspection, we noted that the vehicle has sustained an impact damages on the n/s front portion(s). For more detail of the damages, please see photograph attached.

4. Description of Damages			
THE VEHICLE SUSTAINED DAMAGES AT THE N/S FRONT PORTION. THE UNDERCARRIAGE AFFECTED DUE TO COLLISION.  DAMAGES SEE DETAILS.

4. Estimated normal period of repair : 6 working days to complete.
5. Enclosed number of photograph : 83 copies.
6. In accordance to your instruction, we have **Not Authorised** repair to the vehicle and the survey was done on a "**Without Prejudice**" basis. We hope that this report will be of assistance to you in dealing with the matter.
7. Should you discover any discrepancy in the report, please kindly notify us **within 2 weeks**, or the report will be treated as correct.
