Preliminary Advice

Insured Vehicle No : SKW7229K

SFD1282D Vehicle Registration Number

VEHICLE DAMAGE INSPECTION REPORT

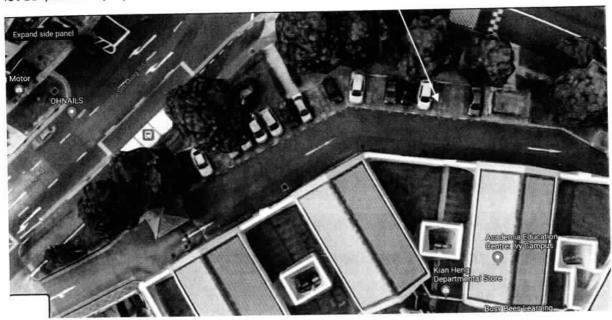
Driver's Signature (If driver is not the policyholder) Date & Time: Reporting Centre Personnel's Signature Name: NRIC/FIN No.: On 4 Aug 2019 (Sunday), 10:30am, I was at the Sin Ming Plaza Car Park. I stopped in front of car park lot 164/165 and prepared to do a reverse parking into car park lot 163 (see attached picture).

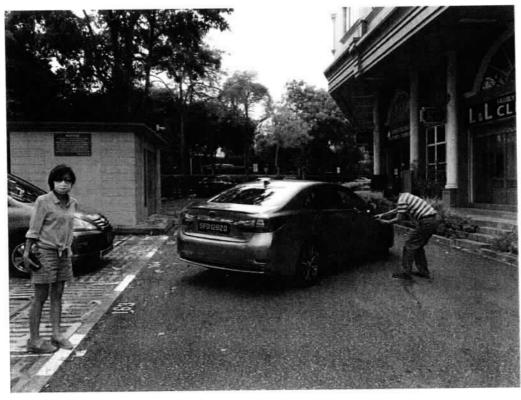
From the rear mirror, there was no oncoming car, and from the side mirrors, I had sufficient clearance for the car's turning radius. I was looking at the rear mirror to ensure that I would not hit the stationary car parked at Lot 164, and when my reversing car was at about 45 degrees to the car park lot, I suddenly heard a 'bang' sound and a vibration coming from the right side of my car.

I quickly stepped on the brake and put the car in parking mode and followed up with turning off the car engine. Attached picture shows the position of my reversing car after I stopped my car immediately after hearing the 'bang' sound:

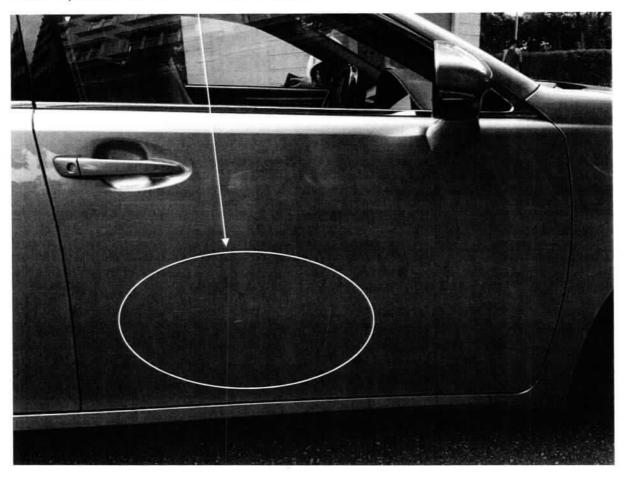
I came out from my car and saw another car (Volks Wagon, vehicle number SKW 7229 K) a short distant away behind my car and the driver was still inside the vehicle SKW 7229 K. I looked at my car and saw that there was a dent on the right door (at the driver's side). When I walked to the driver of SKW 7229 K, he apologised for knocking my car and said that he was rushing. He gave me his NRIC as Mr Zhang Weilin, NRIC # S2661427I of 6 Sin Ming Road, #03-06 S(575585).

Attached picture shows the dent on the front door:

No.	Qty Part No.	Particulars	Condition	Repairer's	Amount
1	1	*SUNDRIES	Necessary	80.00 FS	*50.00 FS
2	1	*SEALANT	Necessary	100.00 FS	*100.00 FS
3	1	*PANEL, DOOR FR RH	Bent	1,400.30 FS	*1,400.30 FS
4	1	*STRIPE, FR DOOR	Necessary	77.60 FS	*77.60 FS
5	1	*STRIPE FR DOOR	Necessary	43.50 FS	*43.50 FS
6	2	*PAD, FR DOOR	Necessary	194.00 FS	*194.00 FS
7	1	*WEATHERSTRIP RR DOOR	Necessary	124.60 FS	*124.60 FS
8	1	*MOULDING, FR DOOR	Necessary	97.80 FS	*97.80 FS
9	8	*RIVET	Necessary	11.20 FS	*11.20 FS
F=Fra	anchise part. S=Spo	Nett.	77		V Star lens
			Total Parts (S\$)	2,129.00	2,099.00

No	Particulars	Lab.Type	Repairer's	Amoun
Lab	our Items			
1	TRANSFER R/F DOOR COMPONENT AND MECHANISM TO NEW DOOR SHELL	New	866.00	866.00
2	REMOVE / REPLACE R/F DOOR DOOR ASSY AND REALIGN	New	866.00	649.50
3	SPRAY PAINT R/F DOOR	New	742.00	742.00
4	TO RESET ECU & REPROGRAMME	New	216.50	216.50
	Gross Labo	2,690.50	2,474.00	
	Report was unsubmitted du	ing this print-out.
