PRE-REPAIR INSPECTION REQUEST – SLD5097A vs SLM3448L (OI) on D.O.A.: 01/08/2019

Accident involving SLD5097A & SLM3448L on 01-08-2019

DATE: 15/08/2019 OUR REF: UAPL1287
REPAIR ESTIMATE TO THE TOYOTA CAMRY NO: SLD5097A

VEHICLE DAMAGE INSPECTION REPORT

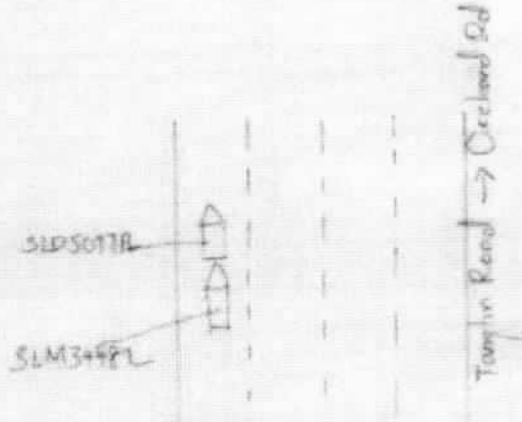
SKETCH PLAN

DESCRIBE CIRCUMSTANCES OF THE ACCIDENT

I was waiting (not moving) for the bus in front of me to drive off, when suddenly the car (SLM 3448L) hit my car on the back.
