VEHICLE DAMAGE INSPECTION REPORT

Our File No: CS/CTI19013908/KTF3N2

Handling Insurer:	China Taiping Insurance (Singapore) Pte. Ltd.	Policy No:	DMPCSN30097119066	
Claimant Vehicle No :	SGT3711Z	Insured Vehicle No :	SFY9755T	
Date of Loss:	06/08/2019	Nature of Claim:	TP	Claim No: SNM19D203693C02

Reg No:	SGT3711Z	Engine No:	3ZZ4632577
Make & Model:	TOYOTA COROLLA ALTIS, 1.6 CVT (A)	Chassis No:	MR053ZEC107141859
Reg. Date:	10/04/2007 (Man. Year: 2006)	Odometer:	187416 km
Colour:	Metallic Green		
Engine Capacity:	1598 cc		
Market Value/New Car Price:	N/A		
Sum Insured (\$\$):	Market Value/New Car Price

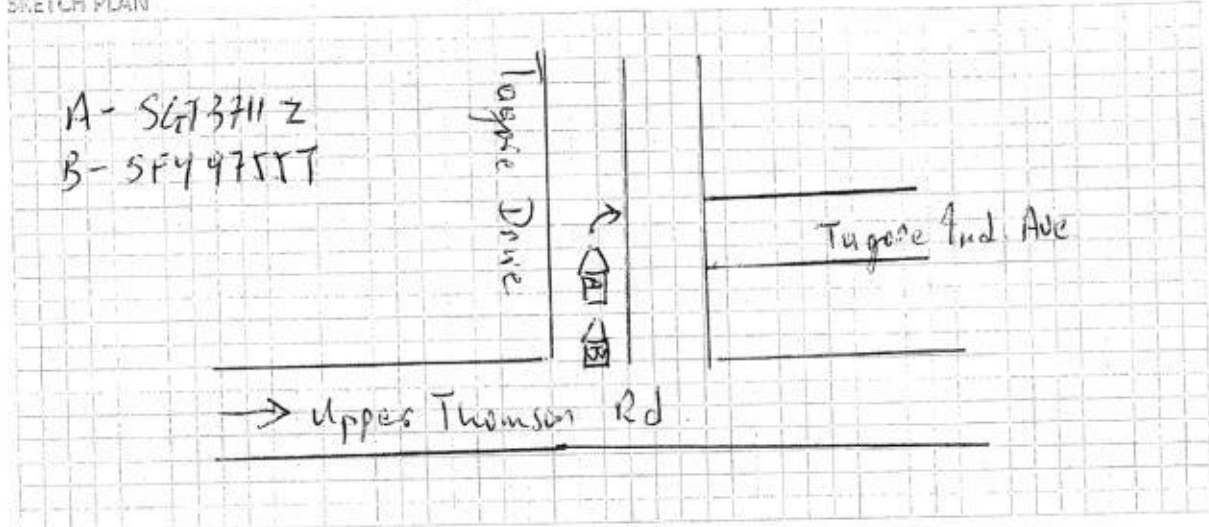
SKETCH PLAN

At 8:30am on 6-Feb-19, I was driving in from Upper Thomson Road to Tagore Drive and at the junction of Tagore Drive and Tagore Industrial Ave when I stopped to allow the on-coming vehicle to drive pass me before I turned to Tagore Industrial Ave. The vehicle behind me suddenly bang into the back of my vehicle. The driver of the vehicle no. SFY975ST (Nissan Latte) admitted his mistake and agreed to pay for the repair. The name of the driver (SFY975ST) is Wu Zhuming,
