**Preliminary Advice**

Vehicle No	: SLK2353T	Accident Date	: 15/08/2019
Make	: TOYOTA COROLLA ALTIS	Policy No.	: A28881428QMY
Assignment Date	: 16/08/2019	Excess	: S\$800.00
Date of Inspection	: 16/08/2019	Est. Duration of Repair	: -
Inspection At	: Borneo Motors (S) Pte Ltd (Pandan) 2 Pandan Crescent Singapore 128462

**Point of Impact / General Description of Damages**

## VEHICLE DAMAGE INSPECTION REPORT

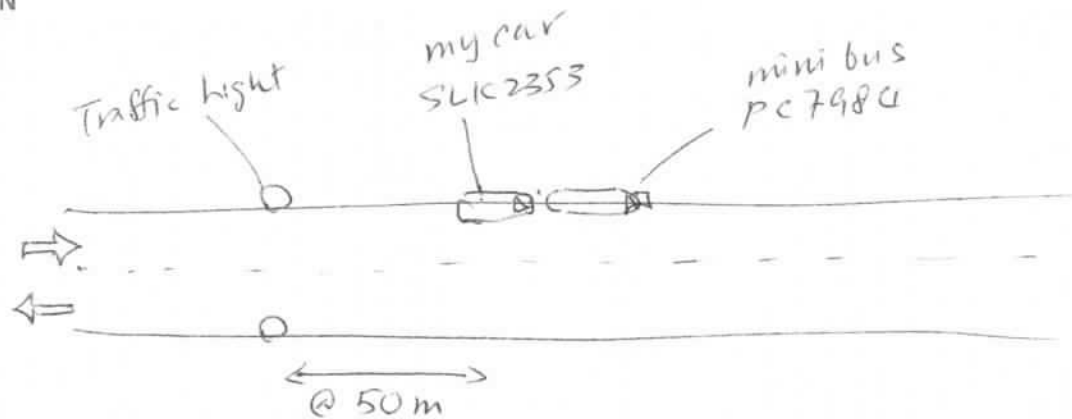
# SKETCH PLAN

I was driving along West Coast Road behind a white mini bus PC 7984 J at around 7.20 am on 15 Aug 19. My son Chang Shu Ren was sitting at the back seat of the car. My car speed was 50~60 km/h. The mini bus suddenly slow down. I immediately pressed the brake. However, it was too late and I hit the back of the mini bus. I was a bit panicle and continued to press the brake till both cars stopped.

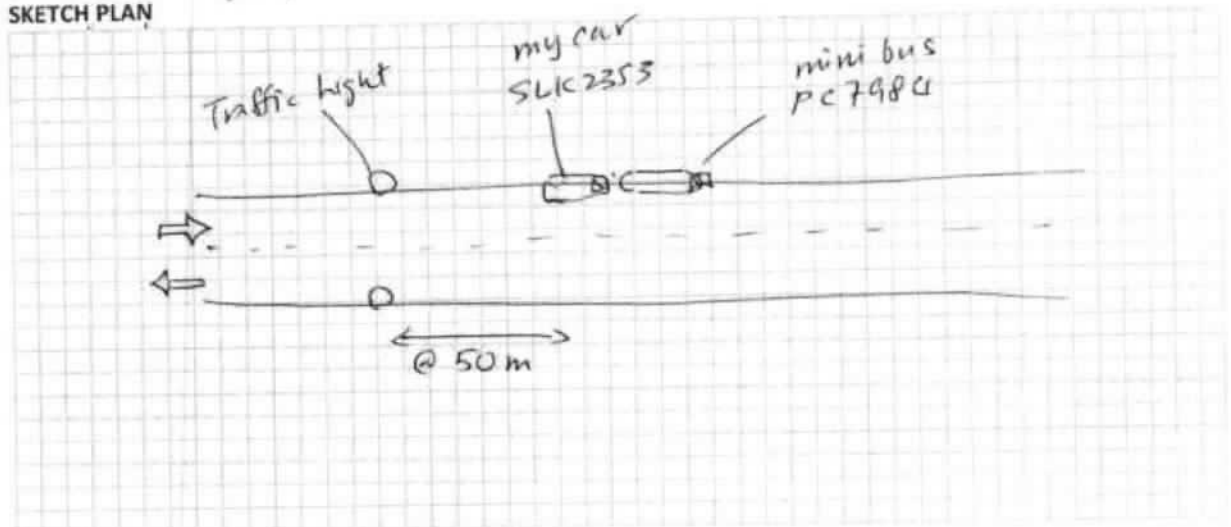
# Sketch Plan #2

I was driving along West Coast Road behind a white mini bus PC 7984 J at around 7.20 am on 15 Aug 19. My son Chang Shu Ren was sitting at the back seat of the car. My car speed was 50 ~ 60 km/h. The mini bus suddenly slow down. I immediately pressed the brake. However, it was too late and I hit the back of the mini bus. I was a bit panicle and continued to press the brake till both cars stopped.
