VEHICLE DAMAGE INSPECTION REPORT

Our File No: CS/CTI19014352/R1SF3E2

Claimant
Vehicle No : SDM2345BInsured
Vehicle No : YP9788X

Make & Model: MERCEDES-BENZ C180, 1.6 (A)

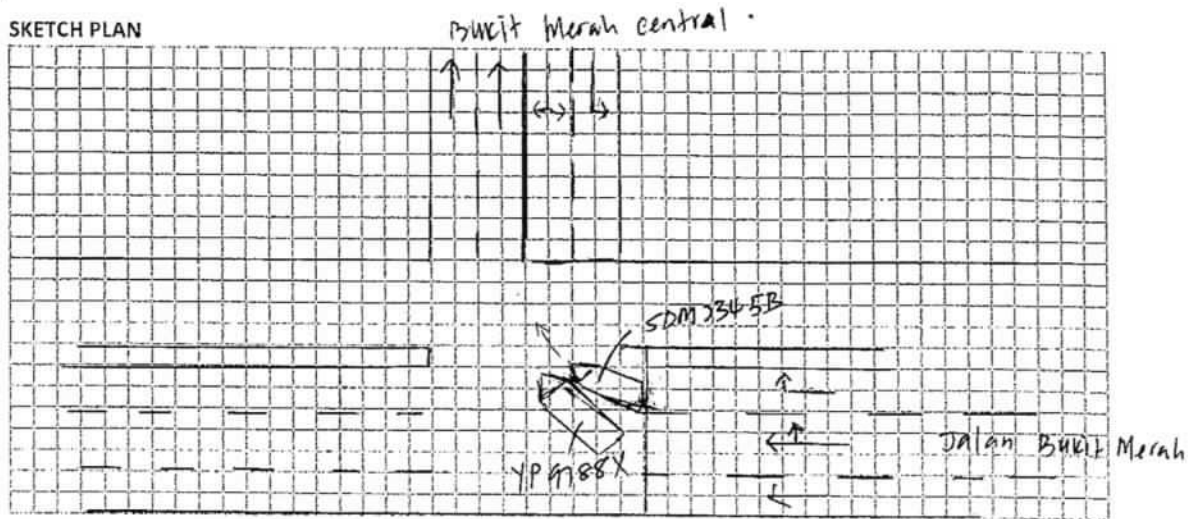
SKETCH PLAN

LICENSE PLATE: SDM2345B	ACCIDENT DATE & TIME: 7/8/19 @ 9.12am
CONTACT NUMBER: 93666893	E-MAIL ADDRESS: joanteo@hotmail.com
LOCATION: Junction at Jalan Bt. Merah and Bt Merah Central.	
Both vehicles (YP9788X and SDM2345B) are stationary at the traffic junction. After that, YP9788X made a very sharp right turn and hit my car cut into my lane and hit the left side of SDM2345B.	
The driver of YP9788X, Mr Velmarasu Thiyyagay (Licence No. G8137107K) admitted his mistake and asked me to contact his boss Mr Kelvin (HP 97868334).	
The driver's HP is 83129213.	
Company Name: Seng Soon Huat Construction.	
NOTE: PLEASE NOTE THAT YOUR INSURER MAY HAVE 14 DAYS TIME FRAME FOR YOU TO SUBMIT AN OWN DAMAGE CLAIM UNDER YOUR OWN POLICY. PLEASE CHECK YOUR POLICY FOR MORE INFORMATION	
Please state:	
<input type="checkbox"/> Claim Own Policy <input checked="" type="checkbox"/> Claim Third Party <input type="checkbox"/> Claim OD/TP at other workshop <input checked="" type="checkbox"/> Reporting Only
