VEHICLE DAMAGE INSPECTION REPORT

Our Ref: 399/TP/2019

Reg No:	GY1957T	Make &	Toyota
Reg date:	25/1/2005	Model	Liteace 5 DR
Colour:	Silver	Engine No:	3C4007306
Type:	Van	Chassis No:	CR425011110
Type of Claims:	Third Party	Odometer No:	759736km
		Engine Cap:	2184cc

Our visual inspection of the vehicle revealed that the damages noted are at the rear portion.

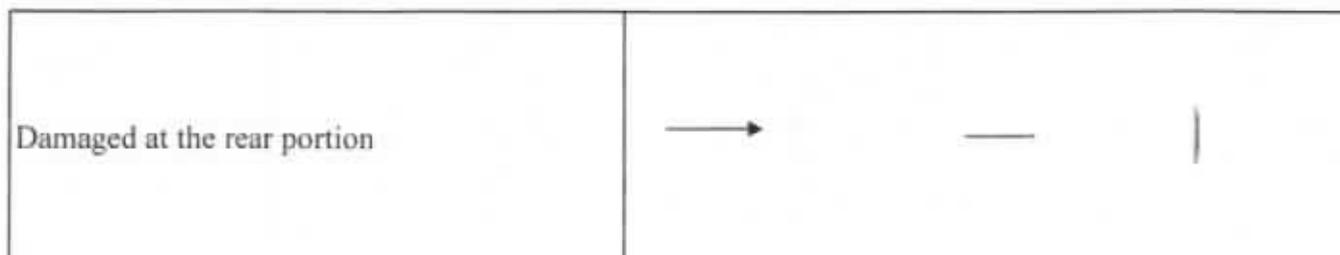
POINT OF IMPACT

The Insured's vehicle collided onto the Third Party's vehicle along CTE Expressway towards City before Braddell exit.

We have inspected the actual damages found on the vehicle and recommend the replacement of parts and repairs accordingly. The estimated repair cost is \$8,677.50. The repairer has agreed to undertake the repairs at our adjusted lump sum amount of \$6,500.00.

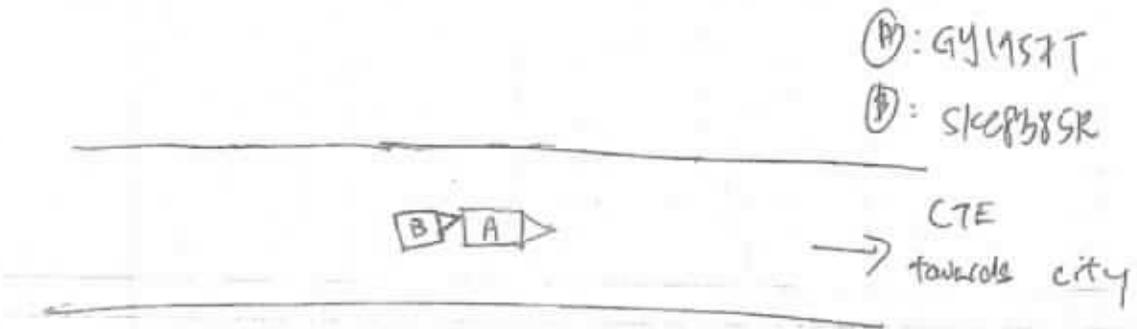
SKETCH PLAN

On 26 Jun 2019, I was travelling along CTE towards city, before broadell exit. My vehicle was stationary when vehicle B hit the rear of my vehicle.
