Preliminary Advice

Insured Vehicle No	: FBE8992J	Accident Date	: 09/08/2019
TP Vehicle No	: SLR9794X	Assignment Date	: 19/08/2019
Make	: HONDA GRACE HYBRID	Est. Duration of Repair	: 4.00
Date of Inspection	: 20/08/2019		
Inspection At	: LION CITY RENTALS PTE LTD (HQ) 60 JALAN LAM HUAT, #04-01 CARROS CENTRE SINGAPORE 737869

VEHICLE DAMAGE INSPECTION REPORT

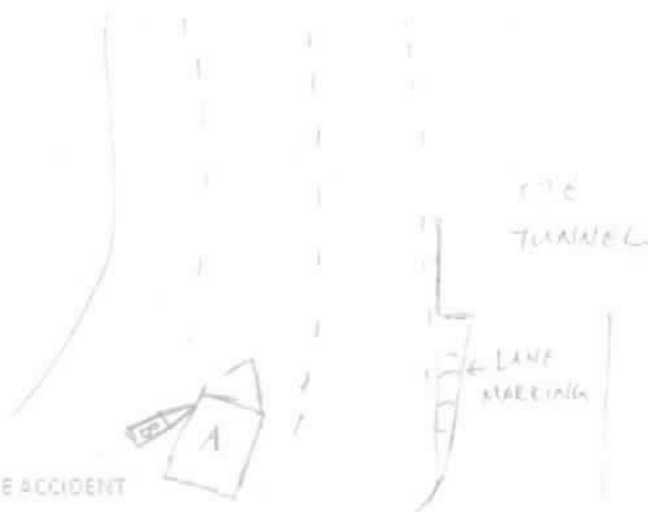
Sketch Plan #2

A JLR 9794X
B FBZ 8992J

On 9th August about 1929, I George Stefan Reale driver of JLR 9794X along upper cross st towards Havelock rd I was along the center lane I notice a motorbike rode past me and went towards the CTC Tunnel, Subsequently another motorbike plate FBZ 8992J that was riding at a fast speed knock the left side of my vehicle and overtook my vehicle He fell down after overtaking my vehicle Ambulance was at scene and conveyed both rider and pillion to the hospital Traffic Police was at scene shortly after
