VEHICLE DAMAGE INSPECTION REPORT

Handling Insurer: AIG Asia Pacific Insurance Pte. Ltd.	Policy No:	1800123881
Claimant Vehicle No : SJV8330K	Insured Vehicle No :	SME9775H
Date of Loss: 11/08/2019	Nature of Claim:	TP Claim No: 3160242550SG

Reg No:	SJV8330K	Engine No:	HR15287006B
Make & Model:	NISSAN SYLPHY, 2.0 (A)	Chassis No:	JN1BAAG11Z0110655
Reg. Date:	09/02/2010 (Man. Year: 2009)	Odometer:	79402 km
Colour:	Black		
Engine Capacity:	1498 cc		
Market Value/New Car Price:	N/A		
Sum Insured (S\$):	Market Value/New Car Price

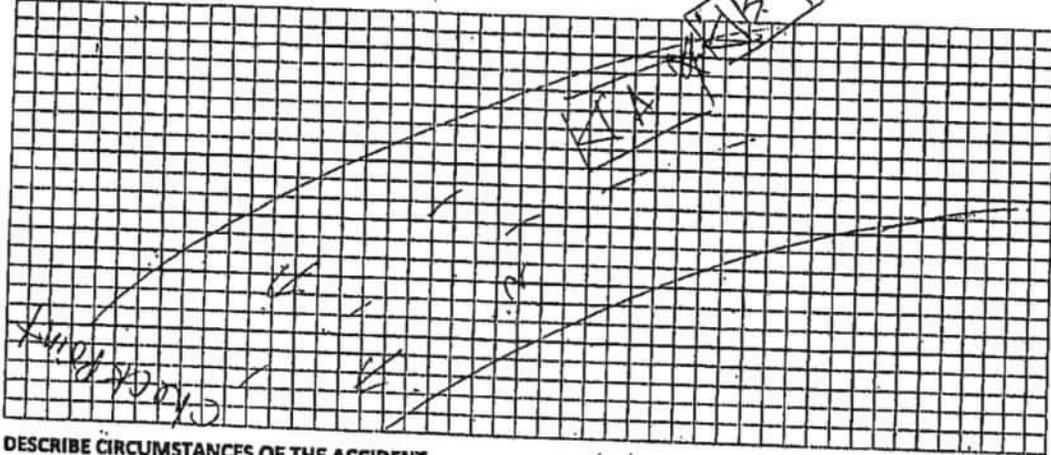
SKETCH PLAN

On 11/8/19 at about 1030am, I was travelling along Johor checkpoint on the right lane. Traffic volume was heavy. Vehicles were moving slowly. When my car (A) came to a stop I felt an impact at the rear of my car (A). I alighted from my car (A) and found out. Car B has hit the rear of my car. We exchanged details.
