### VEHICLE DAMAGE INSPECTION REPORT

**Our File No:** CS/TMI19014599/K1TF3E2

Handling Insurer: Tokio Marine Insurance Singapore Ltd	Policy No:	MJ001819
<b>Claimant Vehicle No :</b> SHC1891C	<b>Insured Vehicle No :</b>	SFK562R
Date of Loss: 20/08/2019	Nature of Claim:	TP Claim No: M1906397

Reg No: <b>SHC1891C</b>	Engine No: 2ZRS063941
Make & Model: TOYOTA PRIUS, 1.8 HYBRID CVT (A)	Chassis No: JTDKB3FU103564236
Reg. Date: 20/09/2017 (Man. Year: 2017)	Odometer: 255897 km
Colour: Blue	
Engine Capacity: 1798 cc	
Market Value/New Car Price: N/A	
Sum Insured (S\$): <b>Market Value/New Car Price</b>

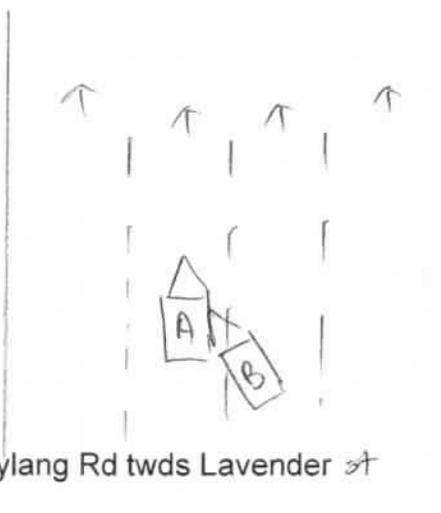
SKETCH PLAN

A- SHC 1891C  
B- SFK 562R

Along Geylang Rd twds Lavender *st*

On 20.08.2019 @ 0150hrs I was travelling along Geylang Rd twds Lavender <sup>st</sup> with one male passenger onboard.
As I was travelling straight suddenly veh(B) SFK 562R cut into my lane and hit onto my vehicle <del>front</del> <sup>front</sup> right portion.
As it took place too fast I could not take evasive action to prevent the accident.
I have company video and photos at scene to support my claims .
No injury in the accident.
Veh(B) SFK 562R MR Koh Jun Hui Johnny HP:8786 7567
