**1. Policy Particulars :- THIRD PARTY CLAIM**

**4. Description of Damages**

| THE VEHICLE SYSTAINED DAMAGES AT THE REAR N/S PORTION.<br>DAMAGES SEE DETAILS. |

## ADJUSTMENT ON REPAIR COST FOR VEHICLE NO. SFW 113R

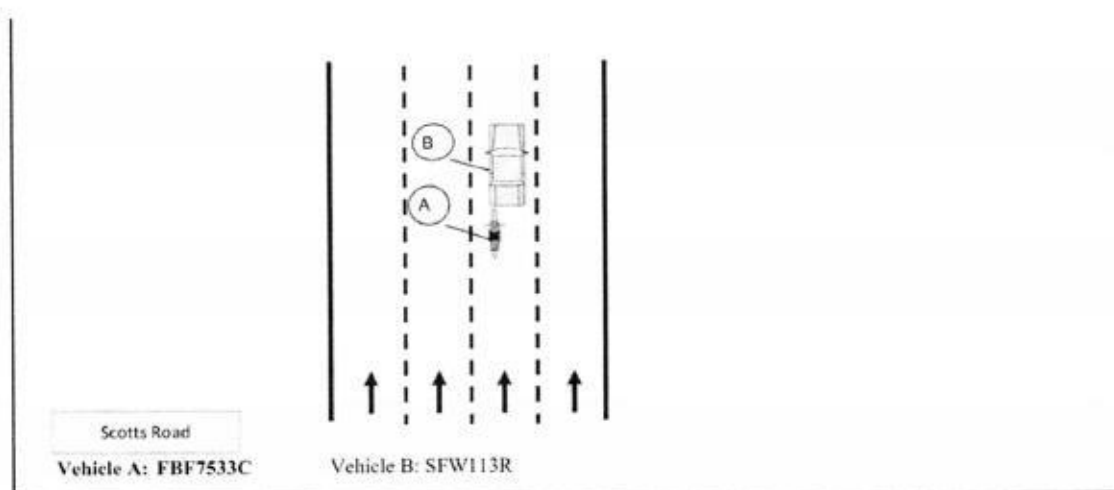
FBF7533C Report as below:

#### DESCRIBE CIRCUMSTANCES OF THE ACCIDENT

I was travelling behind vehicle B. As I did not notice that vehicle B had slowed down and came to a complete stop, thus I hit into the rear left area of vehicle B.

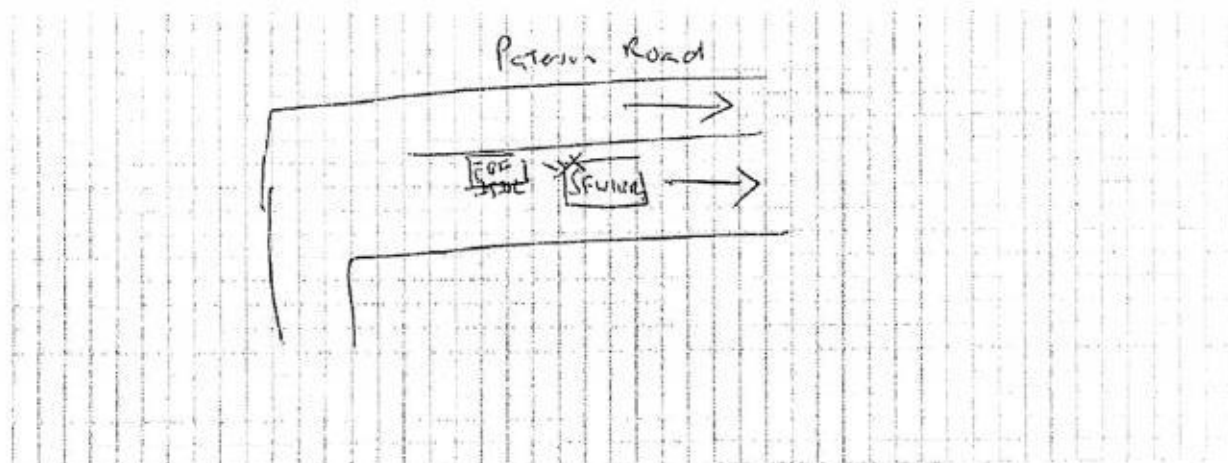
SFW113R Report as below:

#### DESCRIBE CIRCUMSTANCES OF THE ACCIDENT

Turning into Paterson Road on 5th Aug 2019 approx. 1845 at a speed of 25km/hr and when I stopped, FBF7533C knocked into the rear of my car SFW113R. Weather was fine & Mr Chen, rider of FBF7533C admitted he ran into my car and provided me with his insurance NTUC Income policy number 5066535850-04 for claims purpose.
