Report Reference : **TP / 02-19022/AY / 2019**
Date of Report : **21 Mar 2019**

THIRD PARTY SURVEY ACCIDENT HAPPENED ON 21 Feb 2019

Vehicle No: SFV 1541 L
Report No: TP/ 02-19022/AY / 2019

ADJUSTMENT ON REPAIR COST FOR VEHICLE NO. SFV 1541L

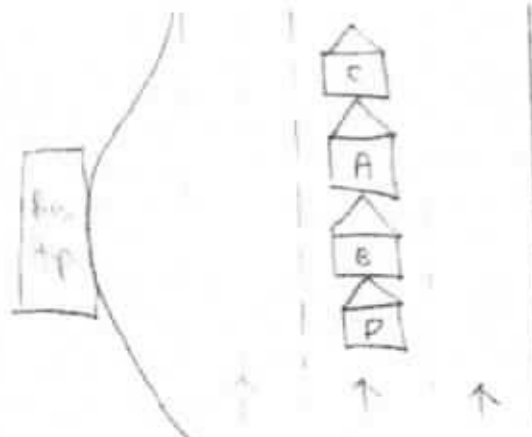
SKETCH PLAN

A. SEV 1541L.
B. SLG 4723.
C. SHD 1462C
D. GEO 7806B.

Upper Chang Rd East
towards Bedok

I was driving along Upper Chang Rd East and the traffic was very ~~congested~~ ^{slow} and traffic was moving along slowly. All of a sudden I felt a massive impact from the rear of my Vehicle A. I was shocked by the impact. After I took a while to compose myself, I exited my Vehicle A and noticed Vehicle B had collided with the rear of my Vehicle A.

It was a chain collision. We exchanged particulars and left the scene.
