REF: CC3/TM1/904816/15 F302

Veh No: SHD 4835R Yr Regn: 6 Mar 2014

Make: Hyundai Z40 c.c. 1685

## VEHICLE DAMAGE INSPECTION REPORT

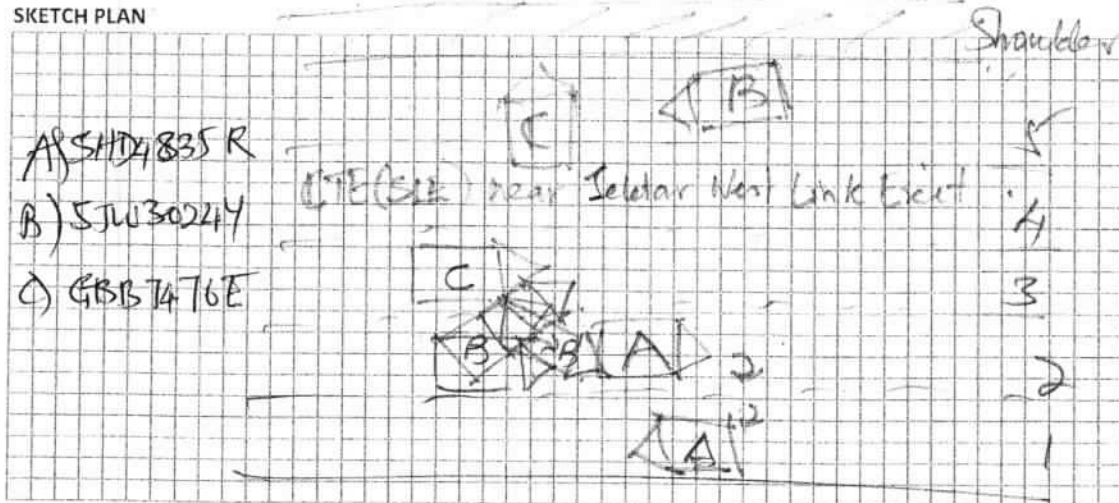
## SKETCH PLAN

On 21/8/19 at about 1130hrs while I was travelling in lane 2, Veh B collided onto the rear of my vehicle. When I came out of my vehicle to check, Veh B + Veh C was stopped on the road shoulder when I verify the collision with both Veh B + Veh C, it was realized the Veh B tried to filter to lane 3 and collided with Veh C and the impact caused Veh B to sway to the lane 2 again and collide onto the rear of my vehicle. The impact caused my vehicle to spin 360° and halted on Lane 1 facing the opposite side of traffic flow.
