From: Denise Tay (LKKAUTO)
Sent: Friday, 23 August 2019 1:53 PM
To: 'Motor Claims'
Cc: SUR
Subject: DIRECT SURVEY INSPECTION ON WORKSHOP - COMFORTDELGRO ENGINEERING PTE LTD, DOA: 21/08/2019, SHA 4500(TP VEHICLE), GBJ 3043E (OI VEHICLE)
Attachments: GIA.pdf, ESTIMATE.pdf

VEHICLE DAMAGE INSPECTION REPORT

Our File No: CC3/TMI19014818/K1TF3N2

Handling Insurer:	Tokio Marine Insurance Singapore Ltd	Policy No:	MS003504
Claimant Vehicle No :	SHA4500Y	Insured Vehicle No :	GBJ3043E
Date of Loss:	21/08/2019	Nature of Claim:	TP
		Claim No:	M1906478

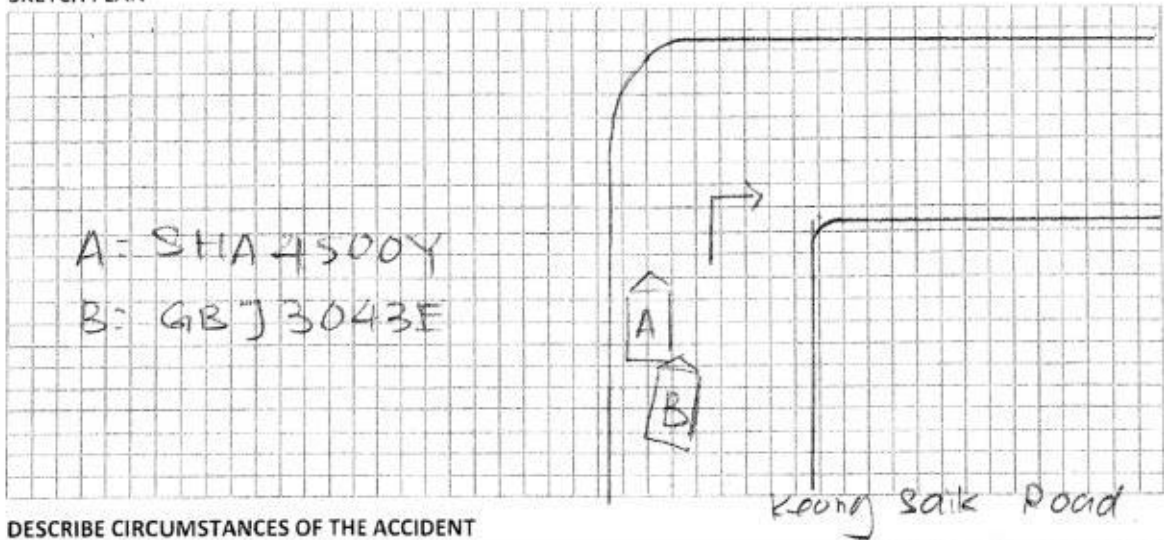
Sketch Plan Pg. 1

On the above-mentioned date and time, I was at the above-mentioned location. At that point of time, I had a passenger in my vehicle (SHA4500Y) and was dropping the passenger off at the main road. I had also switched on my hazard light, to warn the other vehicles that I am stopping. Subsequently, when I stopped the vehicle and while attending to the passenger, I felt an impact at the rear of my vehicle. I noticed that there was a van behind my car. Subsequently, the van then drove off. I did not managed to stop the vehicle.

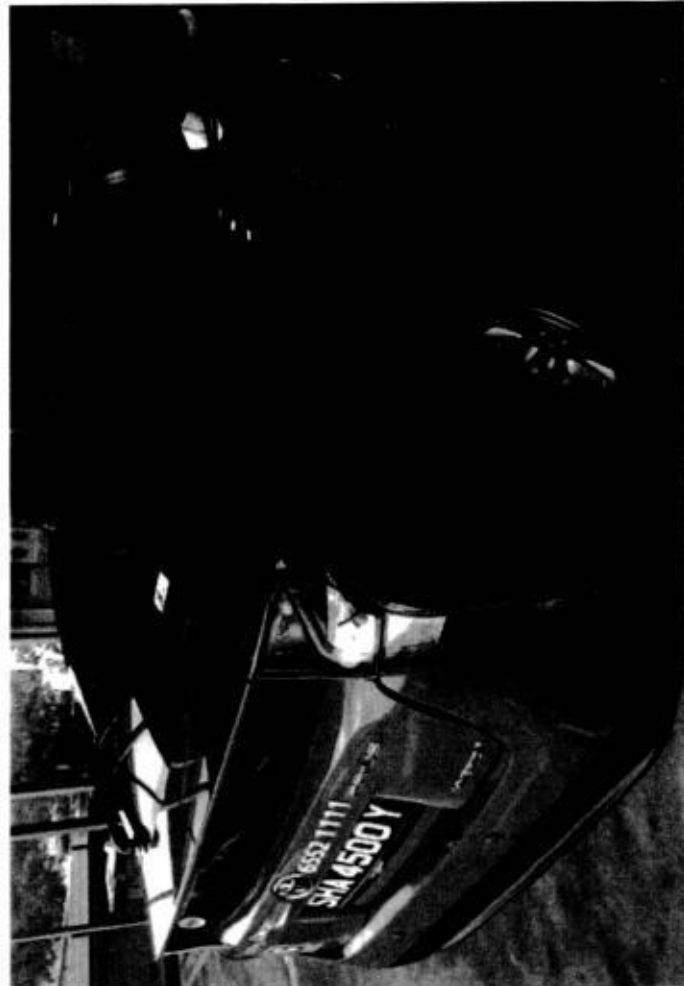
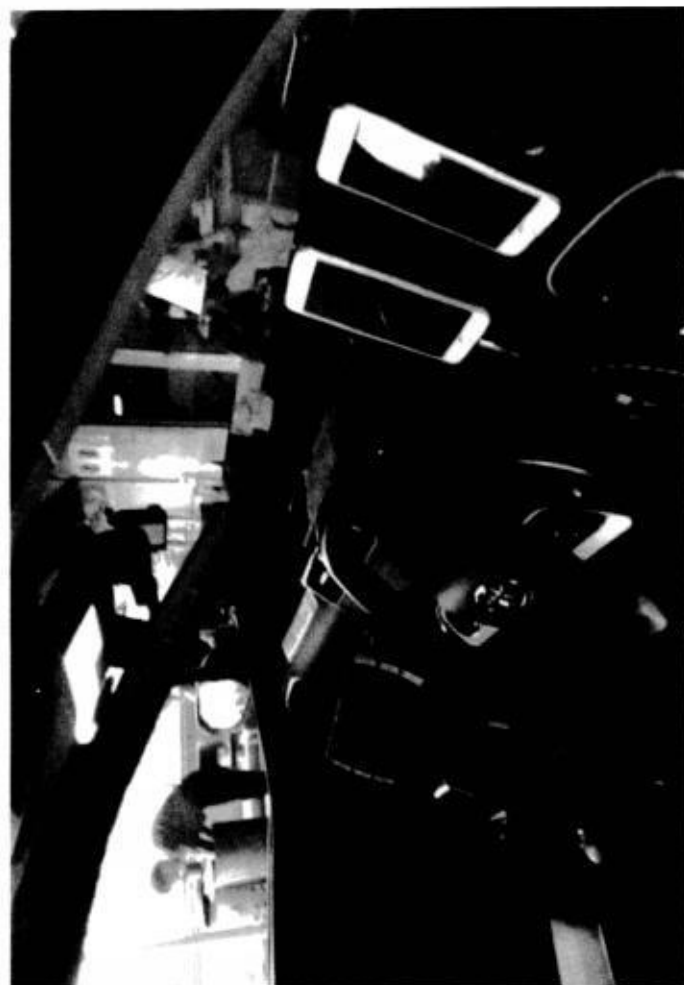
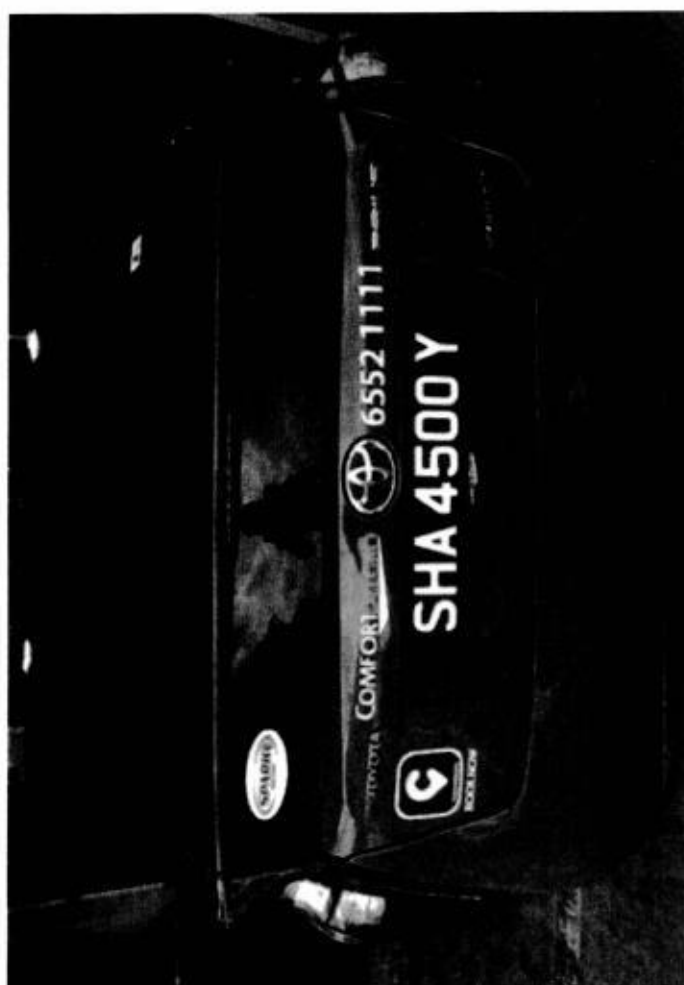
Rear d/c

I do have an in-car camera and that was how I managed to get the vehicle number. I would like to state that no one was injured. There is a dent at the rear right side of my vehicle.

No.	Qty	Part No.	Particulars	Condition	Repairer's	Amount
1	1		*REAR BUMPER	Cracked	458.60 FL	*458.60 FL
2	1		*REAR BUMPER UNDER COVER	Serviceable	552.60 FL	*- FL
3	1		*REAR BUMPER SIDE RETAINER RH	Serviceable	112.70 FL	*- FL
4	1		*REAR BUMPER TOWING COVER	Serviceable	82.70 FL	*- FL
5	10		*REAR BUMPER CLIPS	Necessary	22.00 FL	*22.00 FL
6	1		*RETAINER, REAR BUMPER, SIDE RH	Serviceable	94.80 FL	*- FL
7	1		*SEAL, REAR BUMPER SIDE, RH	Repair	148.40 FL	*- FL
8	1		*TAIL LAMP ASSY UPPER RH	Serviceable	557.90 FL	*- FL
9	1		*TAIL LAMP ASSY LOWER RH	Serviceable	548.40 FL	*- FL
10	1		*REAR BUMPER REVERSE SENSOR	Serviceable	135.70 F	*- FS

No	Particulars	Lab.Type	Repairer's	Amount
<u>Labour Items</u>				
1	PANEL BEATING	New	400.00	200.00
2	SPRAY PAINTING CHARGE	New	300.00	200.00
3	WIRING CHARGE	New	50.00	0.00
4	REMOVE/REFIX REVERSE SENSOR	New	80.00	0.00
Gross Labour Cost (\$\$)			830.00	400.00
