**SINGAPORE
POLICE FORCE**

NTUC INCOME INSURANCE CO-OPERATIVE LTD Ref: NS/INC19014898/K1sf3s2

4. Description of Damages

ADJUSTMENT ON REPAIR COST FOR VEHICLE NO. SHC 945M

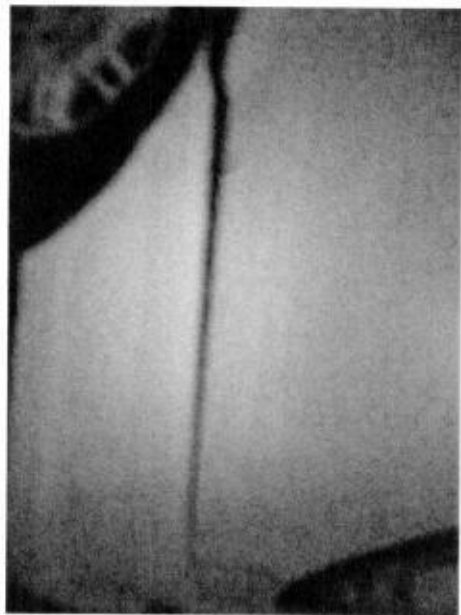
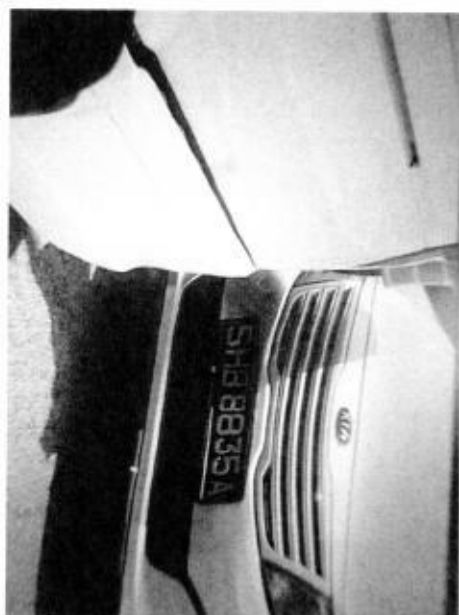
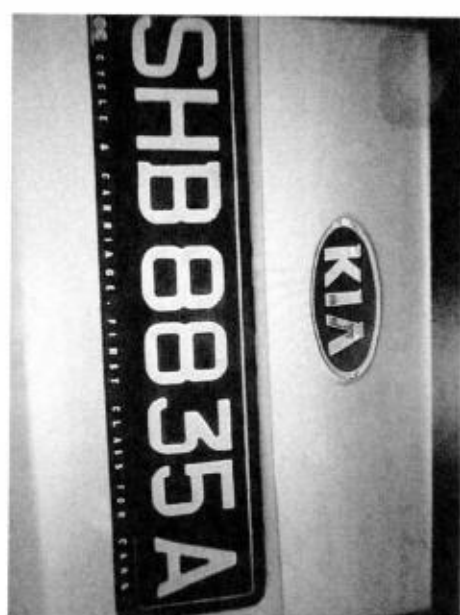
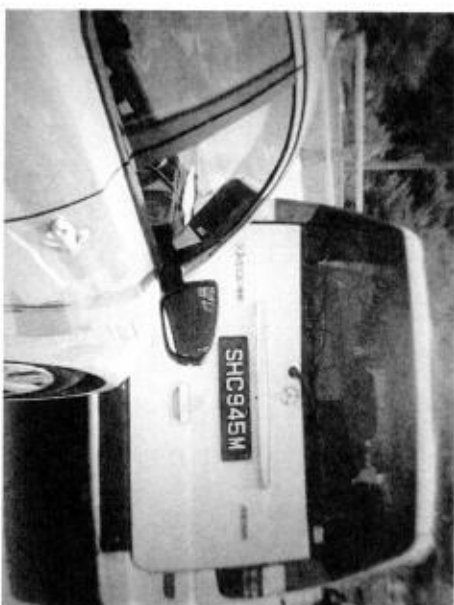
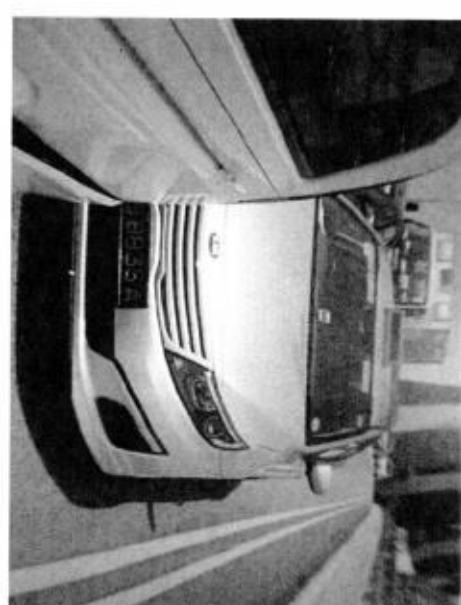
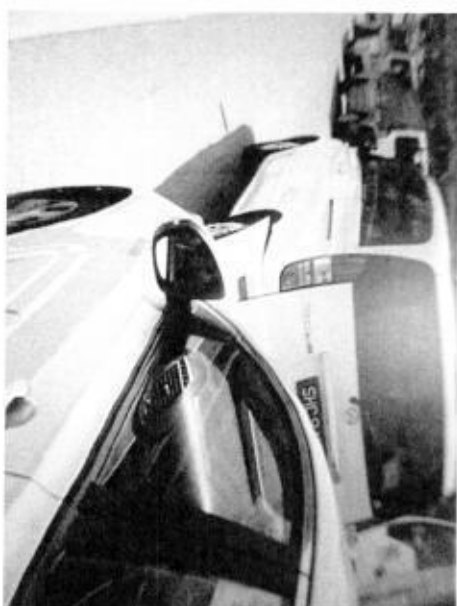
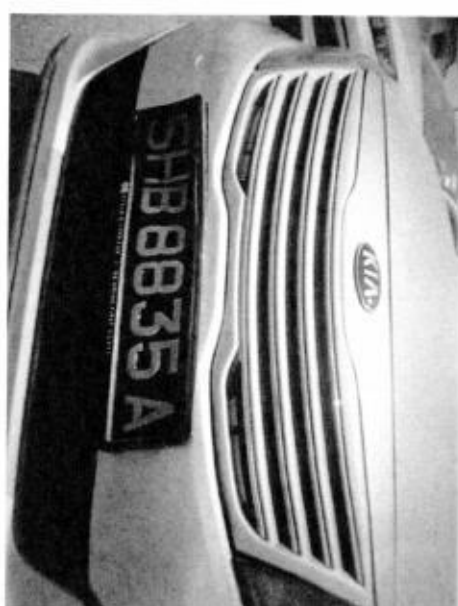
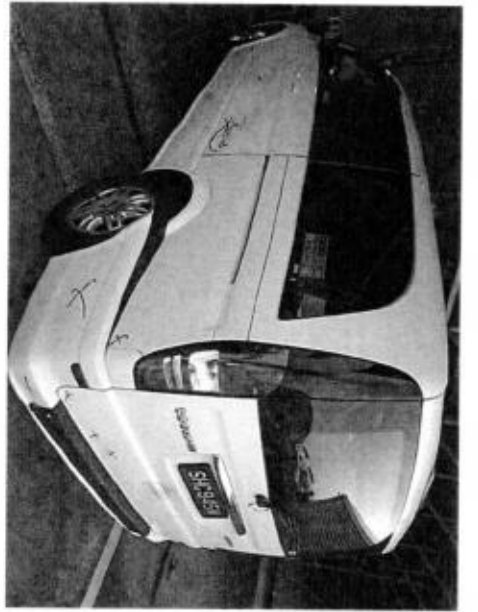
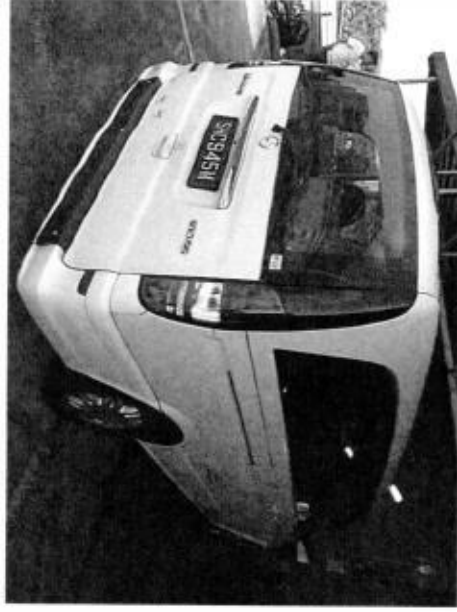
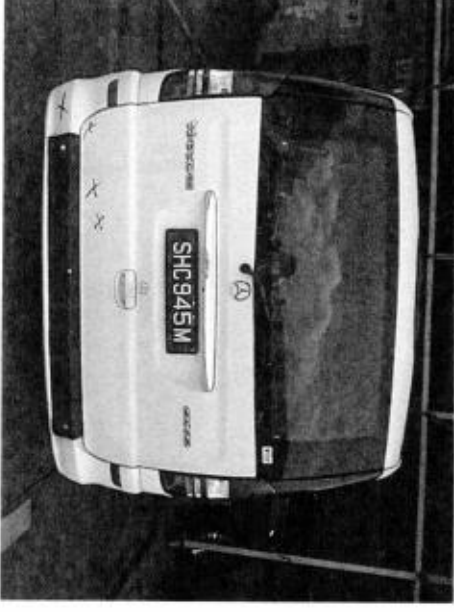
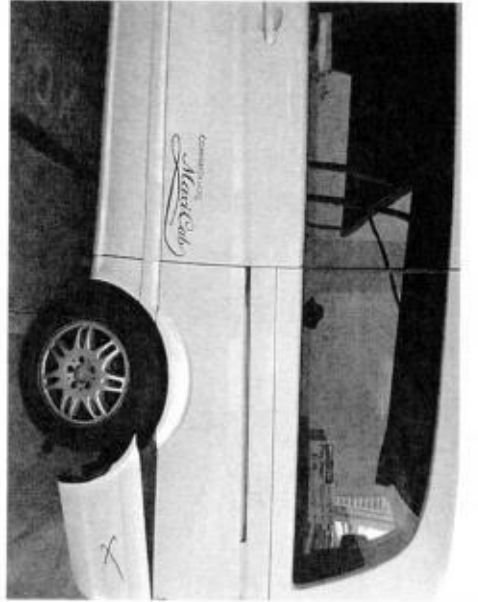
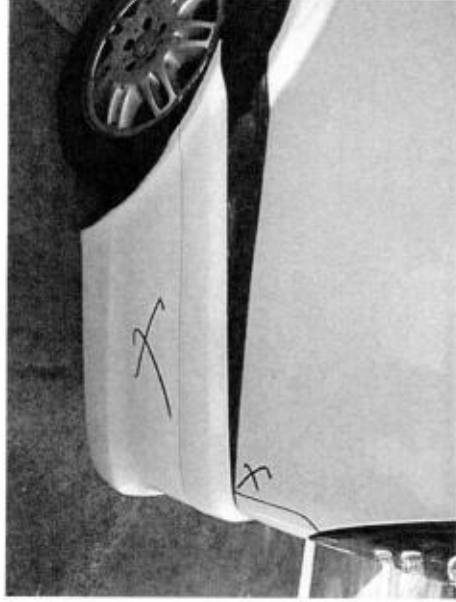
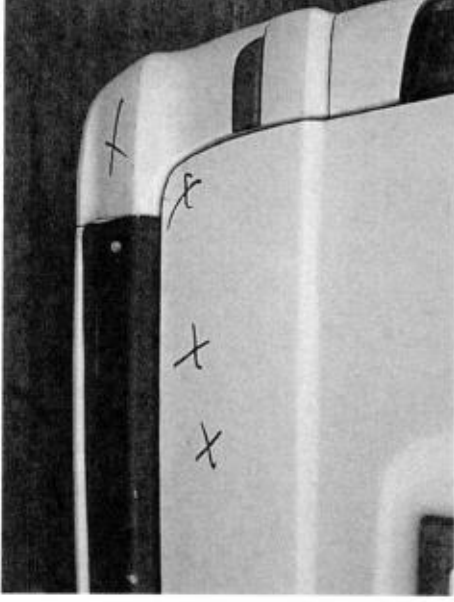
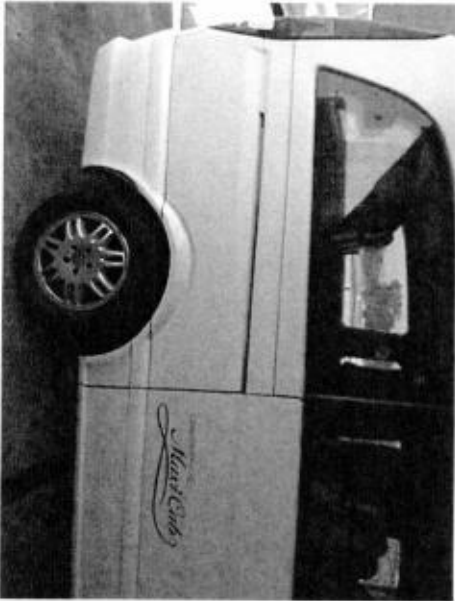
SHC945M

THE VEHICLE SUSTAINED DAMAGES AT THE REAR N/S PORTION. DAMAGES SEE DETAILS.
--

Qty	Description of Parts	Condition	Estimate By Workshop (\$)	Our Adjusted (\$)
REPLACEMENT OF PARTS				
1	REAR BUMPER	DEFORMED	1,372.00	1,372.00
1	BUMPER REFLECTOR RR/LH	SERVICEABLE	46.00	-
1	REAR WHEEL RIM (LH)	SERVICEABLE	756.00	-
1	REAR BUMPER LH	DEFORMED	473.60	473.60
1	REAR TAILGATE (NPA)	TO REPAIR SEE LABOUR	-	-
1	TAIL GATE MERCEDES STAR LOGO	NECESSARY	45.46	45.46
1	TAIL GATE 'CDI' LOGO	NECESSARY	78.00	78.00
1	TAIL GATE '2.2' LOGO	NECESSARY	78.00	78.00
1	TAIL GATE 'VIA NO' LOGO	NECESSARY	78.00	78.00
1	TAIL GATE MAXICAB LOGO	NOT NECESSARY	30.00	-
	LESS 20% DISCOUNT		-591.41	-425.01
			2,365.65	1,700.05
LABOUR				
	PANEL BEATING. INCUSIVE OF THE REPAIR OF REAR TAILGATE.		500.00	300.00
	SPRAY PAINTING CHARGE.		600.00	400.00
	WIRING CHARGE.	NOT NECESSARY	50.00	-
	TUFF KOTE.	NOT NECESSARY	50.00	-
	REMOVE / REFIX REVERSE SENSOR.		120.00	30.00
	REAR WHEEL ALIGNMENT.	NOT NECESSARY	120.00	-
			1,440.00	730.00
GRAND TOTAL			3,805.65	2,430.05

RECOMMENDED COST OF LUMP SUM REPAIRS (TO ITS PRE-ACCIDENT CONDITION) (CONFIRMED)				1,900.00
