Preliminary Advice

Insured Vehicle No : SLM9740C

: SHB8985A

: KIA OPTIMA

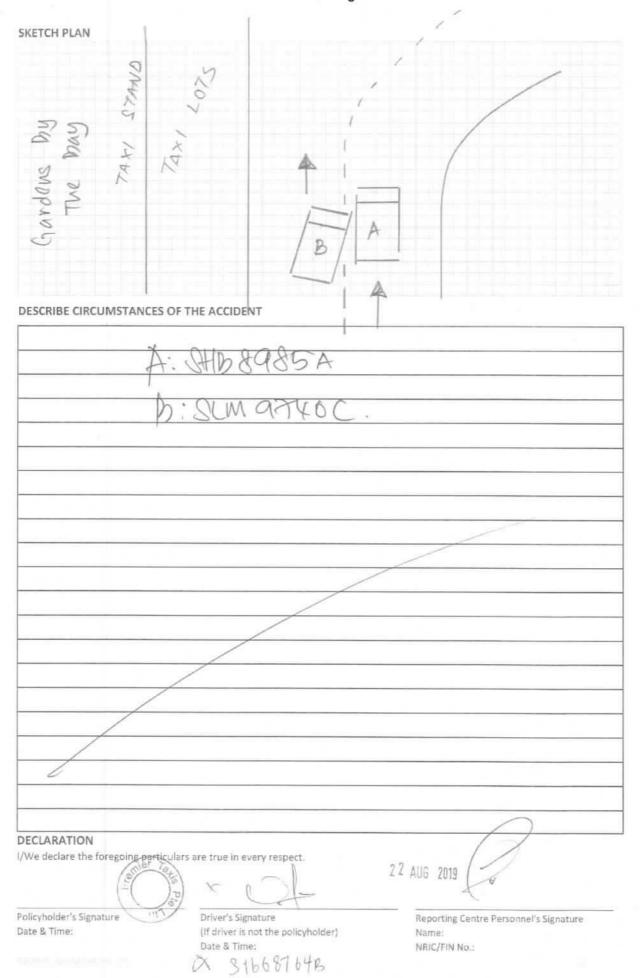
Sketch Plan Pg. 2

ON 21/08/2019 @ 1835HRS, I WAS DRIVING MY TAXI (SHB 8985 A) TRAVELLING ALONG THE DRIVEWAY @ GARDENS BY THE BAY, WITH 2 PASSENGERS ONBOARD, IN THE RIGHT LANE.

WHILE I WAS MOVING STRAIGHT AHEAD - WITHIN MY LANE & ACCORDING TO THE FLOW OF TRAFFIC, SUDDENLY I FELT AN IMPACT FROM MY LEFT.

WHEN INSPECTED, I DISCOVERED THAT VEHICLE B (SLM 9740 C – HONDA VEZEL) WHICH WAS IN THE MIDDLE LANE, FAILED TO KEEP FOR PROPER LOOK OUT & FAILED TO OBSERVE FOR CLEARANCE FROM MY ROUTE, HAD ENCROACHED ONTO MY PATH MY LEFT ABRUPTLY.

AS SUCH, THE FRONT RIGHT OF VEHICLE B COLLIDED ONTO THE LEFT PORTION OF MY TAXI – WHILE SHE WAS FILTERING INTO THE RIGHT LANE.

DUE TO THE IMPACT, MY TAXI HAD DAMAGES ON THE LEFT PORTION AND VEHICLE B HAD DAMAGES ON THE FRONT RIGHT PORTION.
