**PRE-REPAIR INSPECTION REQUEST – SMJ2612P vs SLF1927X (OJ) on D.O.A.: 24/08/2019**

## VEHICLE DAMAGE INSPECTION REPORT

Our File No: CS/AIG19014950/KQF3

Handling Insurer:	AIG Asia Pacific Insurance Pte. Ltd.	Policy No:	0999994251
Claimant Vehicle No :	SMJ2612P	Insured Vehicle No :	SLF1927X
Date of Loss:	24/08/2019	Nature of Claim:	TP
		Claim No:	0497322089SG

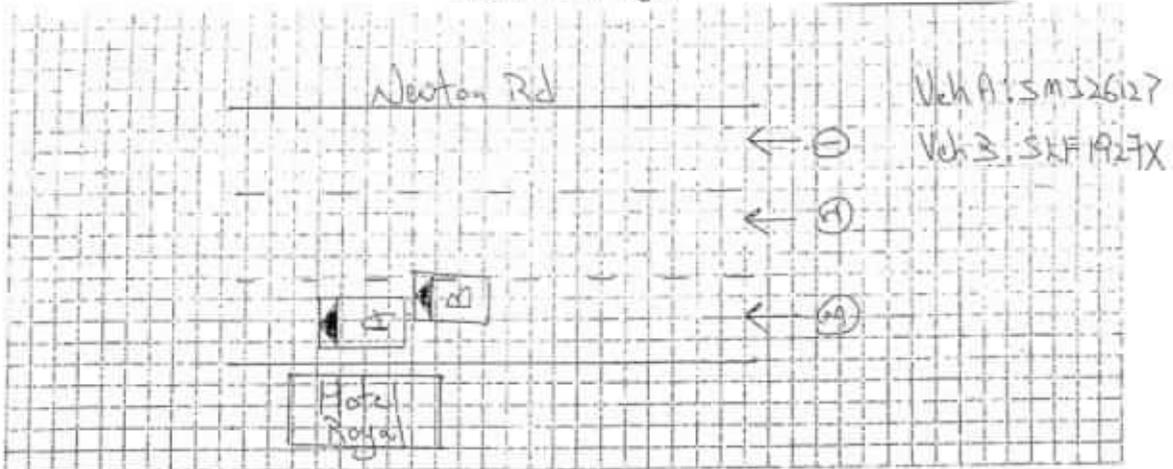
Sketch Plan #2 Pg. 1

On 24/8/2019 @ arnd 1830hrs, I was travelling along Newton Rd towards Newton Circle. Just in front Hotel Royal, I slowed down my vehicle in order to turn into Surrey Rd. Suddenly, I felt an strong impact from the rear of my vehicle. I got out of my vehicle and realised that veh B (SKF1927X) had collided into my vehicle rear portion
