**Insurer Reference: Ntuc Income**  
**Repairer Reference: SLC 5406Y(HondaVezel)**  
**Date calculated: 26/08/2019 3:39 PM**

Claim Type:	THIRD PARTY	Ref. No:	SLC5406Y
Policy No:		Date of Loss:	23/08/2019
Vehicle Reg. No.:	SLC5406Y	Driveable?	
Party At Fault:	UNKNOWN		
Driver (TP):	NG ZI YANG	Driver (Insured):	WEE KUAN HOE
Make/Model:	HONDA VEZEL, 1.5 (A)	Vehicle Reg. Date:	18/05/2016
Vehicle Colour:	BLUE		
Engine No:	L15B4035848	Chassis No:	RU11115843
Odometer:	1 KM		
Paint Type:			
Total Loss?	NO		
Est. Duration of Repair (day)	5		
Description of Accident/Loss	1 STOPPED MY CAR SLC5406Y BEHIND TRAFFIC LIGHT JUNCTION, TRAFFIC LIGHT WAS RED AT THAT TIME. SHORTLY I FELT A STRONG IMPACT FROM BEHIND UPON CHECKING, SMJ5412E HAD BANG ONTO THE REAR PORTION OF MY CAR.		
Present Location:	JIN AUTO SERVICES PTE LTD (DEFU)

## VEHICLE DAMAGE INSPECTION REPORT

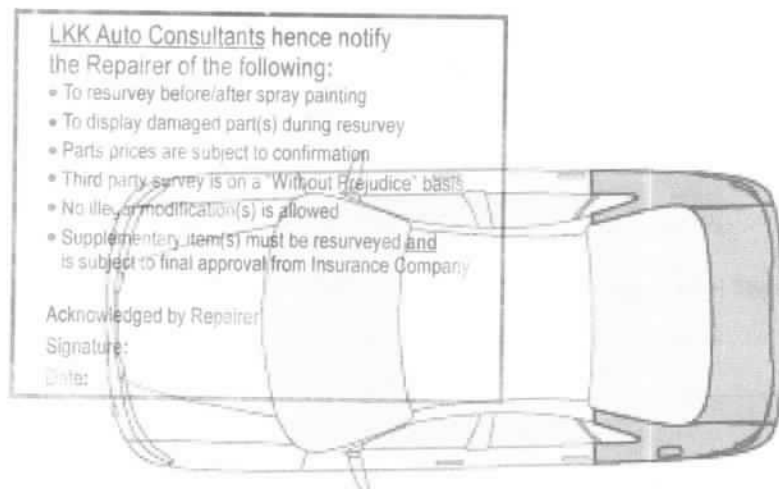
**Damage Areas**

Des. of Damages: Frt / Rear / O/S / N/S / U/C / Rooftop orRear

The U/C / Chassis frame / Body Structure affected due to collision.
