Veh No: GBG 7700G Yr Regn: 2017 / May  
 Type: M.Cár / M.Cycle / Bus / Van / Lorry / Taxi / Prime Mover /

Make: Nissan NV350 cc 2488

## Estimate Repair Cost to Vehicle No :GBG7700G

## VEHICLE DAMAGE INSPECTION REPORT

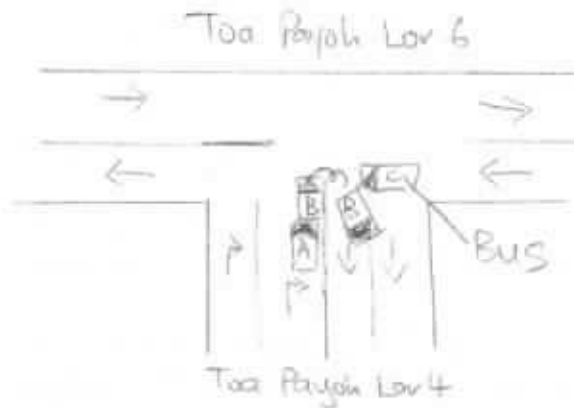
## SKETCH PLAN

A: GBL7700G  
 B: SKP3681A  
 C: SBS 9109 H  
 (Bus)

My vehicle was stationary at the junction of Toa Payoh Lor 4/Lor 6, waiting for the traffic light to turn green to make a right turn to Toa Payoh Lor 6. While waiting, Veh B (SKP3681A) was turning right from the opposite direction. Suddenly, Veh C (SBS Bus) which was travelling straight along Toa Payoh Lor 6 collided to Veh B. The impact pushed Veh B to spin to my direction & collided to my front portion causing damage. Police & ambulance came but nobody was conveyed to hospital. After the accident, I felt pain on my neck & went to consult doctor & was given 2 days MC.
