**From:** Stanley Lai <stanley.lai@iii.com.sg>  
**Sent:** Wednesday, 28 August 2019 6:11 PM  
**To:** Admin-D (LKKAuto); 'sur@lkkauto.com'  
**Cc:** Mekavathanan Sarangapani; Pooi Chin Han Daniel  
**Subject:** III REF: MCT19070562 | REQUEST PAPER SURVEY TP PC948K

**ROAD TRAFFIC ACCIDENT INVOLVING MOTOR VEHICLES PC 948K & SHA 2044K ON 21.07.2019 @ 1000HRS ALONG KRAMAT LANE (EXIT CONCORDE HOTEL)**

## VEHICLE INSPECTION REPORT

## ADJUSTMENT ON REPAIR COST FOR VEHICLE NO. PC 948K

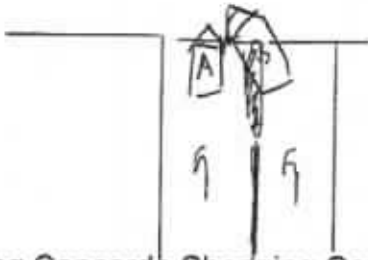
A-SHA2044K

B-PC 948K

Along Concorde Shopping Carpark Centre Driveway

I was on the extreme left lane,Suddenly veh (B) on my right lane cut into my lane,and hit onto my taxi (A) front RH portion. My taxi (A) front RH portion was damaged.

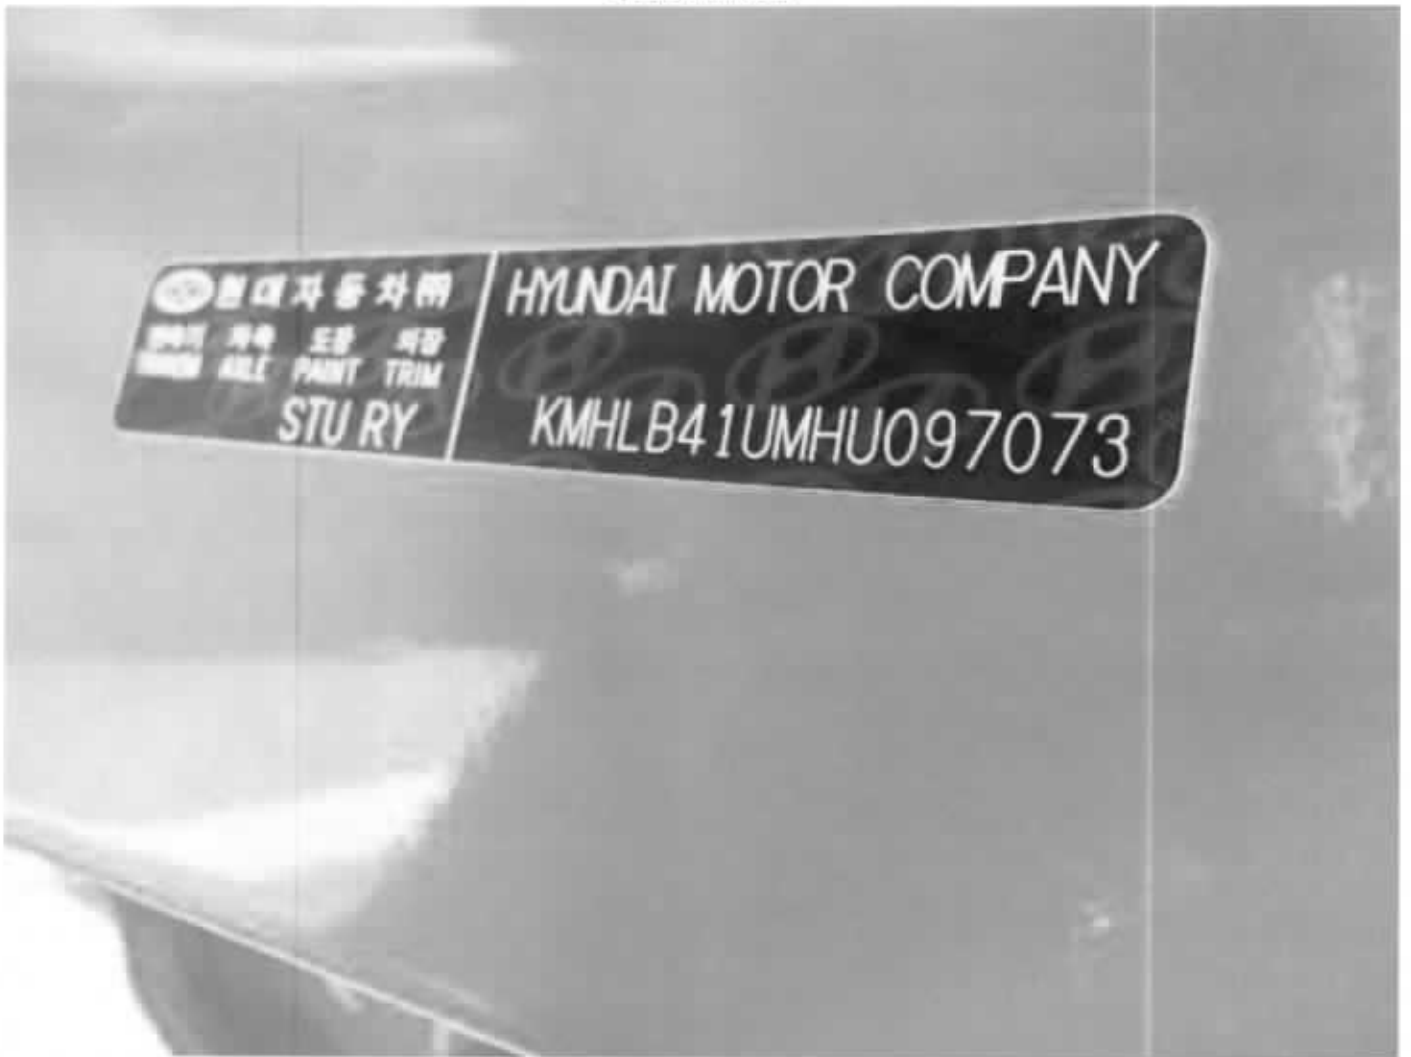
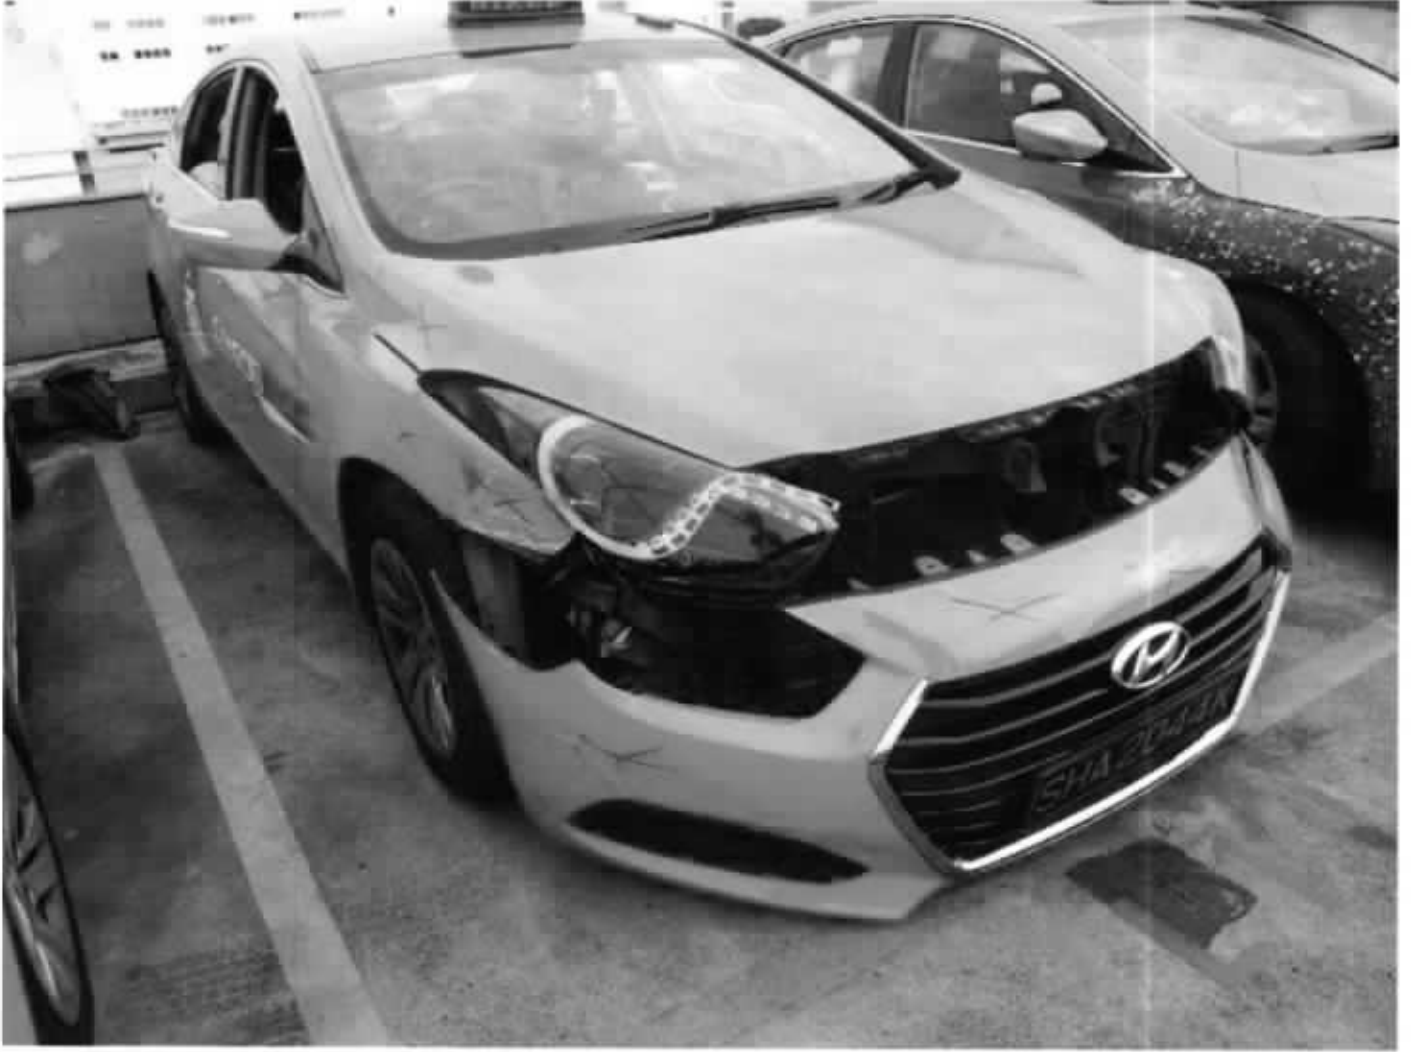
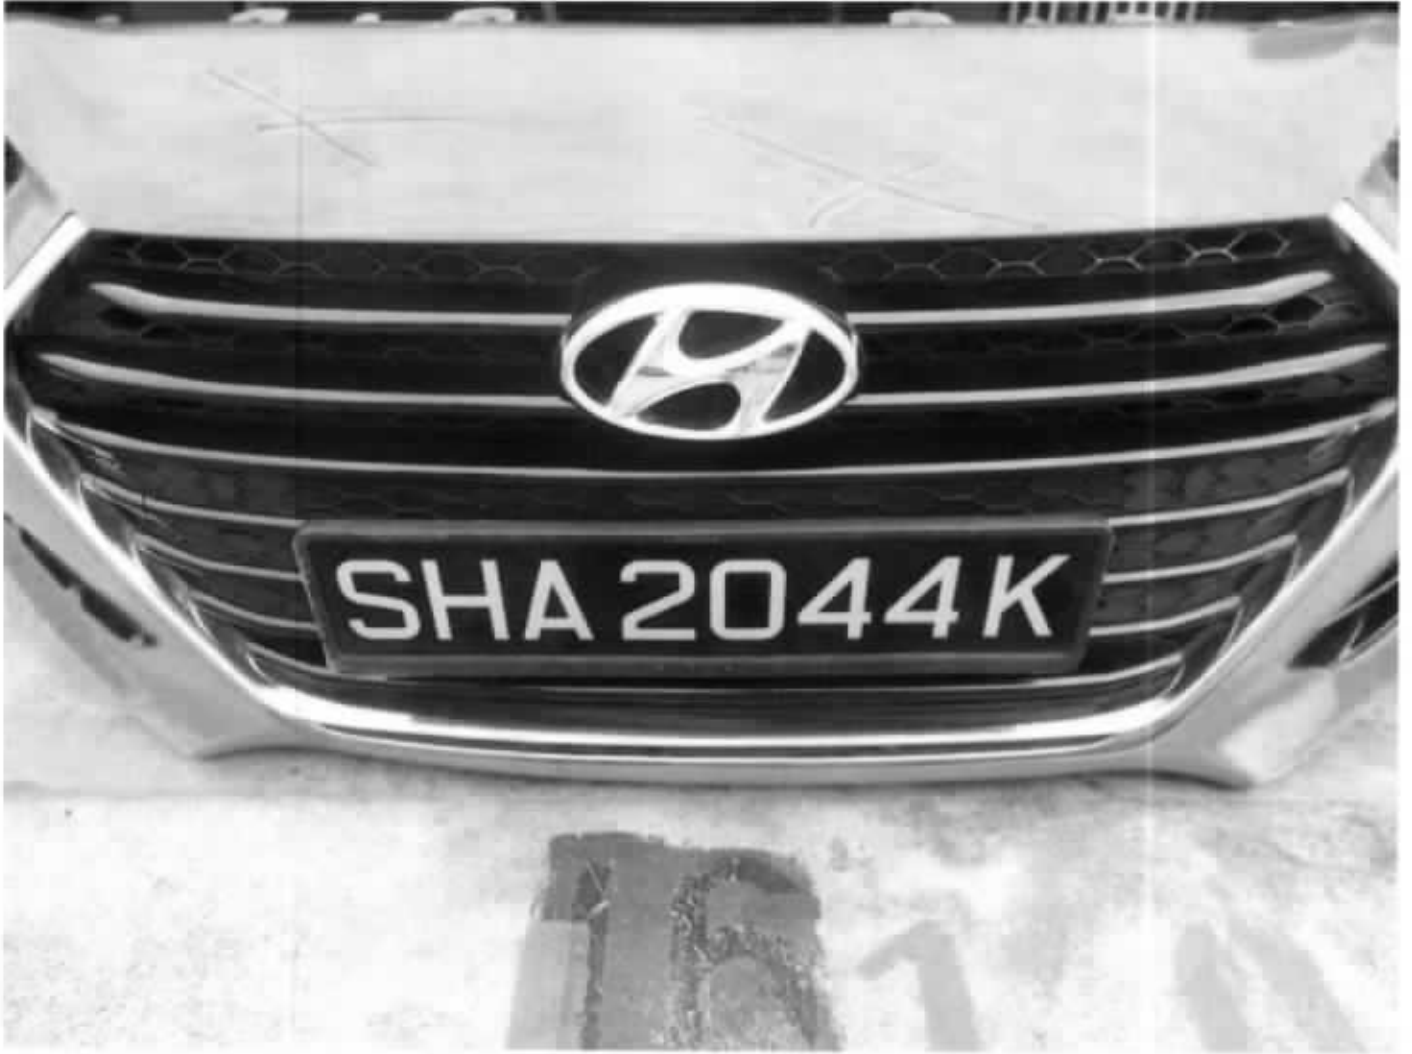
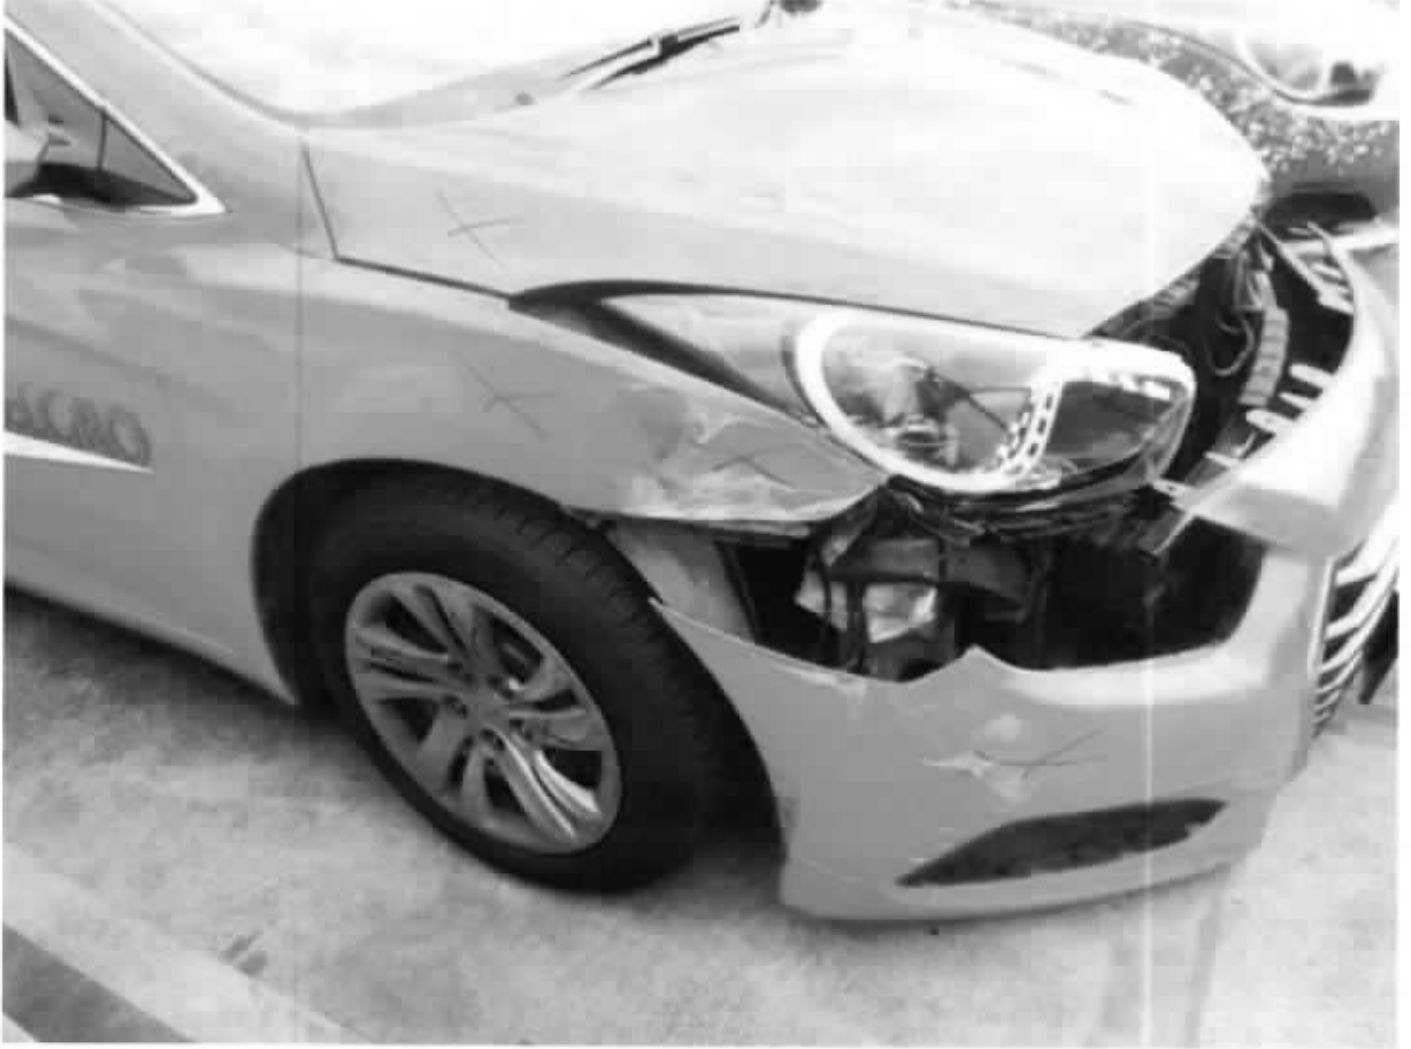
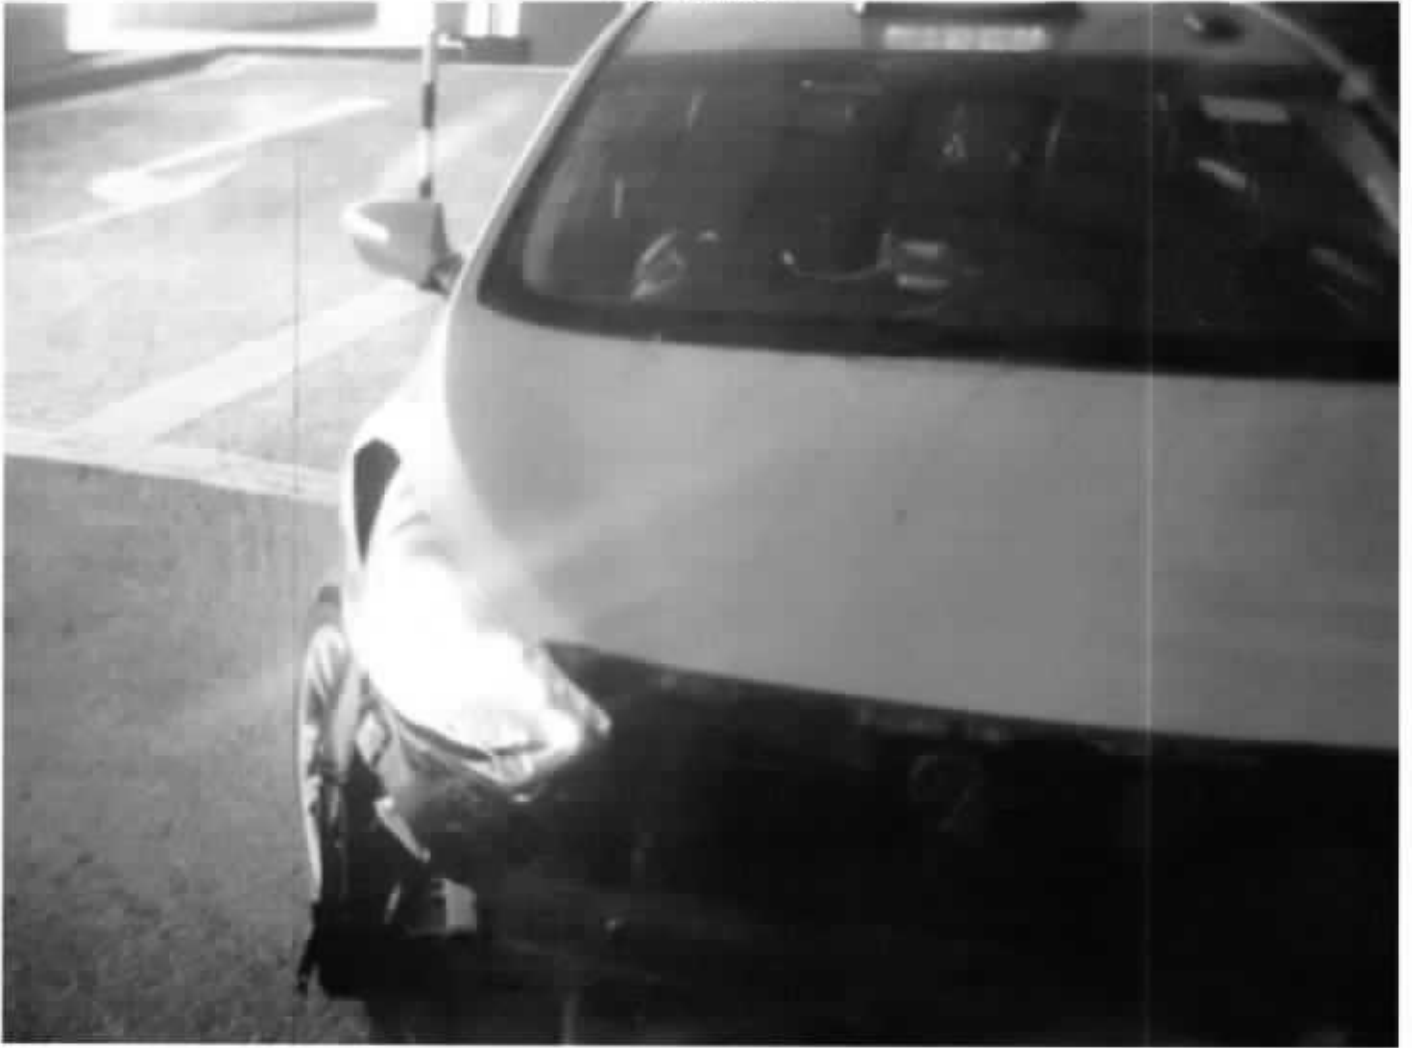
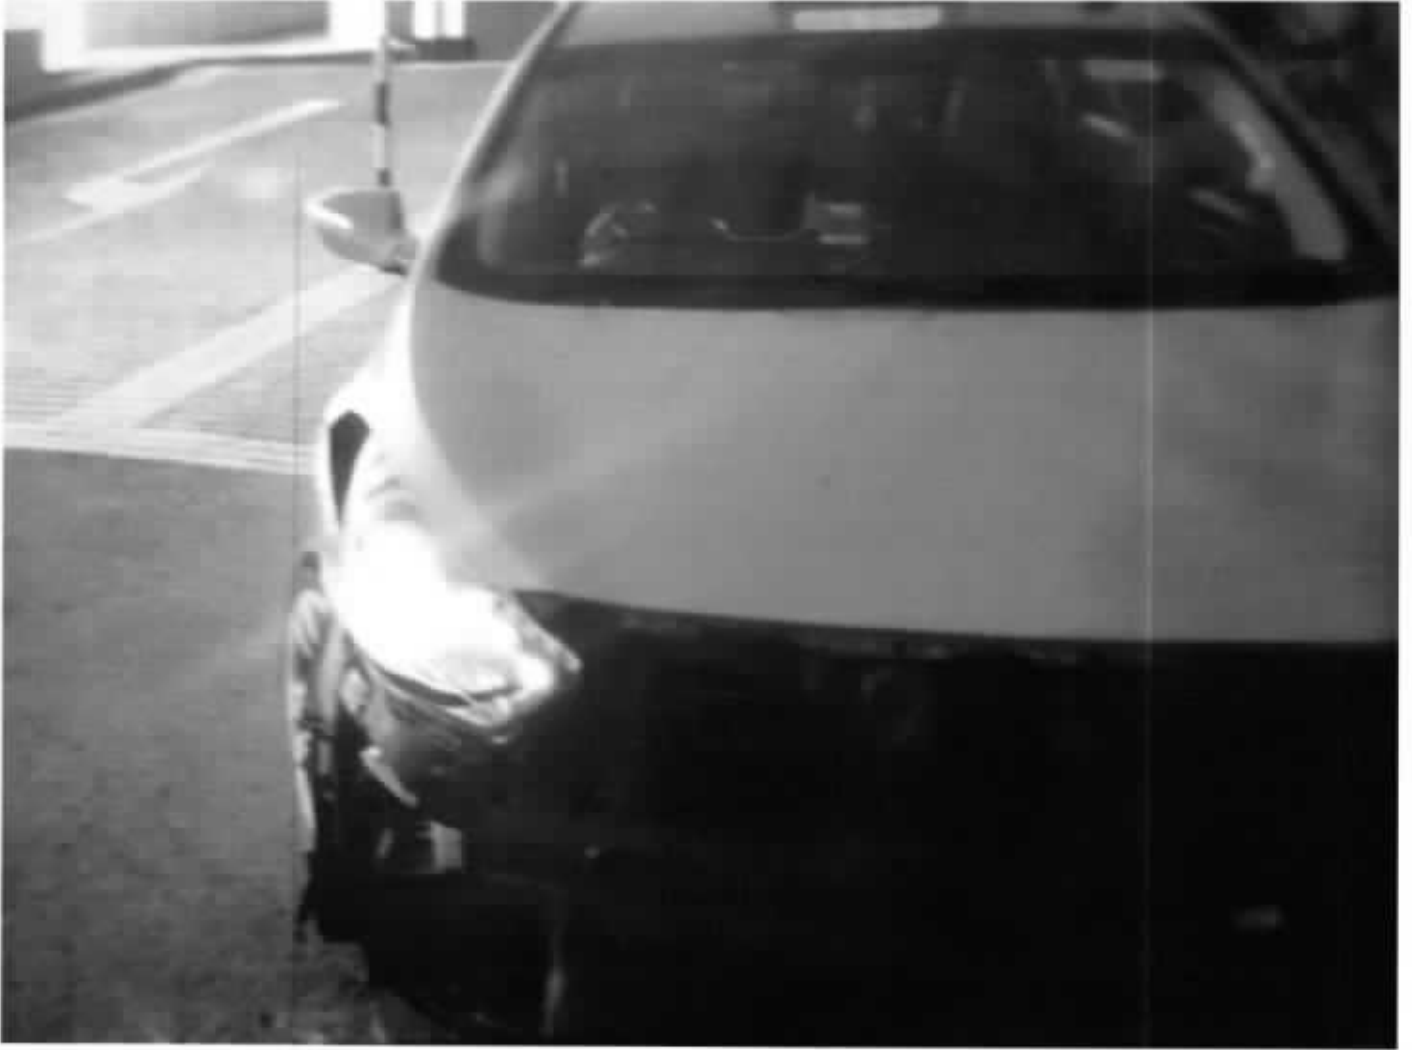
Accident Photo

The impact damages sustained on the vehicle at the time of inspection is on the n/s front portion.  
(Details refer to the photographs attached)
