Preliminary Advice

Insured Vehicle No : SLL618M

Make : TOYOTA WISH

VEHICLE DAMAGE INSPECTION REPORT

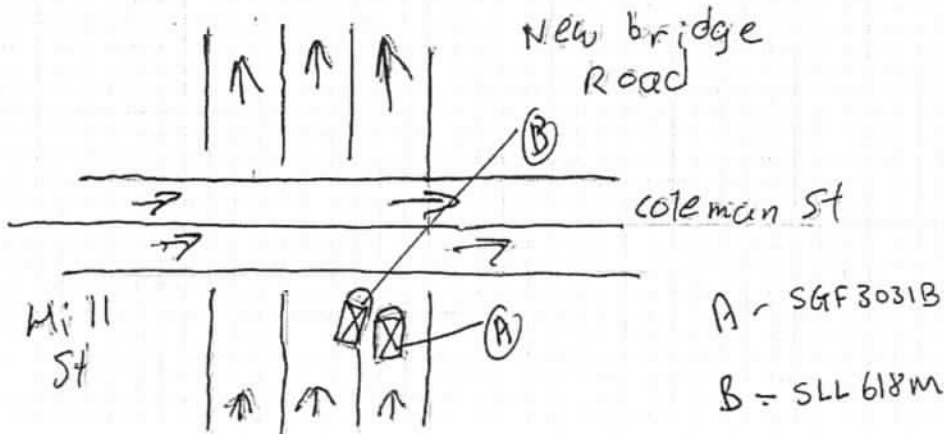
SKETCH PLAN

DESCRIBE CIRCUMSTANCES OF THE ACCIDENT

Junction of hill St & coleman St - 1510 hrs. on 1/9/2019

I was on the first lane when a car hit my car on the front left side.
