To Inspect Vehicle No: SLQ 4985A Insured: YM 457B

## ESTIMATE TO REPAIR TOYOTA C-HR - SLQ4985A

## VEHICLE DAMAGE INSPECTION REPORT

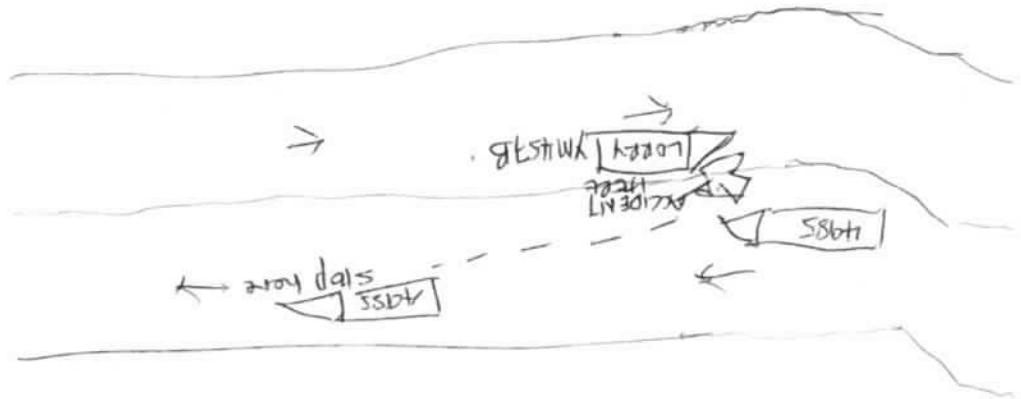
# Sketch Plan #2 Pg. 1

## DESCRIBE CIRCUMSTANCES OF THE ACCIDENT

I WAS DRIVING ALONG WEST COAST DRIVE AT AROUND 4:50PM ON 26/08/19 TO  
 FETCH MY DAUGHTER.

After the impact, I alighted my vehicle and discovered that I am involve in an accident. I noticed that my front right of my vehicle was seriously damaged and the lorry front right of the vehicle was damaged.
