**FBP1493X OD CLAIM**

Vehicle No	: FBP1493X	Accident Date	: 01/09/2019
Make	: HONDA CB150R	Policy No.	: 1900016376
Assignment Date	: 05/09/2019	Excess	: S\$600.00
Date of Inspection	: 5/9/2019	Est. Duration of Repair	: 5
Inspection At	: BIKE PRODUCTION PTE LTD

**ASSESSMENT FOR REPAIR: HONDA CB150R MANUAL - FBP1493X**

## VEHICLE DAMAGE INSPECTION REPORT

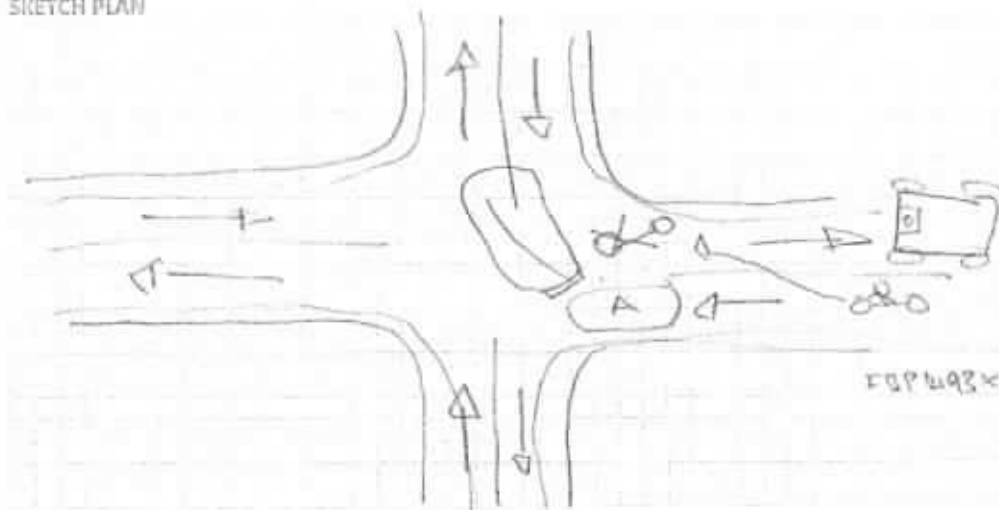
## SKETCH PLAN

ON 1 SEP 2019 I WAS ON MY WAY HOME I WAS ABOUT TO CHANGE  
 lane — a white BMW WAS INFRONT OF ME WHEN I WAS ABOUT  
 TO CHANGE LANE TO CUT THE DRIVER SUDDENLY ~~THE~~ THE DRIVER TURN  
 and I SKIDDED and fell down because there was no room way out other  
 than to jam break then the bike flip over me and I fell down  
 after that I drove back home and I didn't know what to do  
 so I didn't report it till I brought my bike to my bike shop  
 then they advice me on what to do next

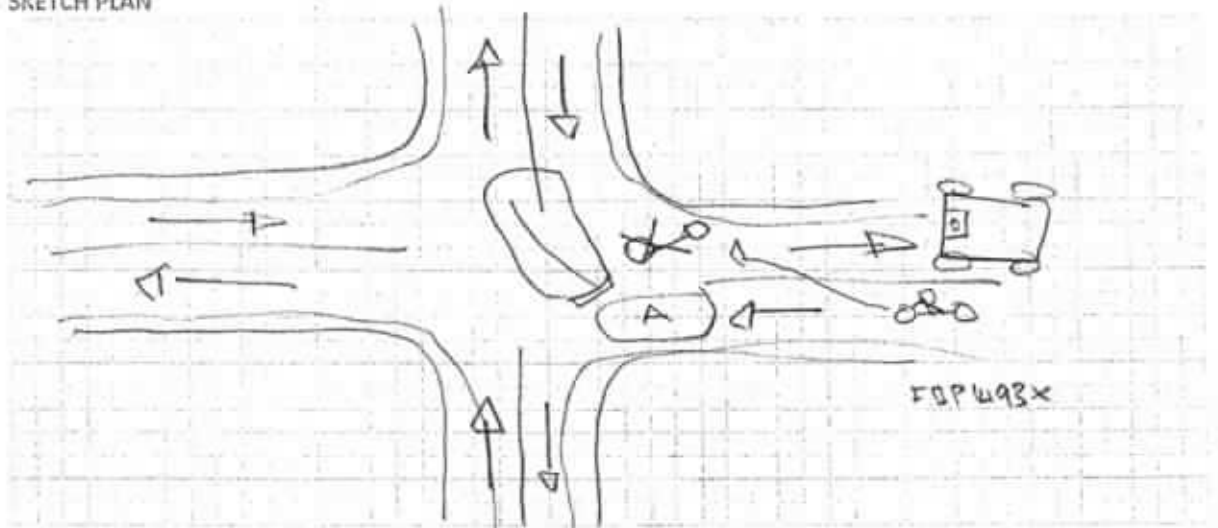
## SKETCH PLAN

ON 1 SEP 2019 I WAS ON MY WAY HOME I WAS ABOUT TO CHANGE  
 lane — a white bus WAS INFRONT OF ME WHEN I WAS ABOUT  
 TO CHANGE LANE TO CUT THE DRIVER SUDDENLY ~~THE~~ THE DRIVER TURN  
 and I Skidded and fell down because there was a car way out there  
 then I jam break then the bike flip over me and I fall down  
 after that I drove back home and I didn't know what to do  
 so I didn't report ... till I brought my bike to my bike shop  
 then they advice me on what to do next
