VEHICLE DAMAGE INSPECTION REPORT

Our File No: CS/SMO19015941/R1TF3E2

Handling Insurer:	Sompoo Insurance Singapore Pte. Ltd.	Policy No:	D19MTPV01001347
Claimant Vehicle No :	SJM2951E	Insured Vehicle No :	SGR3518B
Date of Loss:	07/09/2019	Nature of Claim:	TP
		Claim No:	CMTD1904256

Reg No:	SJM2951E	Engine No:	G4FC8U575123
Make & Model:	HYUNDAI AVANTE, 1.6 (A)	Chassis No:	KMHDU41BR9U657945
Reg. Date:	29/12/2008 (Man. Year: 2008)	Odometer:	192714 km
Colour:	Blue		
Engine Capacity:	1591 cc		
Market Value/New Car Price:	N/A		
Sum Insured (S\$):	Market Value/New Car Price

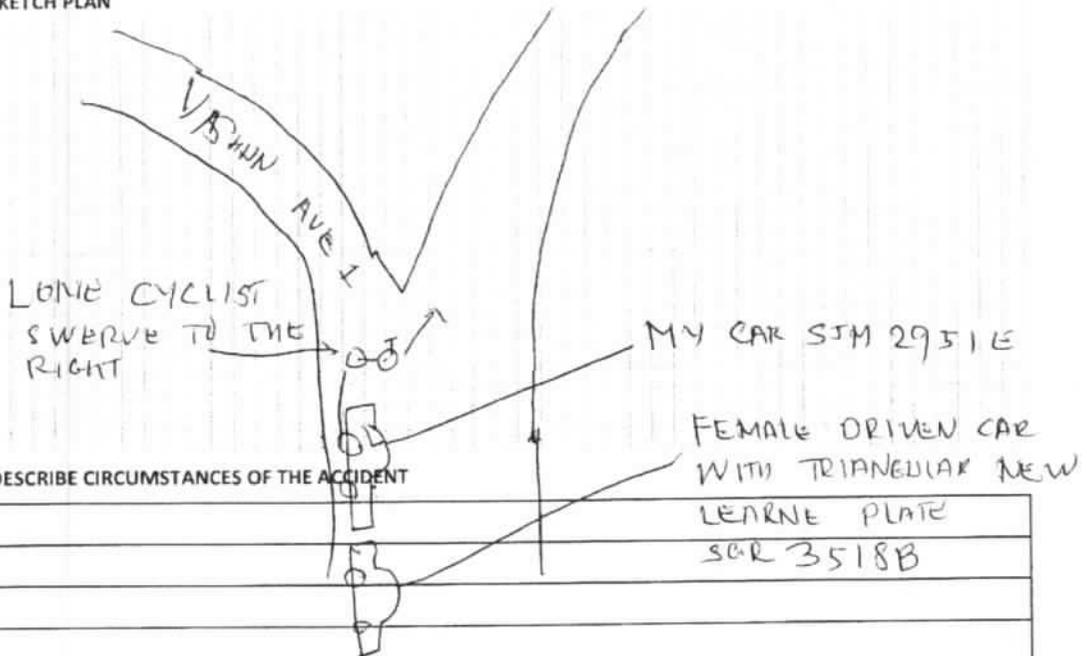
SKETCH PLAN

DESCRIBE CIRCUMSTANCES OF THE ACCIDENT

I WAS DRIVING ALONG YISHUN AVE 1 WITH A FEMALE PASSENGER. IT WAS AROUND 1550 HRS. ON SATURDAY 7 SEPTEMBER. THE WEATHER WAS FINE NO RAIN AND GOOD VISIBILITY. A CYCLIST IN FRONT OF ME SUDDENLY DECIDED TO CHANGE LANES FROM THE EXTREME LEFT TO ~~THE~~ THE RIGHT LANE. I WAS RUNNING AT ABOUT 55-60 KMP HOUR. WHEN THE CYCLIST SWERVED HE DID NOT BOTHER TO CHECK BEHIND HIM SO I HAD TO BRAKE SUDDENLY AND AVOID HIM SO AS NOT TO HIT ~~HIM~~ HIM. THE CAR BEHIND ME COULD NOT BRAKE IN TIME AND SO HIT ME FROM BEHIND IN THE REAR BUMPER CAUSING DAMAGE TO MY REAR THAT THE BUMPER COULD NOT BE CLOSED. SINCE IT WAS DANGEROUS TO STOP AND INSPECT FOR ANY DAMAGE ON THE MAIN ROAD AS IT WAS ON THE CORNER, I DROVE SLOWLY AND FOUND A SAFE PLACE TO INSPECT FOR DAMAGE AND EXCHANGE PARTICULARS WITH THE OTHER DRIVER.
