Insured: SJS 2631Y

4. Description of Damages

THE VEHICLE SUSTAINED DAMAGES AT THE FRONT PORTION. DAMAGES SEE DETAILS.

ADJUSTMENT ON REPAIR COST FOR VEHICLE NO. SG 6119R

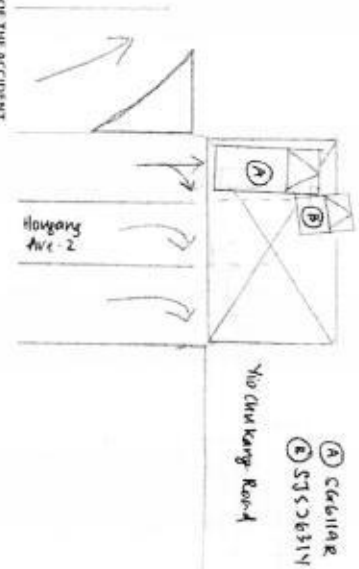
SKETCH PLAN

WHILE TRAVELLING ON THE LEFT MOST LANE ALONG HOUGANG AVE 2 PREPARING TO MAKE A RIGHT TURN TOWARDS YIO CHU KANG ROAD, SUDDENLY I SAW A PTE CAR ON THE CENTRE LANE DASH PASSED TO OVERTAKE MY BUS AND IN PROCESS, THE PTE CAR GRAZED THE RIGHT FRONT PORTION OF MY BUS. I ASSESSED THE DAMAGES ON MY BUS AND FOUND SCRATCH MARKS ON THE RIGHT FRONT BUMPER. THE PTE CAR SUSTAINED THAT DAMAGES ON THE LEFT PORTION. THE PTE CAR DRIVER (PTE HIRE) TOLD ME THAT HE WAS UNAWARE THAT THE CENTRE LANE IS ONLY FOR TURNING RIGHT. THERE WERE ABOUT 30 PAX IN MY BUS AND NO INJURIES WERE REPORTED.
