**Preliminary Advice**

Vehicle No	: YN4524J	Accident Date	: 07/09/2019
Make	: MITSUBISHI CANTER	Policy No.	: DMCPHQ18-007218
Assignment Date	: 10/09/2019	Excess	: S\$3,750.00
Date of Inspection	: 10/09/2019	Est. Duration of Repair	: 7.00
Inspection At	: SNG AH TEE MOTOR & PANEL SERVICE PTE LTD (PIONEER) BLK 3 PIONEER ROAD NORTH, #01-18 SINGAPORE 628457

## VEHICLE DAMAGE INSPECTION REPORT

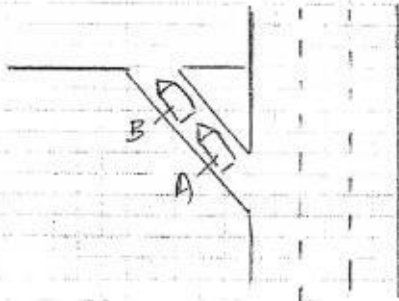
## SKETCH PLAN

ON 07/09/2019 @ ABT 0740HRS. WHEN THE VEHICLE B WHICH IS IN FRONT OF ME SUDDENLY JAMMED BRAKE. AS FOLLOWER, I COULD NOT STOP IN TIME & KNOCKED ONTO THE SAID VEHICLE AT REAR. NO ONE WAS INJURED. THAT'S ALL.

PLE turns Chong ext Rt Barbale East Ave 3

vehicle @: 4N4524J

vehicle @: GBB6554U
