### **PRE-REPAIR SURVEY REQUEST: Accident involving SGW4473M & GBJ1666X on 07/09/2019**

## Preliminary Advice

Insured Vehicle No	: GBJ1666X	Accident Date	: 07/09/2019
TP Vehicle No	: SGW4473M	Assignment Date	: 10/09/2019
Make	: NISSAN SYLPHY	Est. Duration of Repair	: 7 days
Date of Inspection	: 11/09/2019		
Inspection At	: Autoworx House - Sin Ming (HQ) 176 SIN MING DRIVE #02-01 Singapore 575721

## VEHICLE DAMAGE INSPECTION REPORT

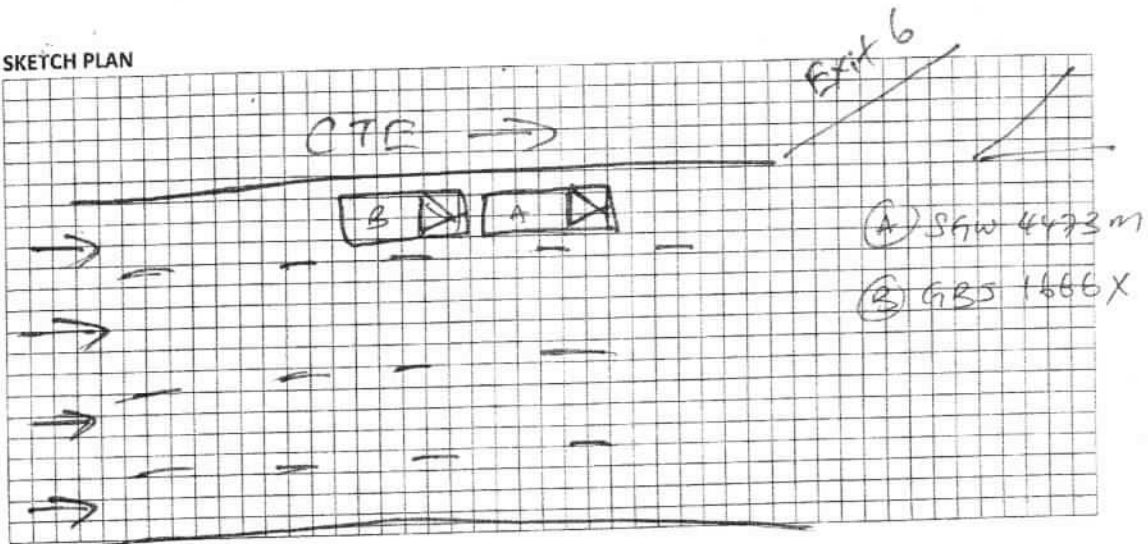
SKETCH PLAN

I was driving along CTE towards ATE on the extreme left lane. Reaching near the exit 6, vehicles in front of me had stopped. I stopped my vehicle (SGW 4473m) too. Moments later, lorry (GBS 1666X) failed to stop in time, collided into the rear of my vehicle with a hard impact.
