Registration no. : PA 9876 K / HIGER KLQ6108GQ 6.7 M/T ABS TURBO  
Acc/date: 6.9.2019

**DAMAGE ASSESSMENT REPORT**

NTUC INCOME INSURANCE CO-OPERATIVE LTD Ref: CS/INC19016050/R1qd3n2

## ADJUSTMENT ON REPAIR COST FOR VEHICLE NO. PA 9876K

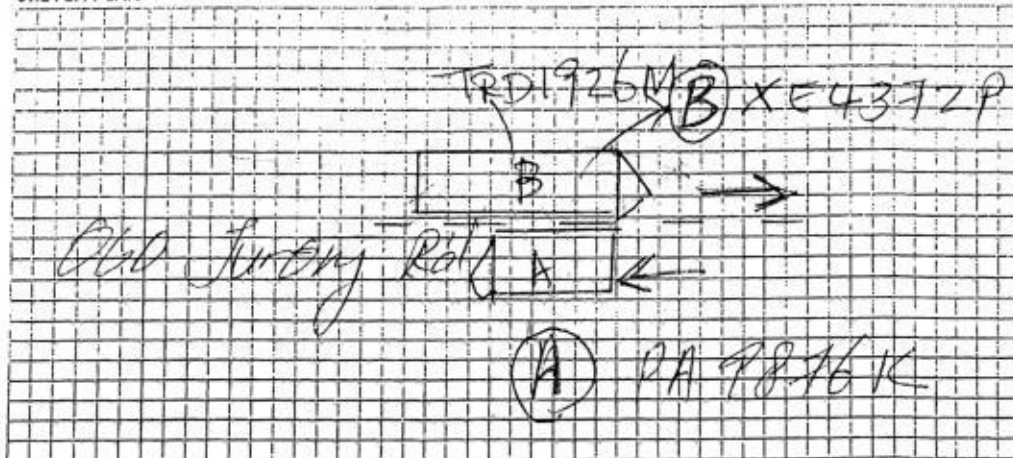
Sketch Plan #2 Pg. 1

I'm driving my vehicle A) PA 9876 K at along Old Jurong Road. On that time, there was only two lanes available and I'm on the extreme left lane and I noticed right side opposite direction an "oversized vehicle" XE 4372 P / TRD 1926 M was passing by towards my direction so I stopped and stationary to give way as the road is slightly bending.

Well, the vehicle passed by halfway, note that the heavy vehicle crane step board panel is too near and caused to my bus rear right side body pillar to damage along with the window glass to shatter.
