Your ref: D19005829MFSH

**INITIAL INSPECTION REPORT OF VEHICLE NO. SHD 89D**

## ADJUSTMENT ON REPAIR COST FOR VEHICLE NO. SHD 89D

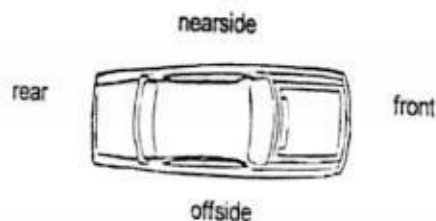
**Description of Damage:**

The vehicle sustained damages at the o/s front portion

**Comments/Present Status:**  
Damages Consistent
